TECHNICAL REPORT NO. 62

## The Trip to Las Campanas During the Big Snowstorm of 1997 August

Brek A. Miller

1997 November 12

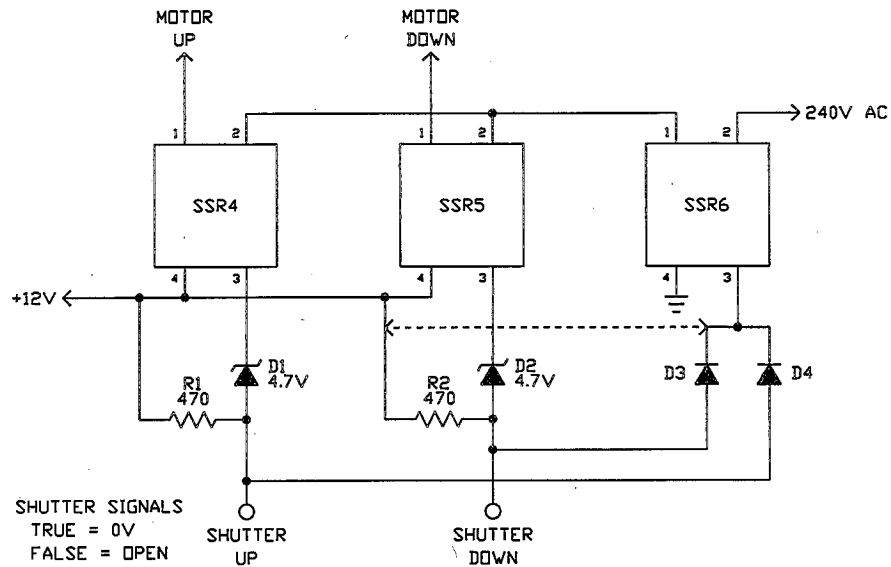
**Figure 1:** The shutter-control section of the relay box. I added the jumped indicated by the broken line to overcome the problem with the 4.7-V Zener diode, for which there was no spare.

The symptoms I first observed were as follows. With the relay box set to automatic and with both SHUTTER DOWN and SHUTTER UP signals at false, the shutter would drive up. Setting SHUTTER DOWN to true caused the motor to stall and hum. It also caused the lights in the dome to dim. Clearly, both the up and down windings in the motor were being powered at the same time. If allowed to remain in this condition, the motor would eventually trip out the thermal cutout. The problem was that SSR<sub>4</sub> was always closed. I replaced SSR<sub>4</sub>.

powered. Setting SHUTTER UP to true would drive the shutter up, however setting SHUTTER DOWN to true would drive the motor in both directions. I traced this problem to diode  $D_1$  on the input of  $SSR_4$ —it was short circuit.

Why did this cause a problem? The answer is not obvious from a first look at the circuit drawing. We need to understand why  $D_1$  and  $D_2$  are required. Assume for the moment that both  $D_1$  and  $D_2$  are short circuit. The two pull-up resistors  $R_1$  and  $R_2$  are meant to keep pins 3 of  $SSR_4$  and  $SSR_5$  at +12 V when the inputs are open circuit. However, the two inputs are connected through  $SSR_6$  to ground, thus pins 3 of  $SSR_4$  and  $SSR_5$  are not at +12 V but are instead slightly lower. They are normally at a voltage that is just above the threshold at which the solid-state relays close, so everything is ok. Now when one of the two inputs is grounded, the corresponding relay closes. However, now only half the original current flows through the input side of  $SSR_6$  so the voltage at pin 3 of  $SSR_6$  goes down slightly. This causes the voltage on the relay side of the pull-up resistors on the other solid-state relay to go down slightly too. It falls to just below the relay threshold and the other relay closes too. The 4.7-V Zener diodes ensure that the voltage on pin 3 stays above the threshold for the relay.

Although I identified the bad diode, I was unable to find a replacement. There were no Zener diodes of any value in both our dome and in the Las Campanas electronics workshop. As a temporary fix, I replaced  $D_1$  with a short circuit and added a jumper as shown in Figure 1. This holds pin 3 of  $SSR_6$  at +12 V all of the time thus keeping  $SSR_6$  permanently closed. It also prevents any voltage drop across  $R_1$  and  $R_2$  and this keeps  $SSR_4$  and  $SSR_5$  open when the corresponding inputs are open circuit.

The drawback to this solution is that we no longer have protection against trying to drive the motor both ways at the same time. However, in all of our years of operation, the dome-control modules have never tried to drive the motors both ways at the same time. This has to do with the design of the dome-control modules and is not software dependent. The software can not drive the motors both ways even it wanted to.
