# **BiSON** Birmingham Solar-Oscillations Network

TECHNICAL REPORT NO. 74

## **A Visit to Las Campanas in 1998 January**

1998 April 2

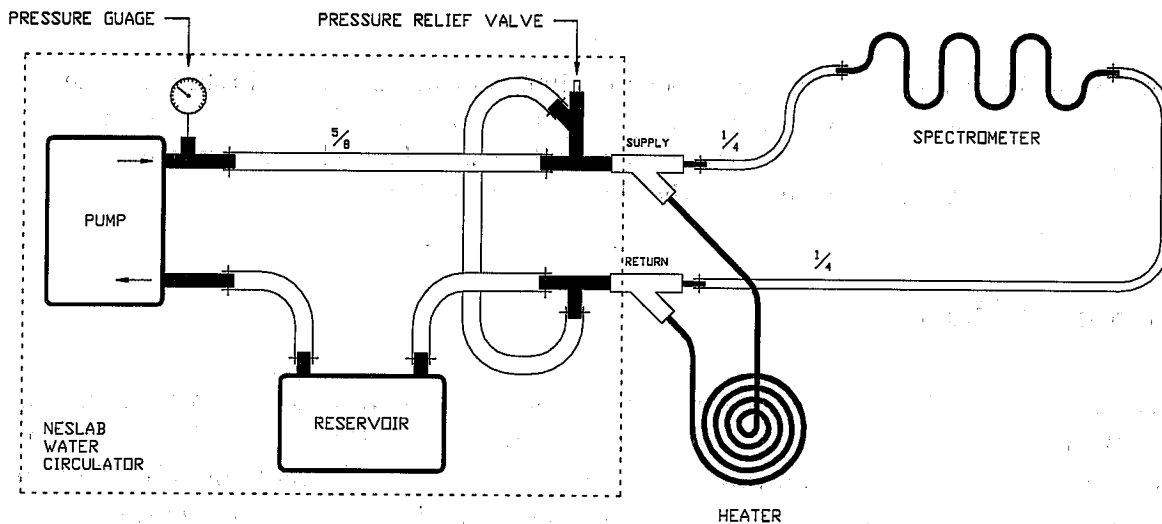
**Figure 1:** The original configuration of the Neslab water circulator. The sizes of the hoses are shown in inches and are the measure of the inner diameters.

The original configuration of the Neslab water circulator is shown in Figure 1 on the facing page. Richard added the oil drum to the return part of the loop as shown in Figure 2 on the next page. The internal reservoir had to be sealed in this configuration so that the pump could draw water from the oil drum. Richard also sealed the oil drum.

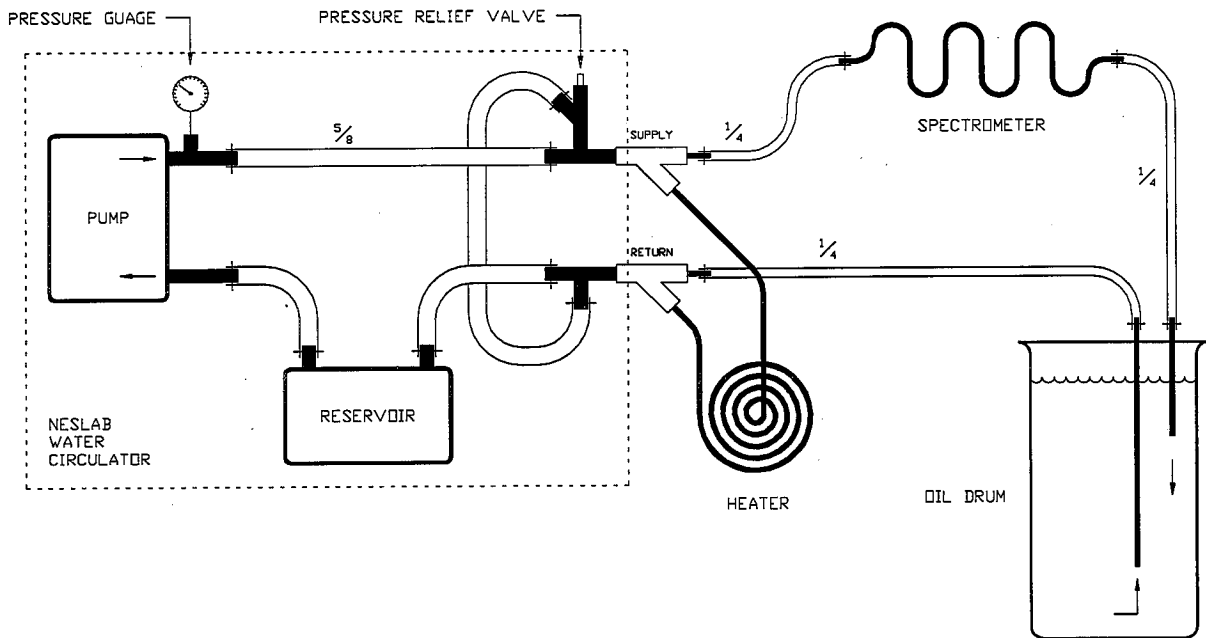
**Figure 2:** The Las Campanas water cooling loop after Richard Lines added a forty-four-gallon oil drum. Note that the drum is sealed. The sizes of the hoses are shown in inches and are the measure of the inner diameters.

The one feature of this configuration that I dislike is that it is necessary to manually prime the system. If the internal reservoir and all of the hoses are empty, the pump cannot draw water out of the oil drum. Two things are responsible for this: First, the internal reservoir contains too much air. Second, the heater loop acts as a short circuit.

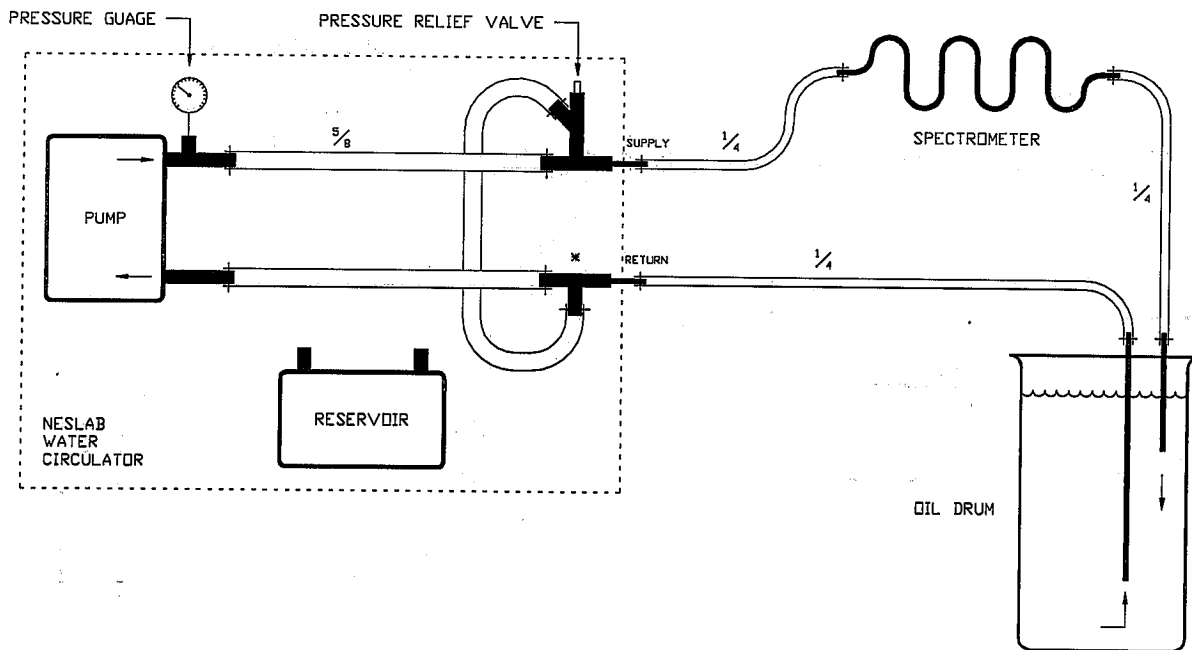
These two steps comprised my first attempt at fixing the water system. The configuration is shown schematically in Figure 3 on the following page. Had the system been completely sealed, it may have worked. However air entered the system at some point near to the pressure-relief valve.

**Figure 3:** The Las Campanas water cooling loop after I removed the heating coil and the internal reservoir from the loop. The star marks the point at which air was leaking into the system. The sizes of the hoses are shown in inches and are the measure of the inner diameters.

In the configuration in Figure 3, a large amount of air was going around in this loop. Small amounts of the air we deflected off, passed through the spectrometer, and then were removed from the loop in the oil drum. One would expect that all of the air in the system would eventually end up in the oil drum. However this did not happen. Air was leaking into the system somewhere.

The pump complained noisily about having air bubbles passing through it. The sealed nature of the oil drum only made matters worse. The tank became pressurized. As the pressure in the system increased, the pump complained more and more loudly.

I removed the heater loop from the back of the water circulator. Remember that the heater was not being used because the control electronics failed some time ago. I have carried all of the pieces, including the mechanical and solid-state relays, back to Birmingham so that Joe Litherland can modify another Neslab water circulator, if we should ever buy another one. The workshop people here were kind enough to weld some fittings to replace the wye junctions that Joe put on the back of the circulator.

I also removed the internal reservoir from the circuit.

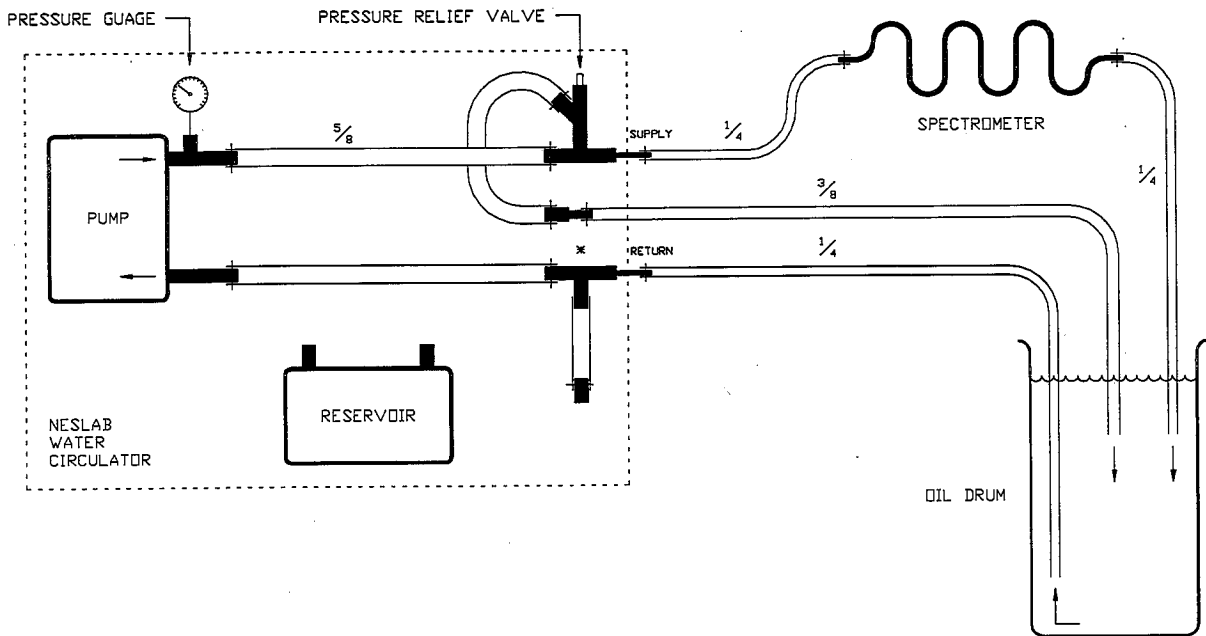
**Figure 4:** The Las Campanas water cooling loop after I redirected the over-pressure water directly to the oil drum. Air was still leaking into the system at the return connection (marked with a star) on the back of the Neslab circulator. The system is now unsealed.

Air still entered the system. Now it was clear that there was a leak at the return connector on the back of the Neslab circulator. I decided to bypass this connector entirely. The workshop gladly made me one more 5/8-inch-to-3/8-inch adaptor and I moved the hoses to the configuration shown in Figure 5 on the following page.

I suspected that the leak was in the pressure-relief system and decided to break the loop and divert the over-pressure water directly to the tank. This is how the water loop is setup in Narrabri. The configuration is shown in Figure 4. The workshop people were kind enough to make for me the 5/8-inch plug and the 5/8-inch-to-3/8-inch adaptor that I needed to accomplish this. I also unsealed the oil drum at this point.

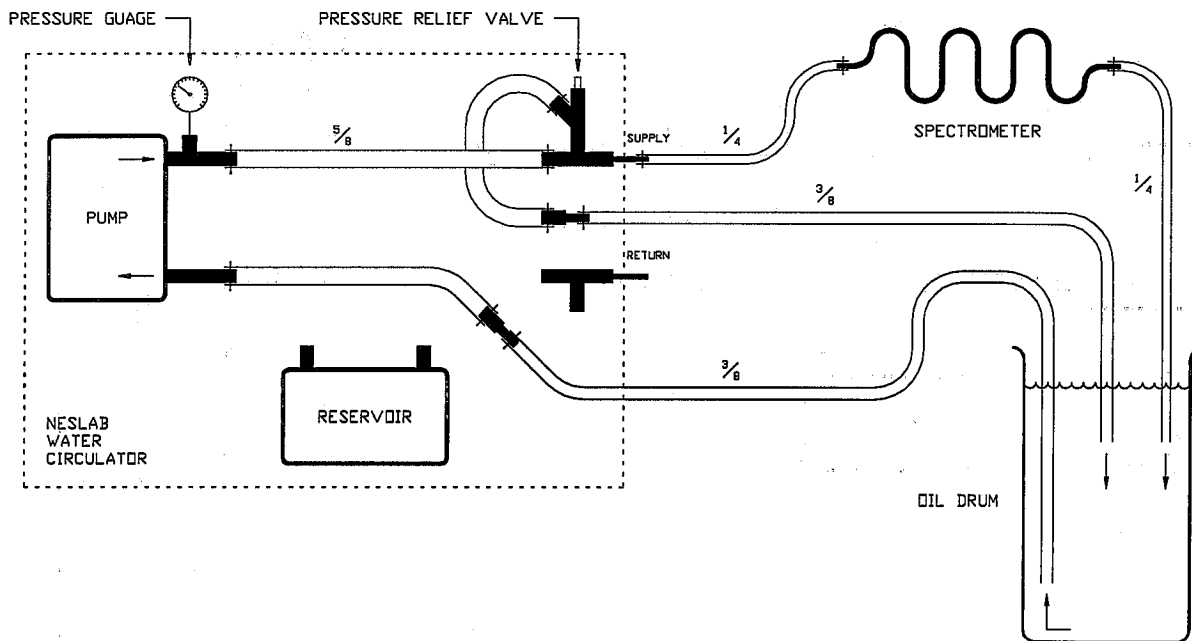
The third try was lucky. There were no more air leaks and the system performed well. An additional advantage to this configuration is that the hose from the oil drum to the pump is 3/8-inch in diameter as opposed to the 1/4-inch diameter hose originally used.

There are now only two things missing from this setup that are present in Narrabri: a radiator and a float switch. With an ambient temperature of 24°C, January 22 was probably one of the hottest days in Las Campanas. A radiator may not be necessary. It will be interesting to see if the heat being deposited in the oil drum can be dissipated quickly enough. The water in the tank may slowly increase in temperature over several days to an unacceptable level.

**Figure 5:** The final configuration of the Las Campanas water cooling loop. Here the return connector on the back of the Neslab recirculator has been bypassed. Also, the hose from the tank is now 3/8-inch in diameter rather than the original 1/4-inch in diameter.

In order to facilitate the removal of heat from the oil drum, I applied some adhesive-backed aluminum foil that I found in our dome to the sides of the drum.

The second item missing, the float switch, may be important and probably should be installed on a future visit. Although a float switch was originally incorporated into the Carnarvon system to prevent the pump from running dry, it serves a much more useful purpose in Narrabri. If in Las Campanas one of the hoses upstairs near the spectrometer breaks, the Neslab circulator will quite happily pump forty-four gallons of water up to the top only to have it all rain back down onto the computer and electronics.

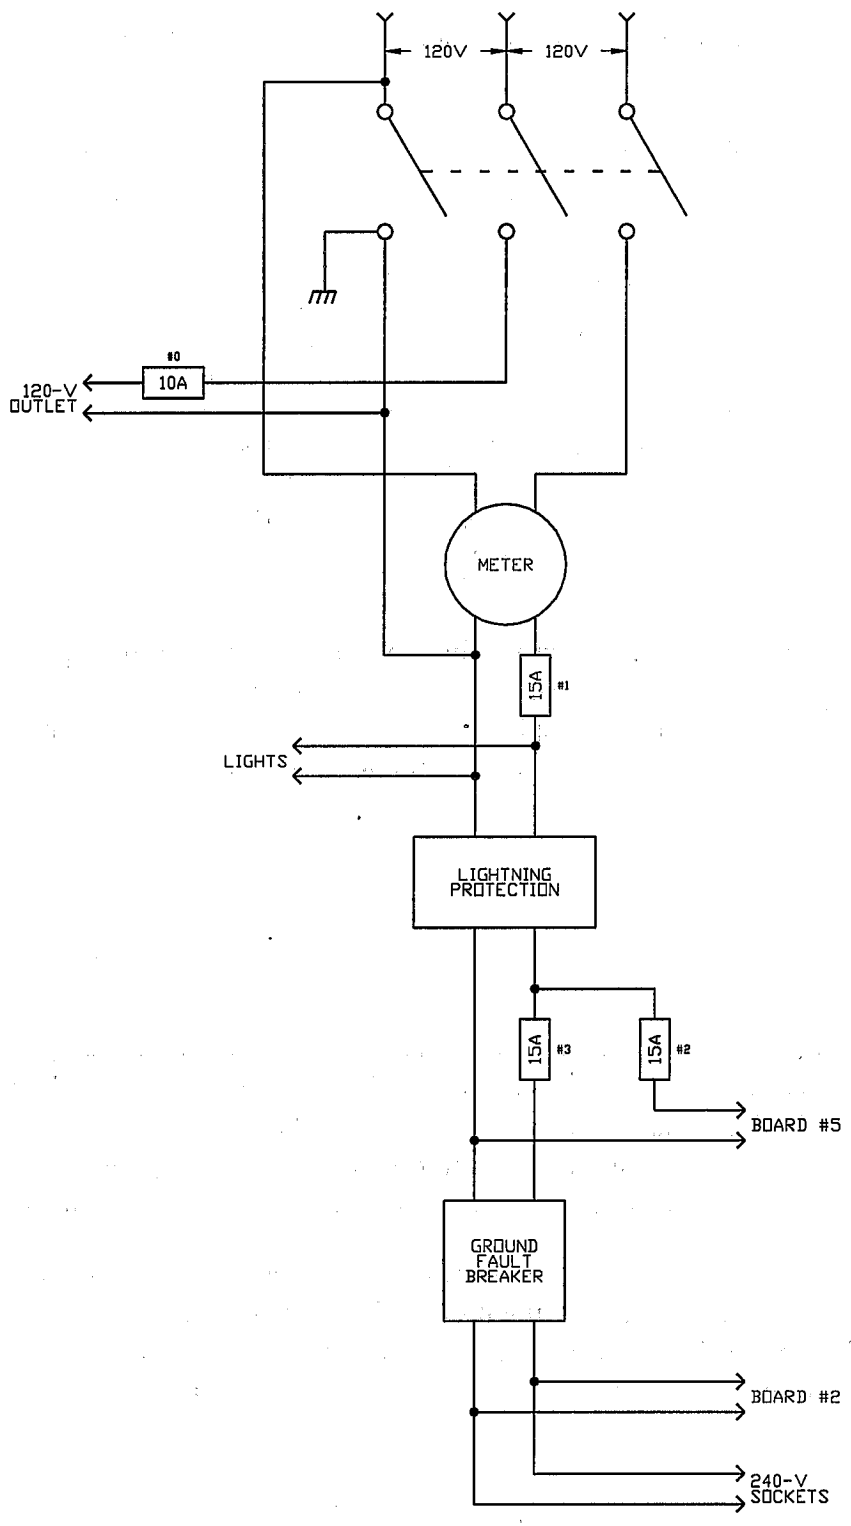
Figure 6: The circuit-breaker box in Las Campanas.

With the addition of the meter, the wiring in the circuit-breaker box is getting quite complicated. In case anyone needs to make sense of it in the future, the connections are shown in Figure 6 on the following page. It is my opinion that the meter is connected incorrectly and is only measuring half of our actual power usage. I made no effort to correct this or to point it out to anyone on site.

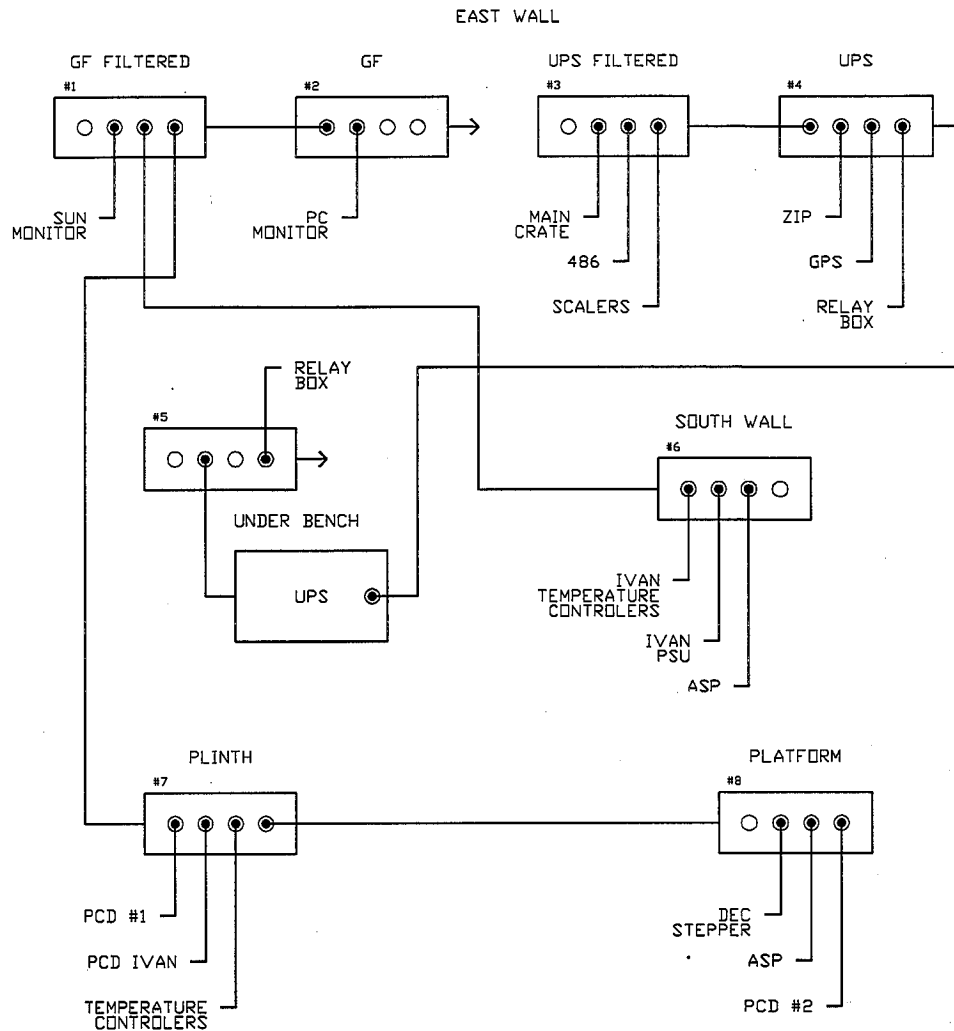
**Figure 7:** The arrangement of the mains cables in Las Campanas. Boards #2 and #5 are hardwired to the circuit-breaker box (see Figure 6 on the preceding page). Board #2 is connected to the ground-fault (earth-leakage) circuit breaker, Board #5 is not. Boards #1 and #3 are filtered.

There has been several devices installed in the time since the last UPS failed and things were plugged in without regard for what needs UPS power and what does not. I rearranged all of the mains cabling, the new layout is shown in Figure 7.

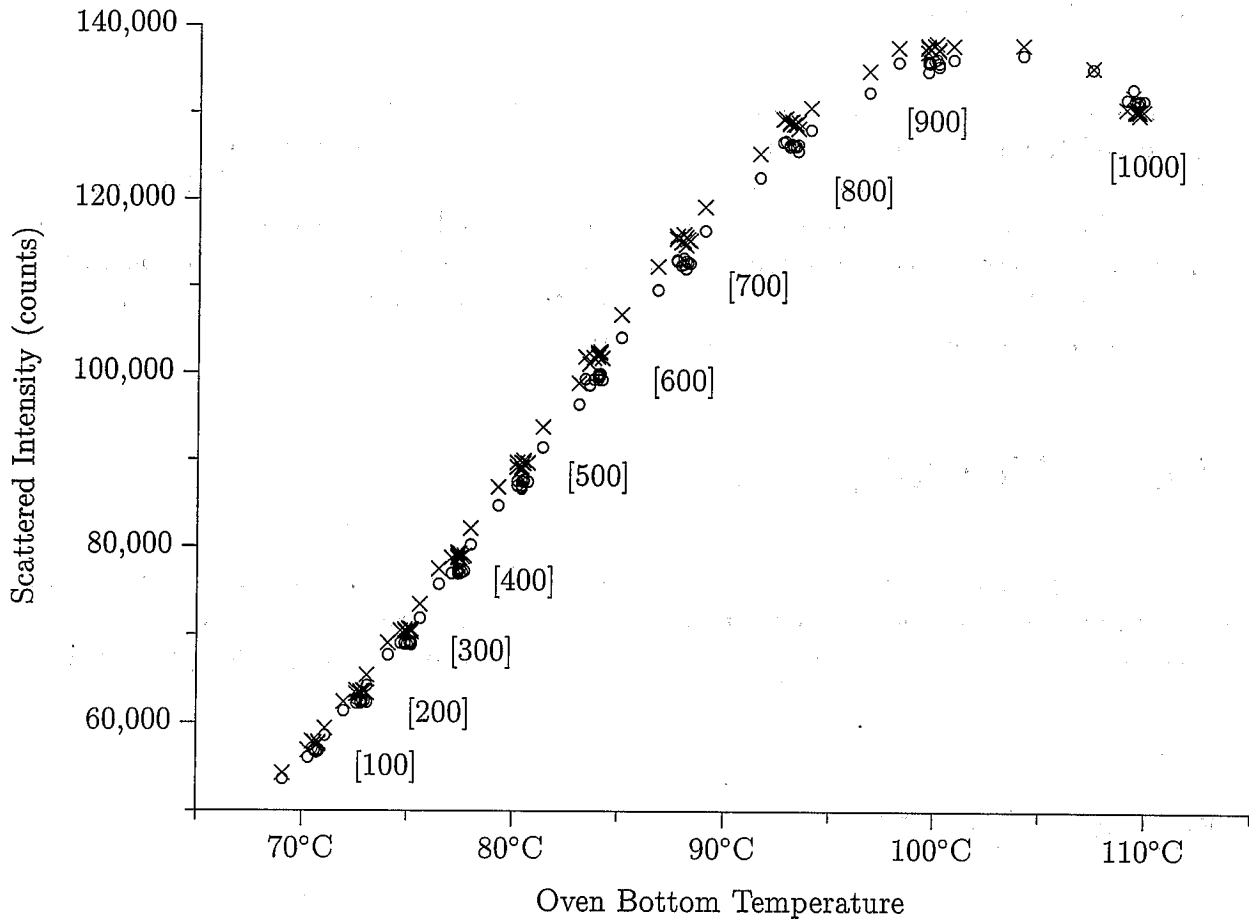
I acquired a heating curve for both instruments. The results for Spectrometer H are shown in Figure 8 on the next page and the results for Ivan are shown in Figure 9 on page 17. In both cases the original temperature setting turned out to be the optimal value.

Figure 8: Heating curve for Spectrometer H. The counts from the starboard detector ( $\circ$ ) are shown separately from those from the port detector ( $\times$ ). The dial on the front of the temperature controller was set at ten positions ranging from 100 to 1000. Each point shown represents the mean of 10 3.2-second readings. Twelve points were collected at each dial setting. The dial values corresponding to each clump of data points are shown.

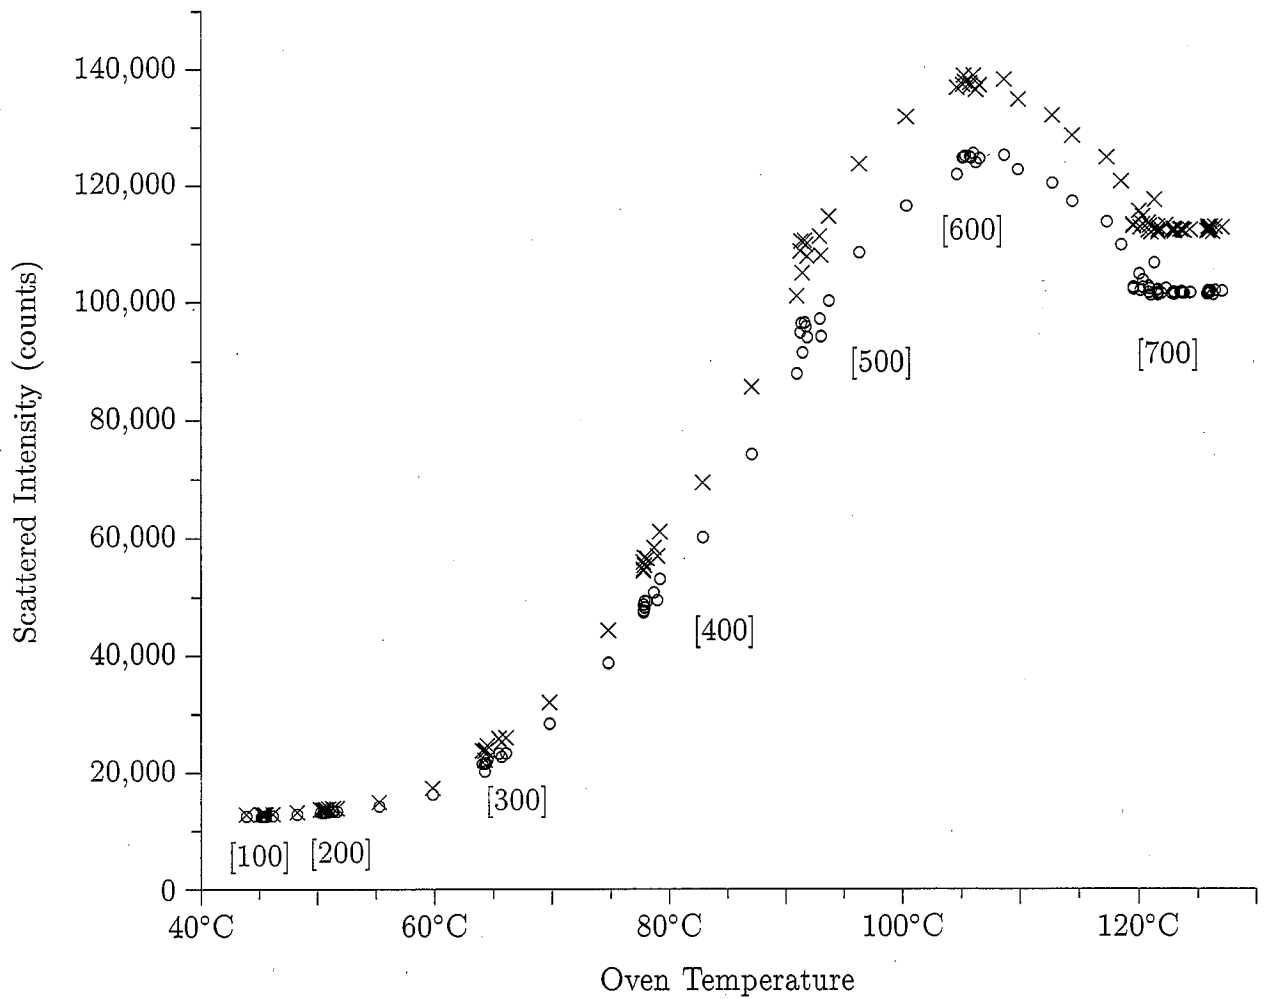
**Figure 9:** Heating curve for Ivan. The counts from the starboard detector (o) are shown separately from those from the port detector (x). The dial on the front of the temperature controller was set at seven positions ranging from 100 to 700. Each point shown represents the mean of 10 3.2-second readings. Twelve points were collected at each dial setting. The dial values corresponding to each clump of data points are shown.
