BiSON Birmingham Solar-Oscillations Network

TECHNICAL REPORT NO. 246

The Installation of a new Transmission Monitor in Izaña in 2004 November

2005 January 26

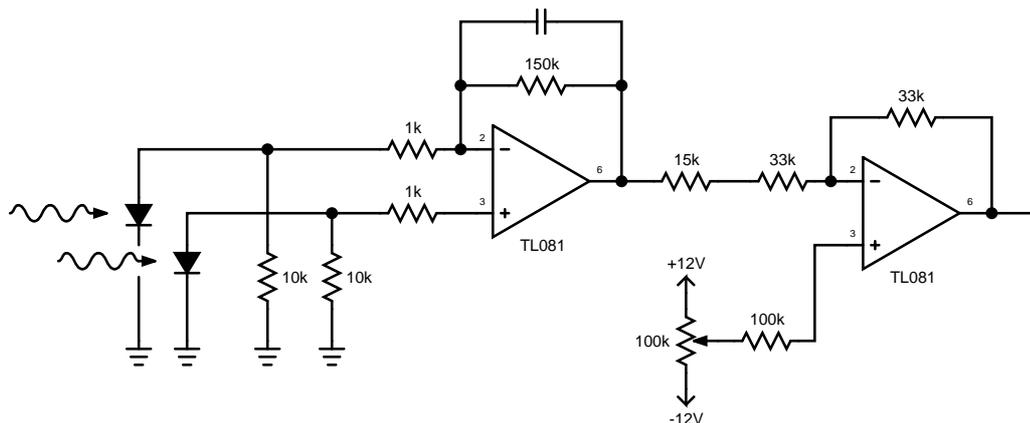
Figure 1: A partial schematic drawing of the autoguider differencer.

Pere told us that the problem was with the power supply inside the autoguider differencer. The internal 5-V supply was working, but someone had had to connect an external ± 15 -V supply to the differencer.

We guess that perhaps there was previously a problem inside the autoguider differencer (a short somewhere, perhaps) that was causing too much current to be drawn from the regulators making them shut down. This problem was probably cleared when the wires were rearranged to accommodate the external supply.

While we were examining the autoguider differencer, we made a note of part of the circuit inside. It is built on a piece of Veroboard. We did not remove the Veroboard so we could not make a complete circuit drawing, but we were able to learn that the photodiodes are being used in voltage mode. The partial circuit is shown in Figure 1.

We decided not to reconnect the external supply. The autoguider differencer worked correctly for the remainder of our visit. We did periodically check the temperatures of the regulators, but nothing seemed amiss.
