TECHNICAL REPORT NO. 261

The Grand Opening of the Las Campanas Zoo

Steven J. Hale and Brek A. Miller

2006 February 1

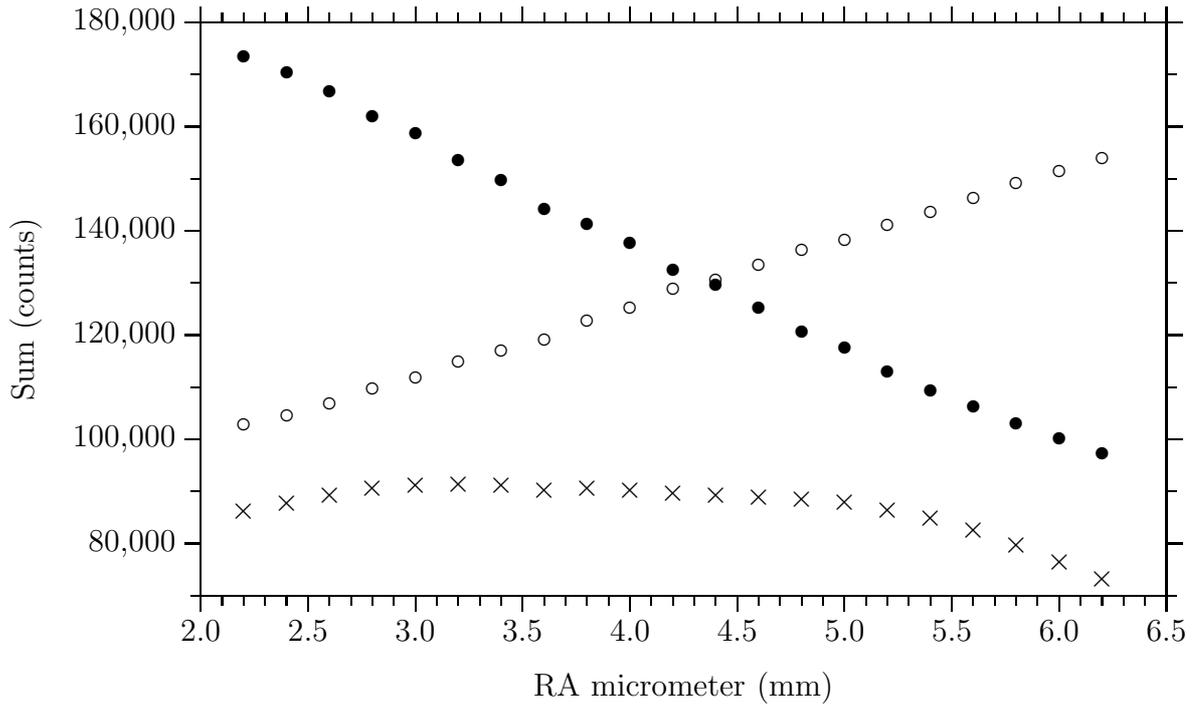
We performed two autoguider scans in order to check the alignment of the mount. The results of the right-ascension scan are shown in Figures 1 and 2. It looks like Hannibal is centered when the right-ascension micrometer is set to 4.3 mm while Ivan is centered at 4.5 mm. The autoguider telescope is 500 mm long, so the angular offset between the two spectrometers is:

Figure 1: Hannibal sums from an right-ascension autoguider scan. The plot shows how the starboard sum (●), port sum (○), and transmitted sum (×) varied. The transmission monitor data has been multiplied by two. This scan was done with the declination micrometer set at 1.6 mm.

After that scan, we set the micrometer to 4.4 mm hoping that this would be in the middle. But it looked like this now favored Ivan, so we nudged the micrometer back to 4.3 mm. Incidentally, the micrometer was set at 4.2 mm before we began the scans.

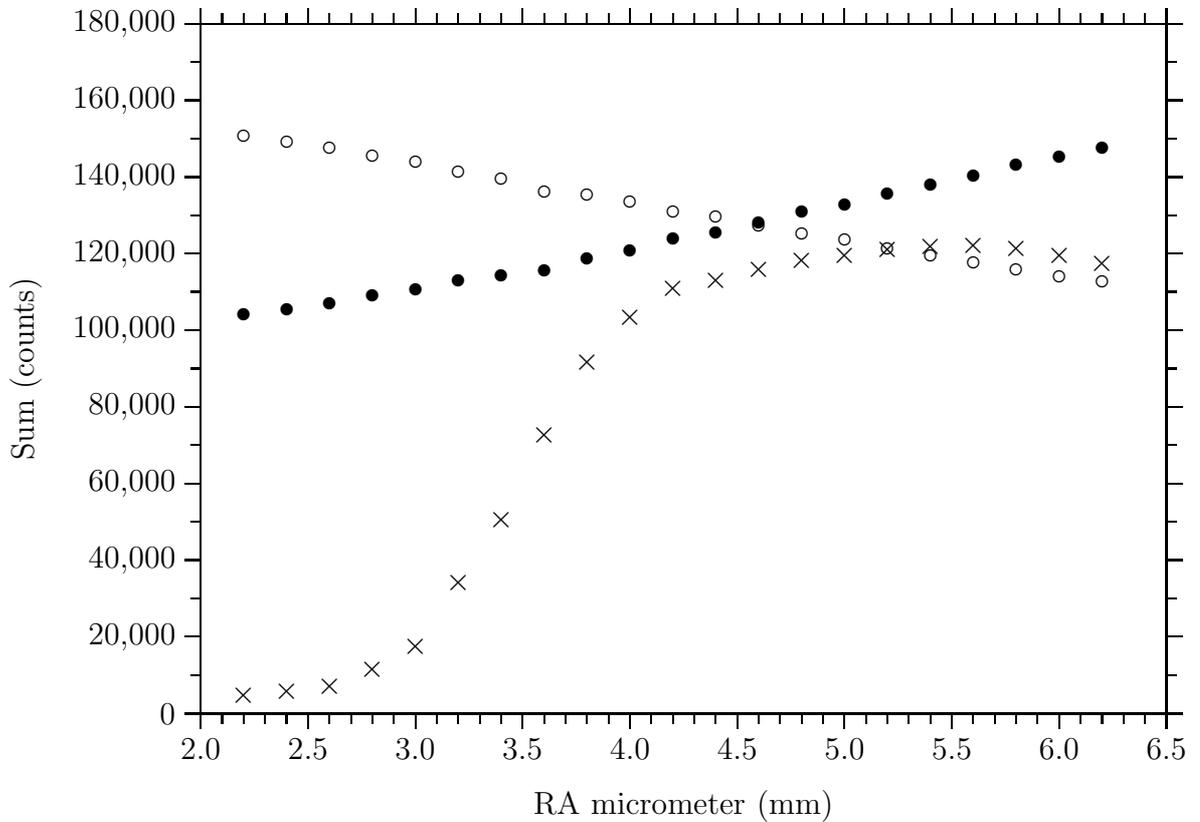
Figure 2: Ivan sums from an right-ascension autoguider scan. The plot shows how the starboard sum (●), port sum (○), and transmitted sum (×) varied. The transmission monitor data has been multiplied by ten. This scan was done with the declination micrometer set at 1.6 mm.

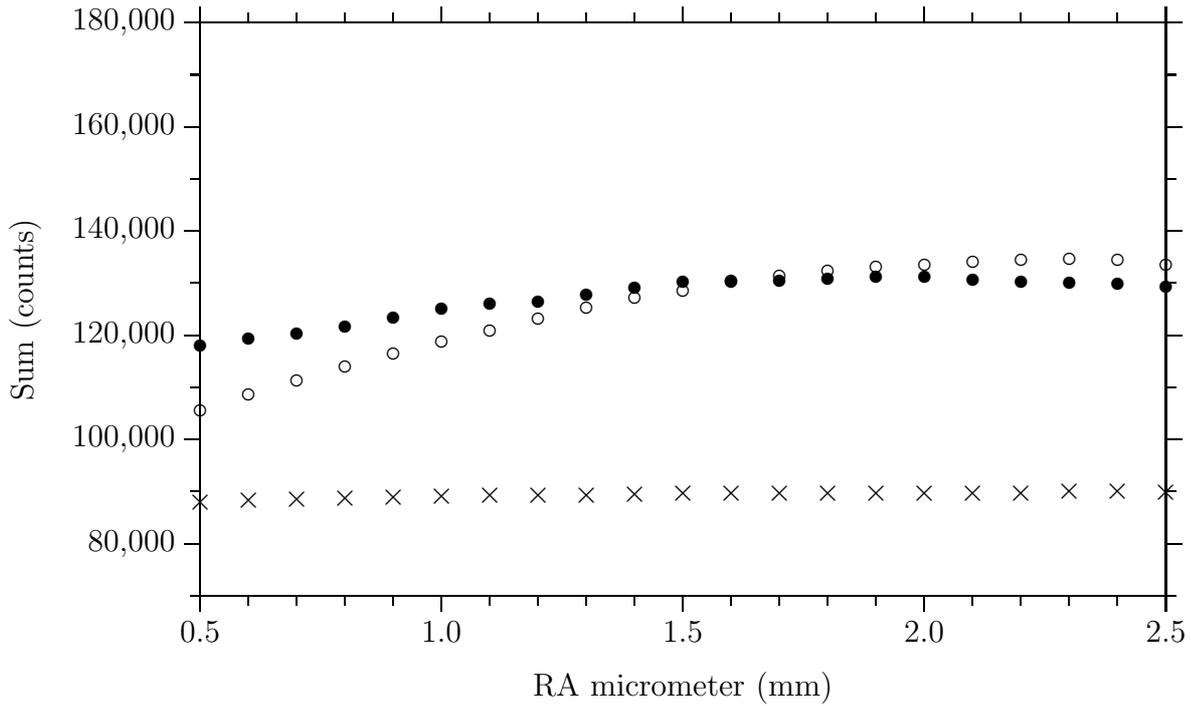
Figure 3: Hannibal sums from a declination autoguider scan. The plot shows how the starboard sum (●), port sum (○), and transmitted sum (×) varied. The transmission monitor data has been multiplied by two. This scan was done with the declination micrometer set at 4.2 mm.

The results of the declination scan are shown in Figures 3 and 4. It looks like Hannibal wants the declination micrometer set to 2.0 mm while Ivan wants 1.25 mm. We compromised and set it at 1.6 mm. Before the scan, the micrometer was set to 1.4 mm.

$$\theta = \frac{0.75 \text{ mm}}{500 \text{ mm}} = 0.00150 \text{ rad} = 0^\circ 08' 59'' = 5'16''.$$

The center box in the mount is 290 mm long. To correct this error, we would need a 0.435-mm-thick shim under the front of Ivan.

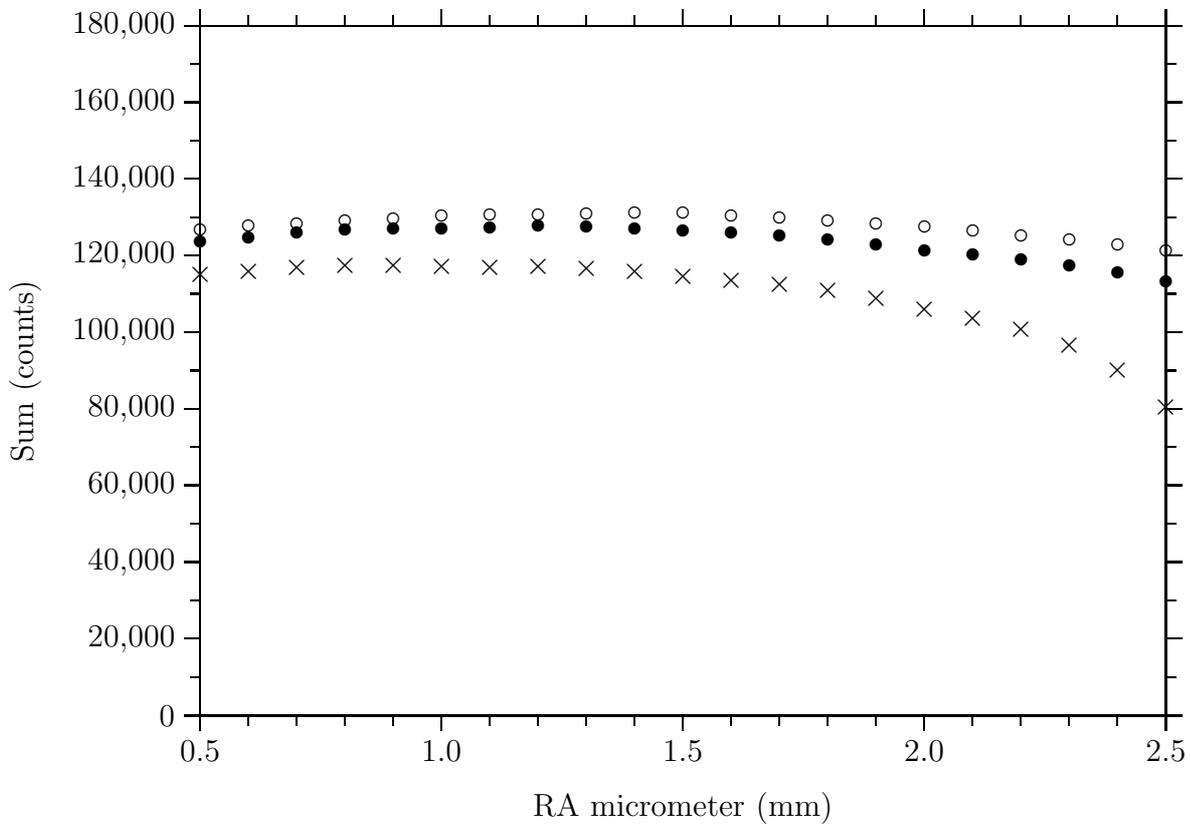
Figure 4: Ivan sums from a declination autoguider scan. The plot shows how the starboard sum (●), port sum (○), and transmitted sum (×) varied. The transmission monitor data has been multiplied by ten. This scan was done with the declination micrometer set at 4.2 mm.
