TECHNICAL REPORT NO. 303

## The Replacement of the Shaft Couplers in Las Campanas in 2008 March

Steven J. Hale

2008 April 23

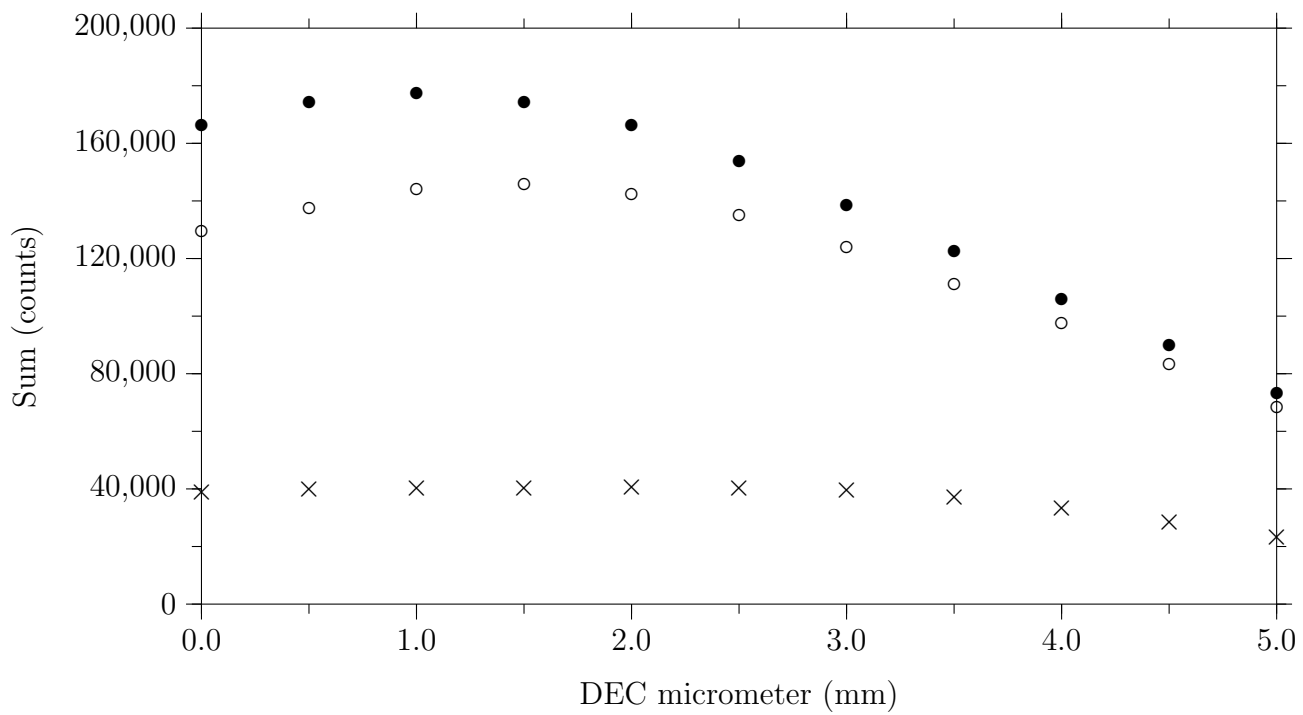
The results of the declination scan are shown in Figures 3 and 4. It looks like Hannibal wants the declination micrometer set to 2.5 mm while Ivan wants 1.5 mm. The best compromise here seems to be a setting of 2.0 mm. The initial setting was 2.25 mm and so a slight improvement was made.

**Figure 3:** DEC scan (Hannibal) - The guider was scanned declination. The plot shows how the starboard sum (●), port sum (○), and the transmission monitor (×) varied. This scan was done with the right ascension micrometer set at 4.0 mm and the cell hot.

**Figure 4:** DEC scan (Ivan) - The guider was scanned declination. The plot shows how the starboard sum (●), port sum (○), and the transmission monitor (×) varied. The transmission monitor data have been divided by ten. This scan was done with the right ascension micrometer set at 4.0 mm and the cell hot.
