TECHNICAL REPORT NO. 332

The Installation of New Temperature Controllers at Narrabri in 2010 February

Ian Barnes and Steven Hale

2010 November 9

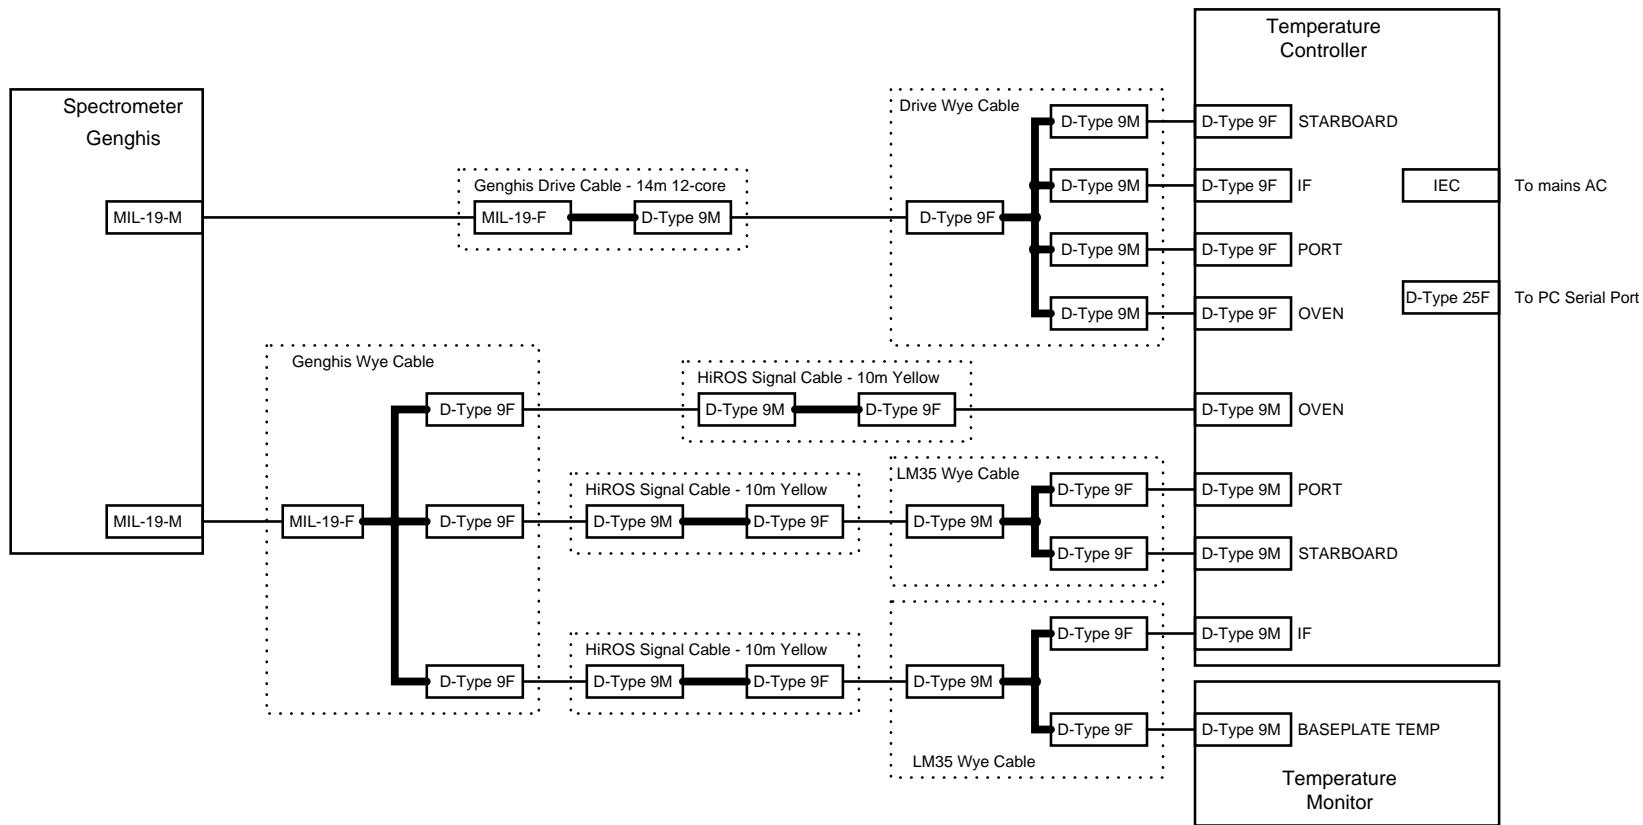
Figure 2: The Narrabri temperature controller system.

With the installation of the new temperature controllers there would also be changes necessary to the temperature monitor. The new temperature controller system is shown in Figure 2.

During the setup of the temperature controllers it was spotted that the power required to keep the port and starboard detectors at the required set-point of 20°C was very different. By switching off the temperature control and allowing the detection to settle at the ambient temperature, it was found that there was a 1.5°C offset between the two temperature sensors in the detectors. To match the powers required by both detectors, the set point of the port detector was increased to 21.5°C to compensate for the offset.

An offset of -210208 counts was applied to the port detector in *zoo.conf*, and the setpoint of both detectors reset to 23°C . The power required to maintain this temperature was now the same in both detectors.

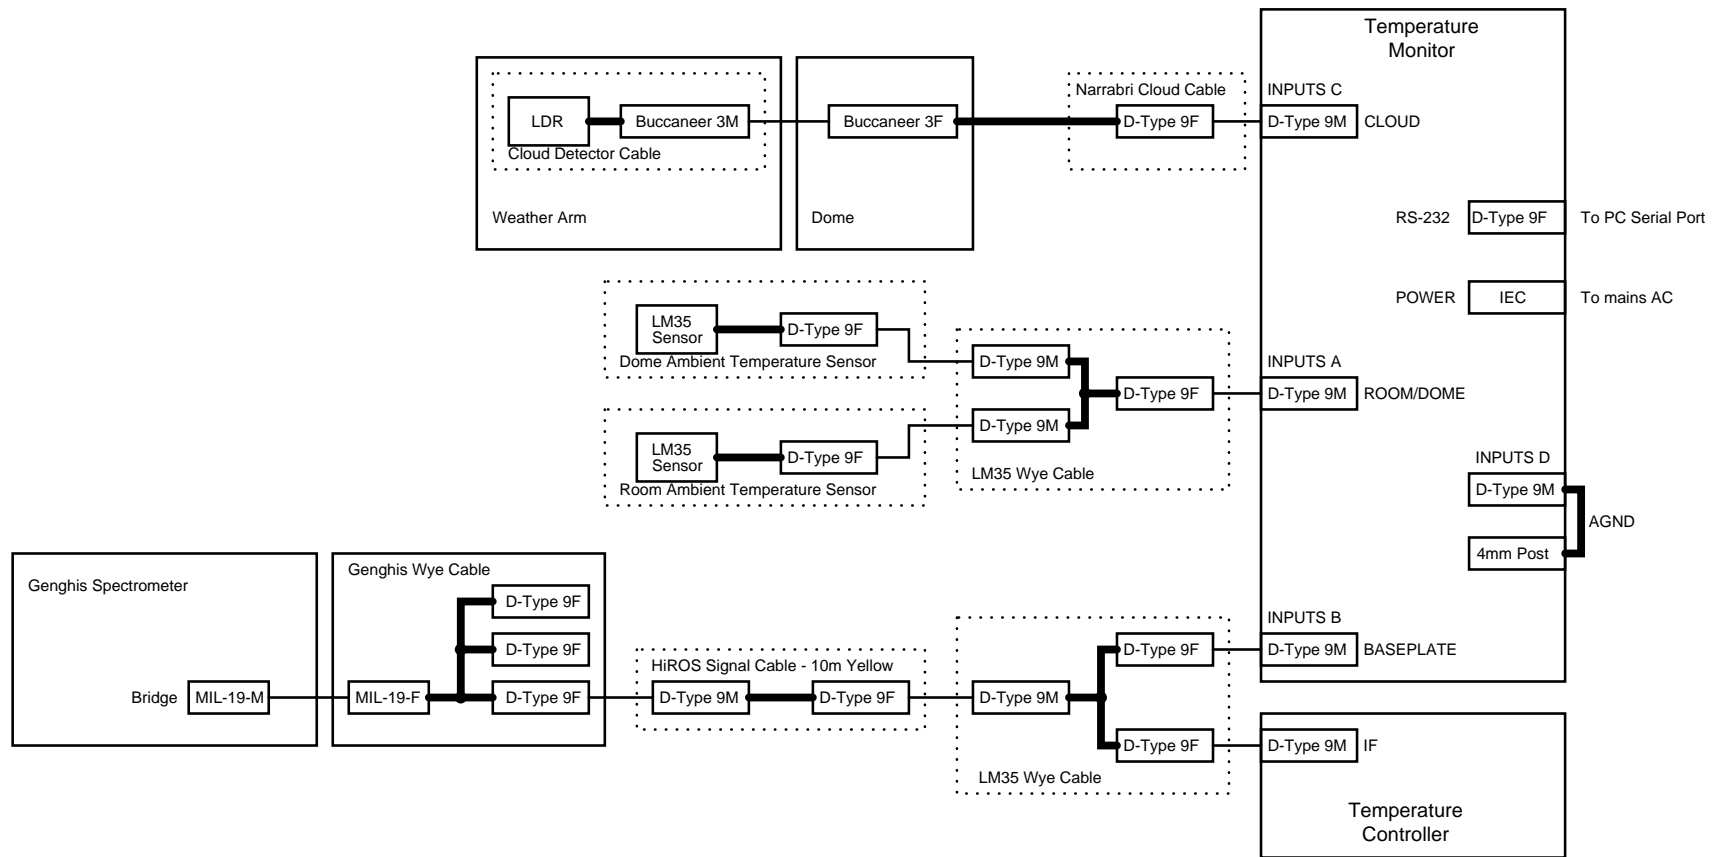
Figure 3: The Narrabri temperature monitor system.

The room and dome temperatures are measured using LM35 temperature sensor ICs on long cables. The spectrometer baseplate temperature comes from within the spectrometer down one of the cables going to the temperature controllers. The system diagram for the re-configured temperature monitor in Narrabri is shown in Figure 3.

Usually the output from the LM35 sensors is fed into an amplifier stage contained on an LM35 board within the temperature monitor main unit. Unfortunately the Narrabri unit does not have an LM35 board inside it and so the LM35s had to be connected directly to the ADC. This meant a loss of resolution but at least the temperatures could still be measured.

The temperature monitor hardware has undergone several hardware revisions since the Narrabri unit was built. Given the lack of the LM35 board and the fact that the cloud detector interface is on veroboard it is strongly recommended that the temperature monitor here gets replaced on the next visit.

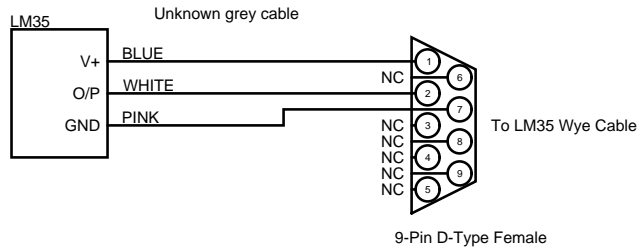
Figure 4: The Narrabri temperature probes.

Also the existing wiring for the LM35 temperature probes was found to be incorrect and used non-standard cable. The probes were re-wired and the wiring is shown in Figure 4.

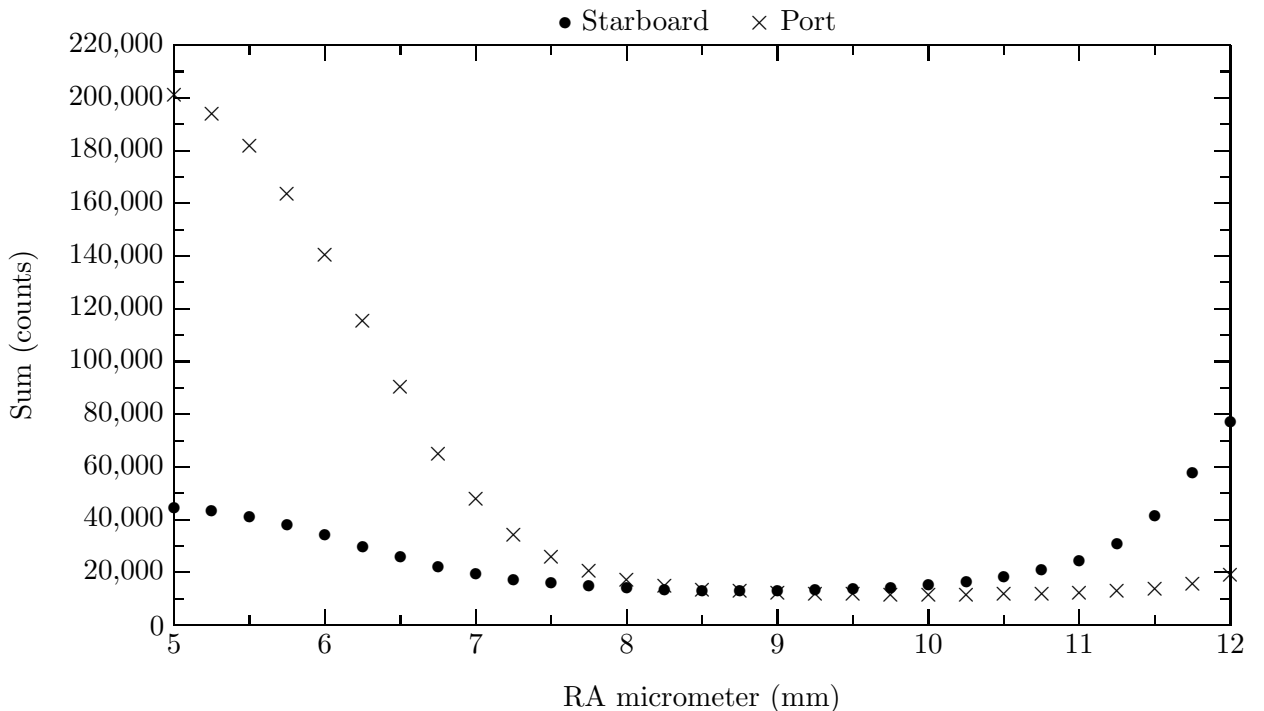
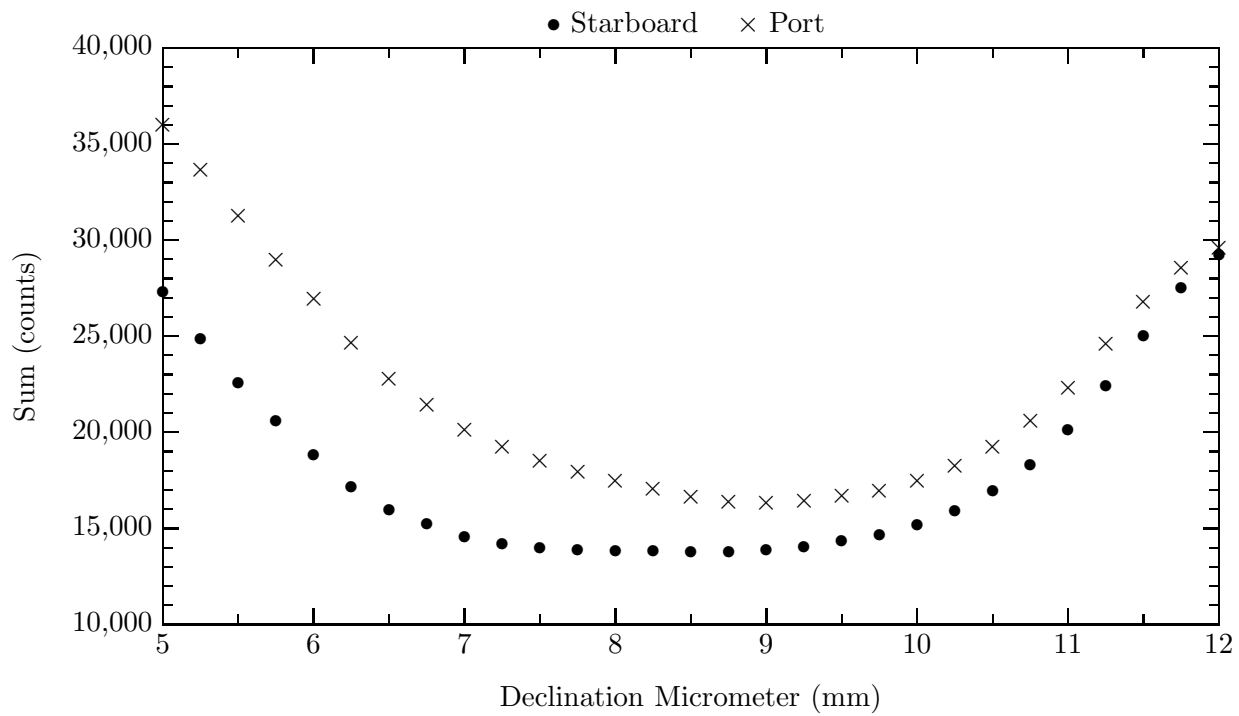
Figure 6: Cold RA scan (2010 February 10).

The first scan was done with the oven cold (see Figures 6 and 7). There appears to be some misalignment in RA of the two detectors, since the scan did not suggest the same position for both. A setting of RA = 9.5 mm and Dec = 8.75 mm seemed the most appropriate to minimize the cold scattering.

Figure 7: Cold declination scan (2010 February 10).

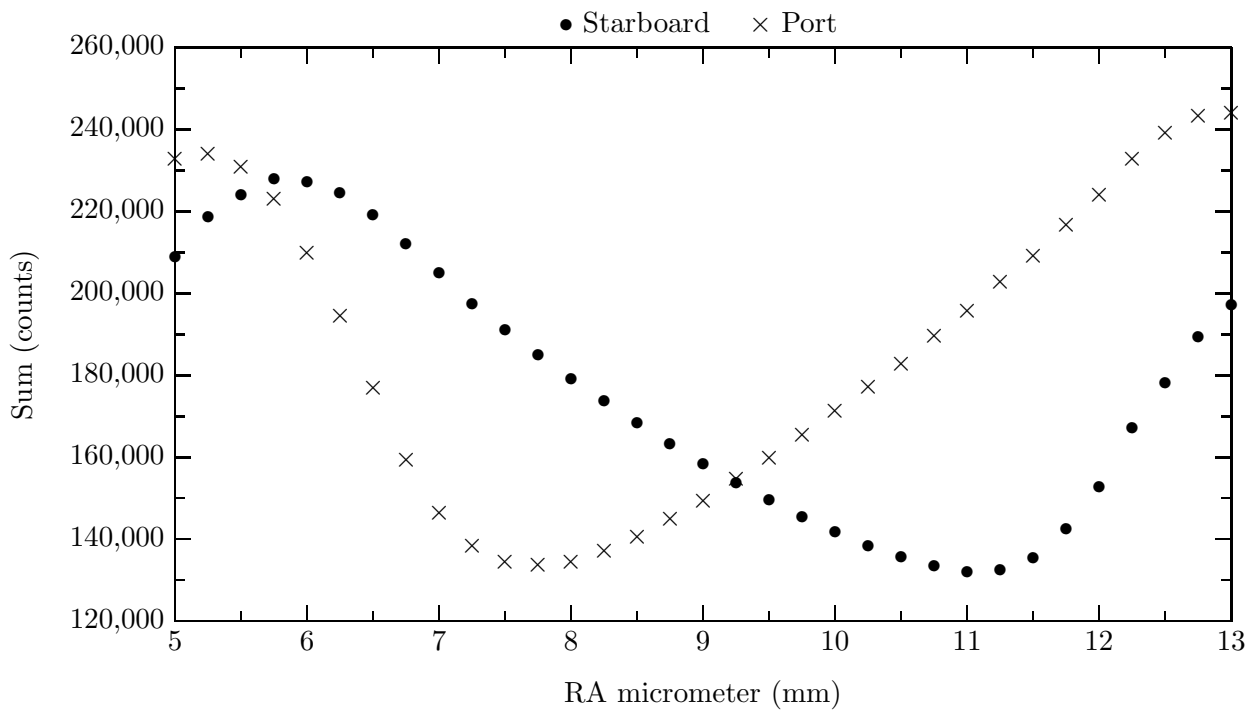
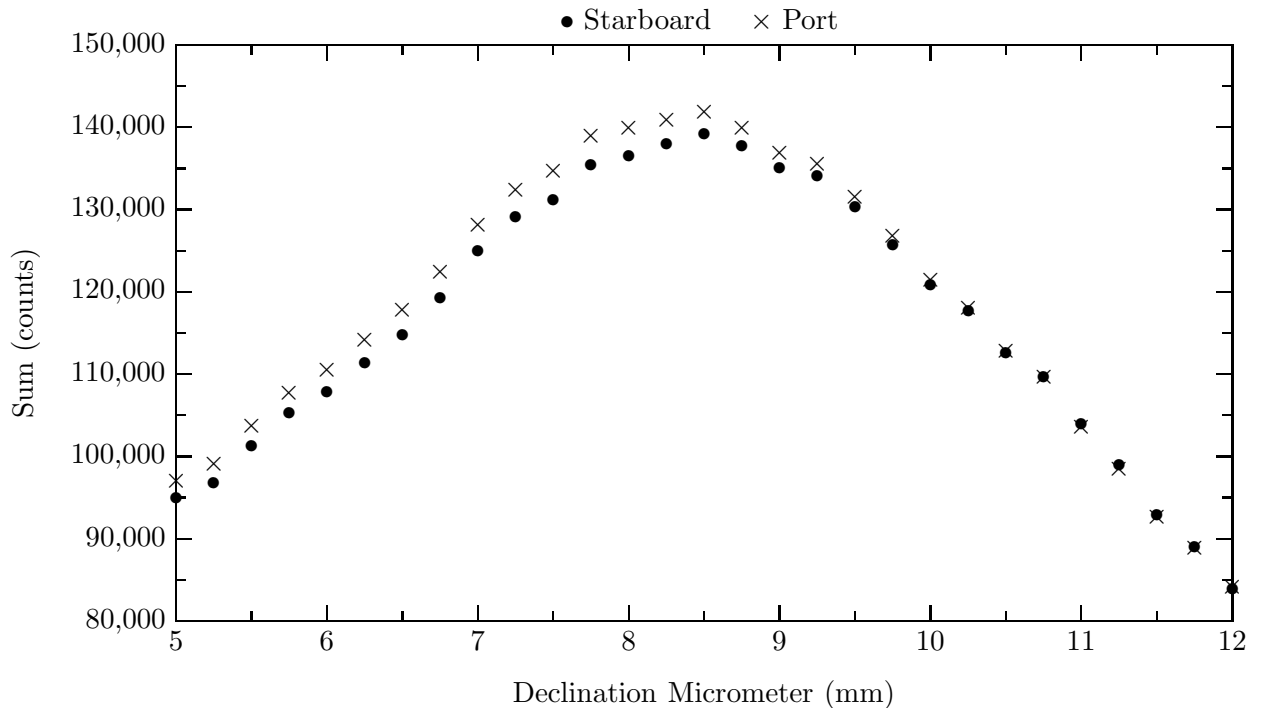
Figure 8: Hot RA scan (2010 February 13).

Figure 9: Hot declination scan (2010 February 13).

The oven was brought back up to temperature and another scan performed (see Figures 8 and 9). With the cell hot, the misalignment between the two detectors was even more obvious. The best position was chosen to be where the two sums crossed over which was RA = 9.25 mm. The best value for Dec was much more obvious with a clear peak at Dec = 8.5 mm.

Following the scans the guider was left at RA = 9.1 mm and Dec = 8.5 mm.

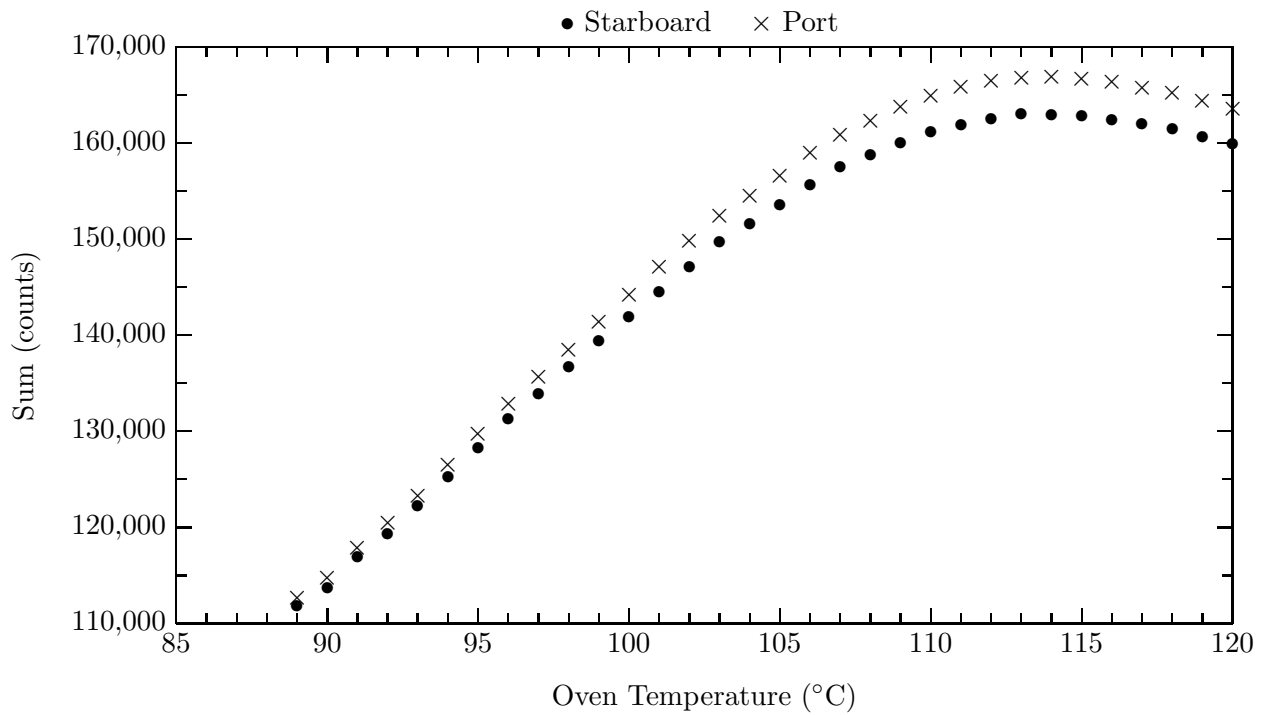
Figure 10: Heating curve (2010 February 16).

On arrival the oven was set to 106°C. After installing the new temperature controllers and optimizing the instrument alignment, a scan was performed on the oven temperature (see Figure 10). The peak was found to be at 113°C and so the oven temperature was increased to this setting.
