BiSON

TECHNICAL REPORT NO. 343

The Installation of a Digital Autoguider in Las Campanas in 2011 March

2011 May 26

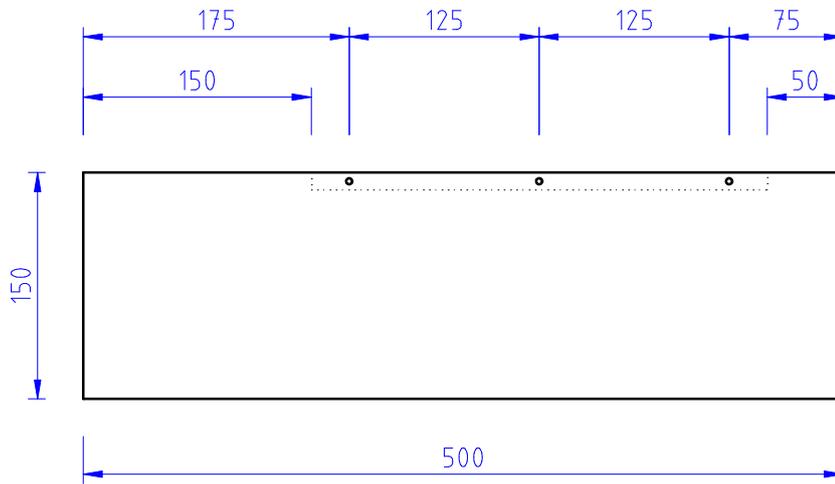
Figure 1: RA worm-wheel sun shield. 1:5 scale.

I believe there was too much grease on the worm wheel and that the grease was too heavy. I will order some more of the lighter, spray-on grease that we have recently been using in Birmingham. I think this will work better. I have also added a sun shield to the front of the mount. It shadows the RA worm wheel. Previously, the worm wheel has been exposed to the sun all day. I am sure that this exposure quickens the deterioration of the grease. The shield that I made is shown in Figure 1 on the facing page. We should install these shields at the other stations too.

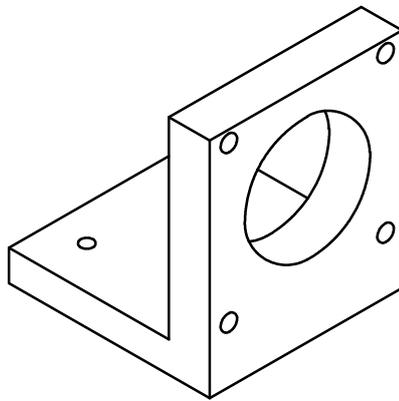
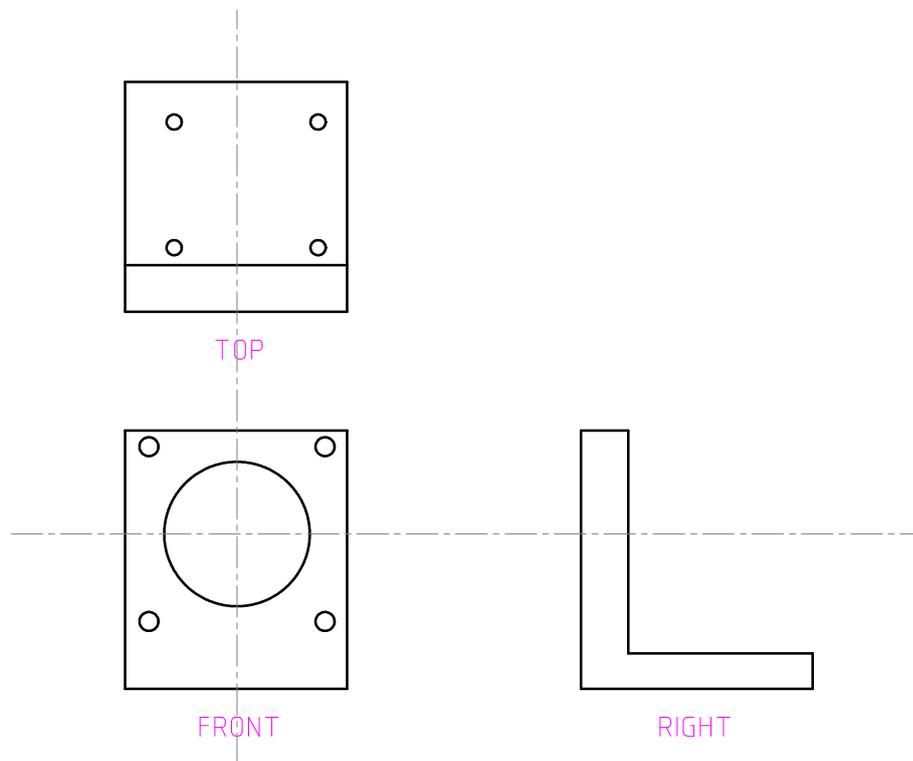
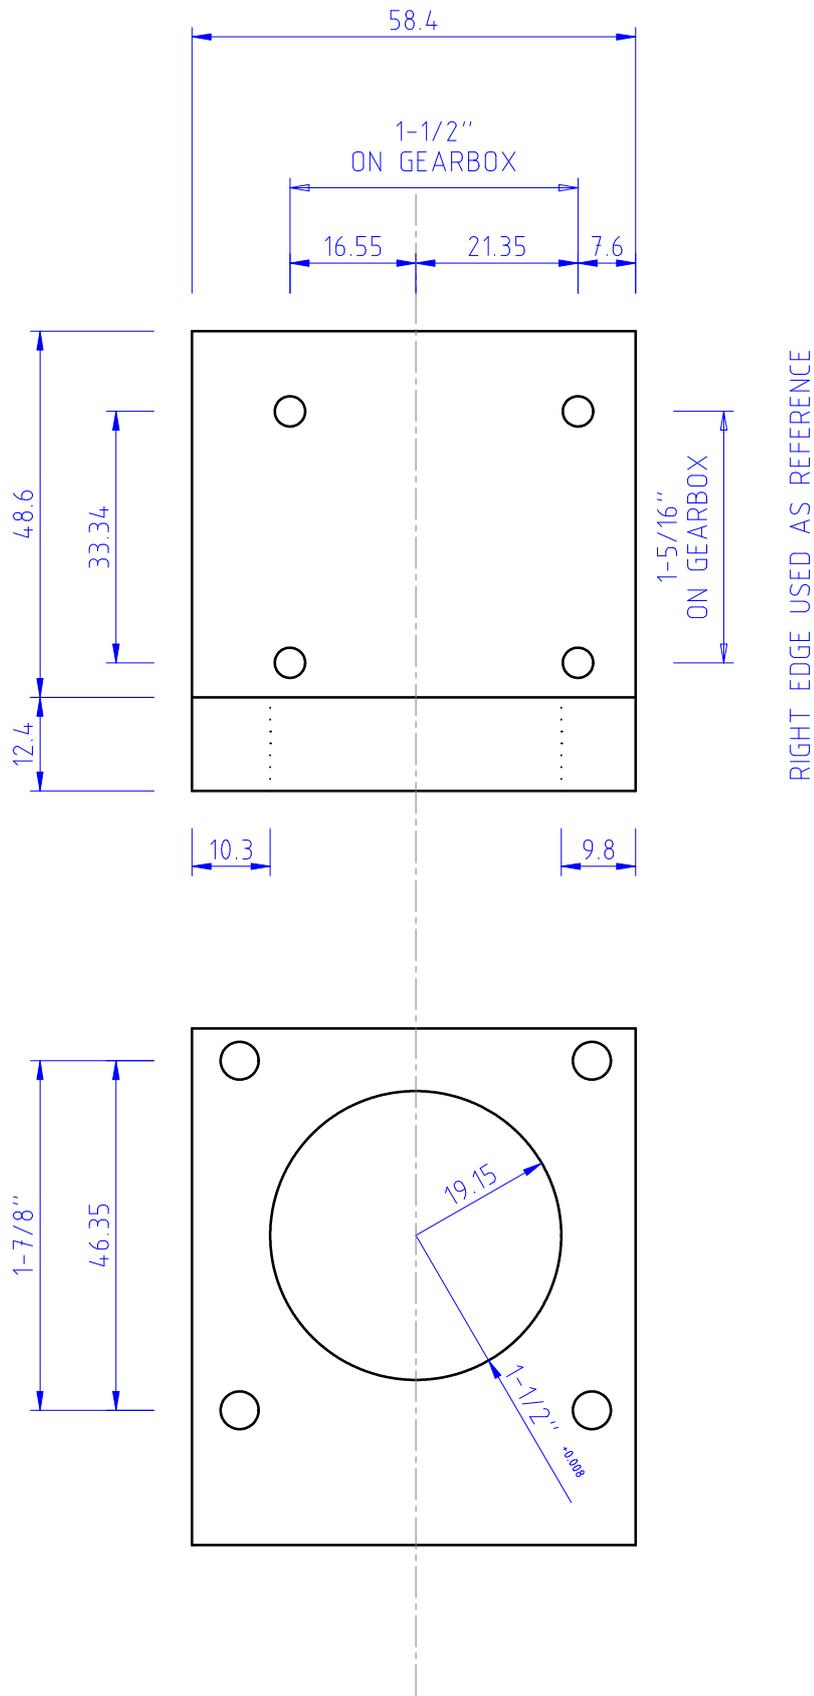
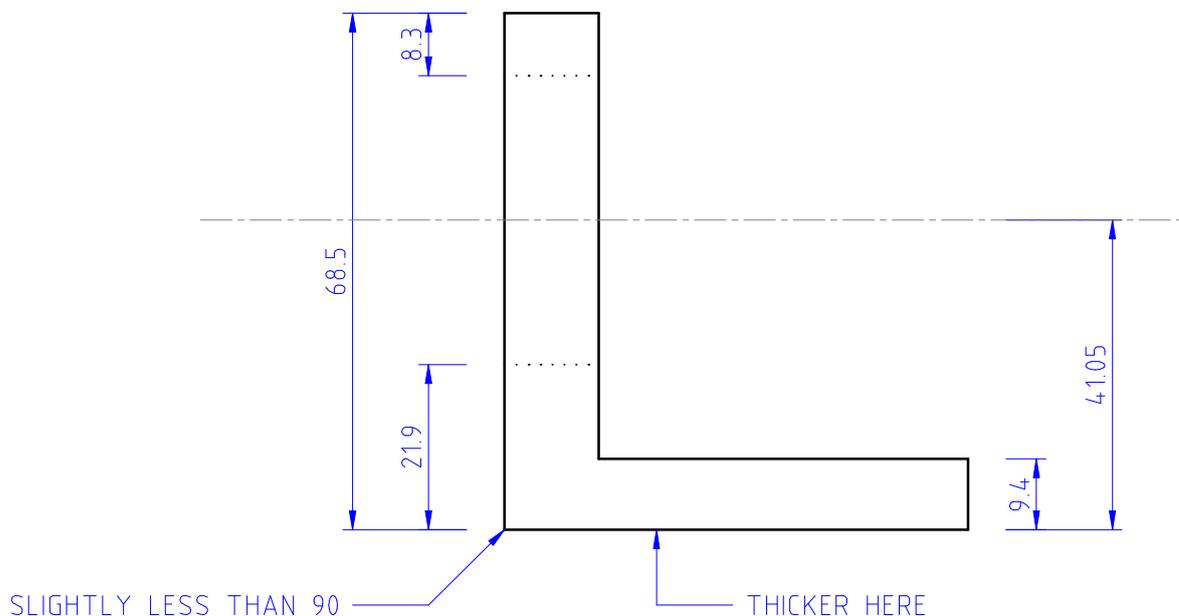
Figure 2: The motor mounting bracket.

Figure 3: Views of the declination mounting bracket.

Figure 4: Declination mounting bracket. Front and top views. 1:1 scale.

Figure 5: Declination mounting bracket. Right view. 1:1 scale.

The new motor is attached to the motor assembly using an L-shaped bracket made by Barry Jackson (see Figures 2 to 5). Barry consulted the master drawings and looked at the motor assemblies in the dome in Birmingham. But there was some ambiguity. He couldn't be sure the Las Campanas mount was exactly the same as the Birmingham mount. So he provided me with several L-shaped brackets.

Barry skimmed two of the brackets to what he believed to be the right thickness in order to hold the motor at the correct height above the motor assembly plate. The other two brackets he left oversized so that they could be machined to the correct thickness on site if necessary. Barry also drilled four mounting holes in the skimmed brackets. But he was worried the holes weren't in the right place. Worse still, they may even be so close to the right place that they prevent holes from being drilled in the right place.

Barry's skimmed L-brackets were the correct thickness. The holes were not in the right place. And, as feared, they were very close to the right place.

The motor assembly plate has slots in it so there is some room to move the holes in the L-bracket in one direction. I decided to try that. I drilled new mounting holes in the L-bracket offset slightly in the direction of the slots. The holes are now not in the ideal location. But their position is correct in the critical direction and close enough in the non-critical direction. The motor fits!

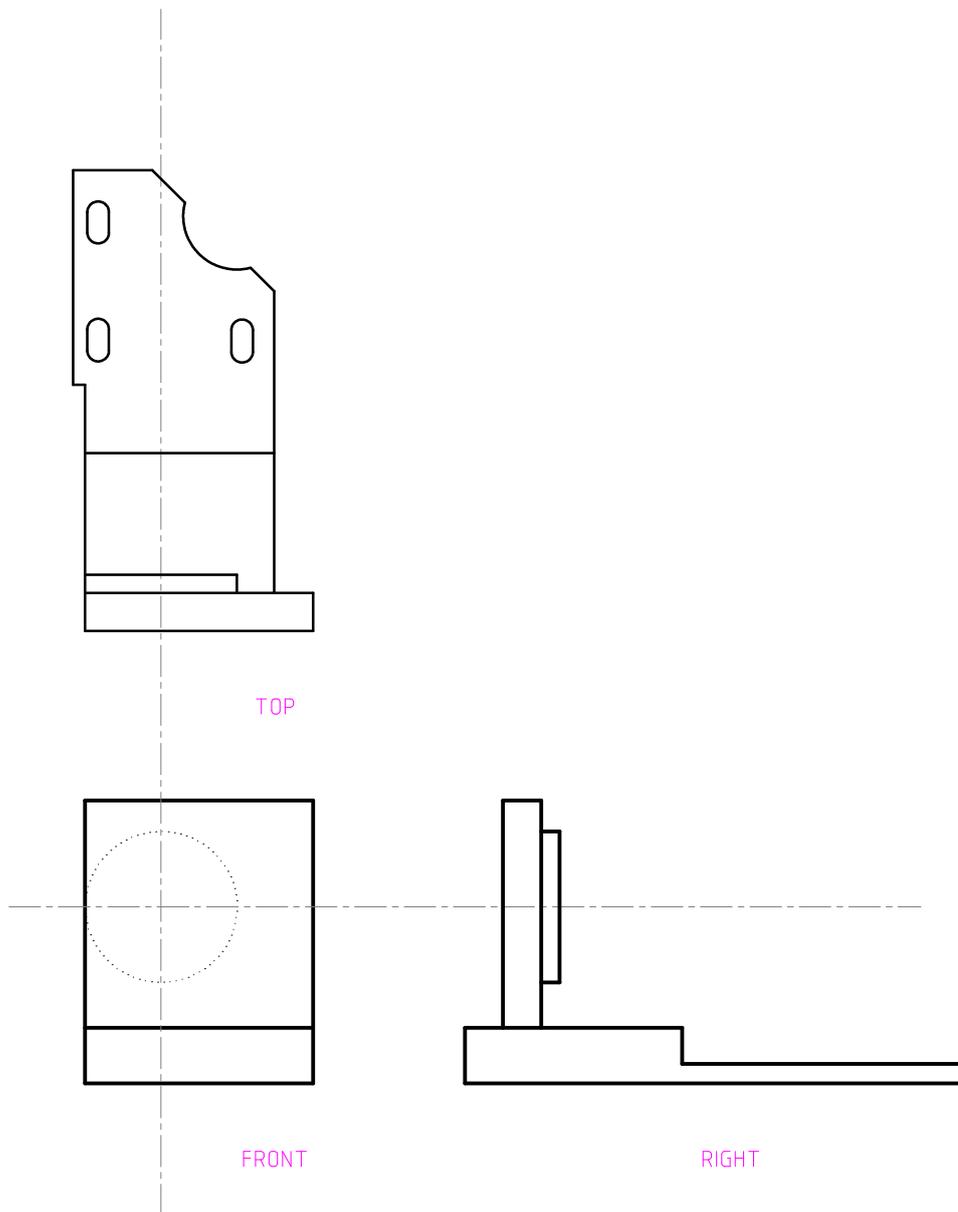
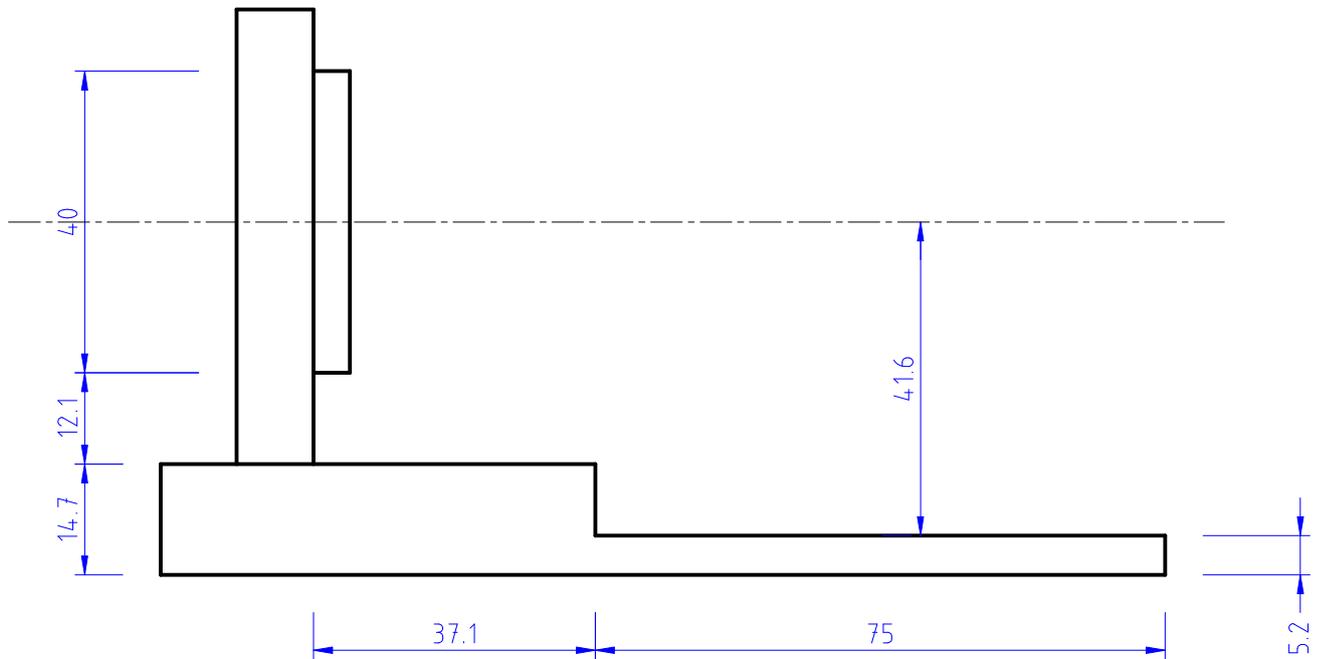
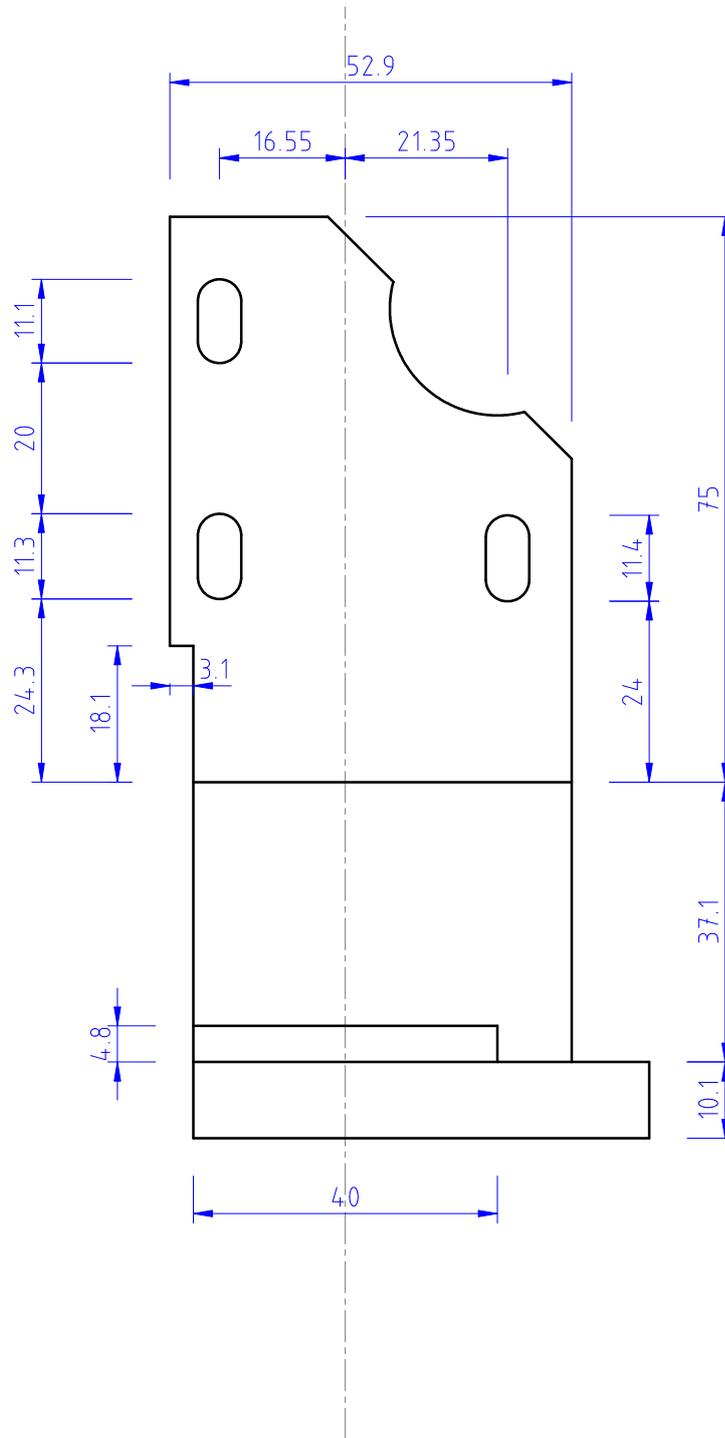
Figure 6: Views of the motor assembly.

Figure 7: Motor assembly. Right view. 1:1 scale.

Figure 8: Motor assembly. Top view. 1:1 scale.

In Las Campanas, I disassembled the motor assemblies. I removed the old motors and gearboxes. I then carefully measured the motor assembly plate and the L-brackets provided by Barry. I have drawn the Las Campanas motor assembly plates; see Figures 6 to 8.

I can now say that the motor assemblies in Las Campanas are indeed different to the ones in Birmingham. However, the important dimensions relating the mounting holes to the motor axle center line are all the same. And they do match the master drawings provided you interpret the drawings in the right way. We now know what the right way is.

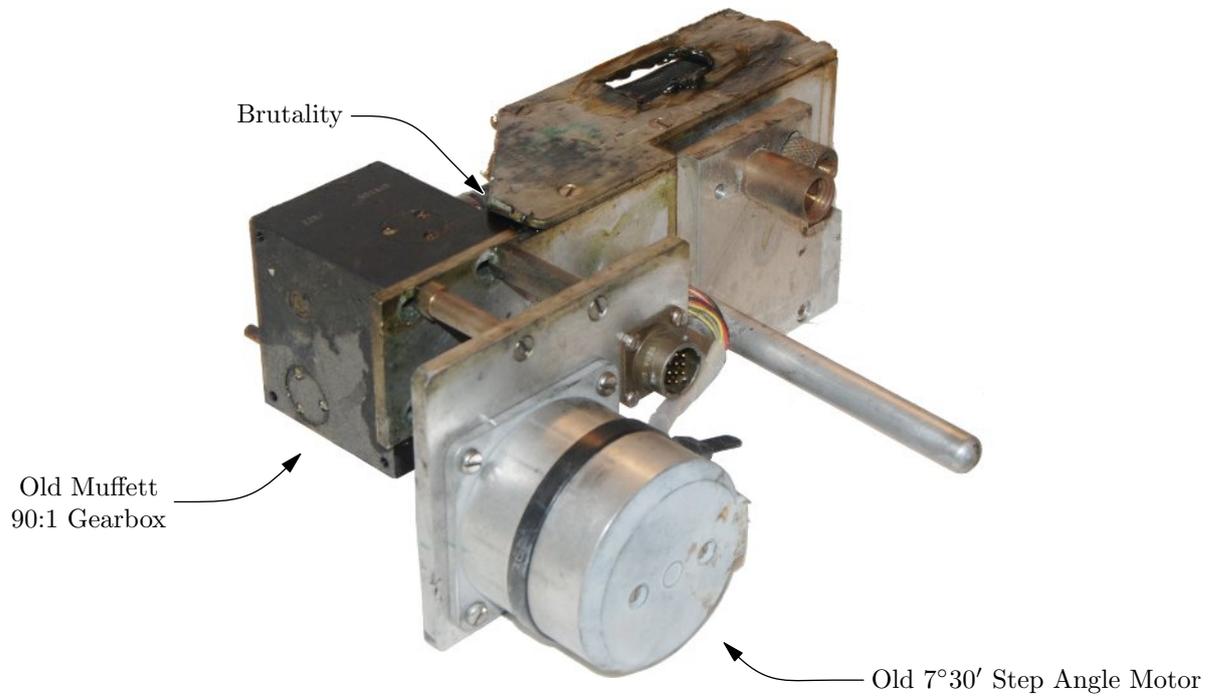
Figure 9: The worm cover was brutally bent out of the way.

Well, almost. The L-bracket fouled the worm cover on the motor assembly. I noticed that the old 90:1 gearbox on the RA assembly also fouled the worm cover. Someone had brutally bent the worm cover out of the way in order to get the gearbox to fit (see Figure 9).

I later found out that it was Steve Hale who modified the worm cover in 2008 when he replaced [4] all the shaft couplers. It was necessary to move the 90:1 gearbox closer to the motor. The slots in the assembly plate were provided for just this purpose. However, the worm cover prevented the gearbox from moving the full length of the slots.

I used a hacksaw and a file to carefully and neatly modify the worm covers on both RA and declination motor assemblies. Now both motors fit and the assemblies don't look like they have been kludged (see Figure 10).

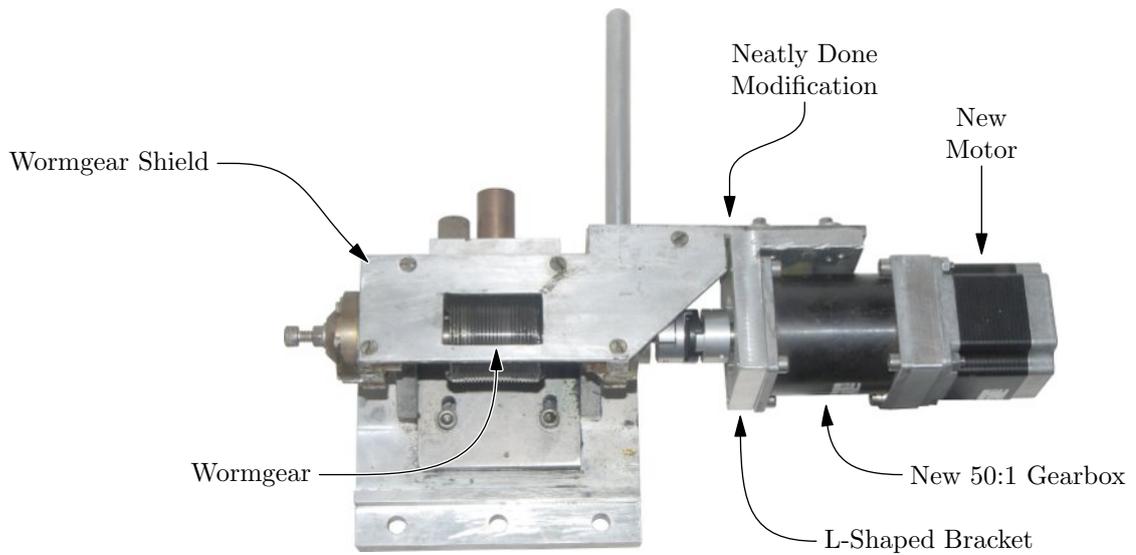
Figure 10: The new declination motor attached to the old motor assembly.

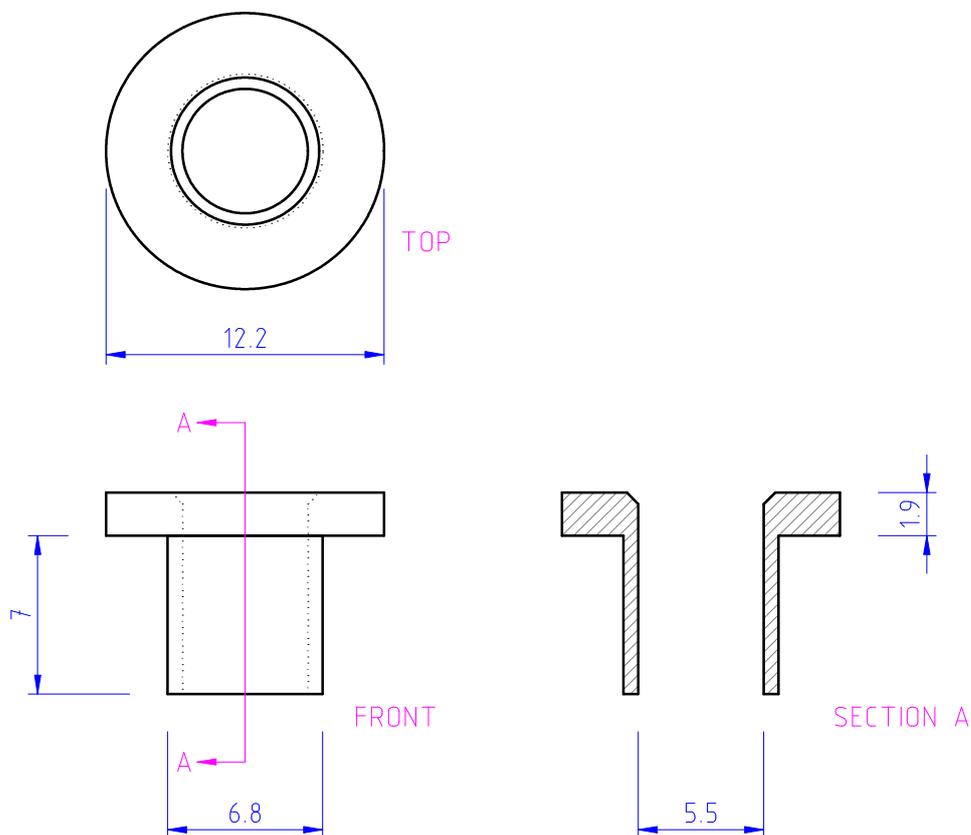
Figure 11: Old collar. 3:1 scale.

There is a plastic collar that fits around the stem and sits between the glass cell and the metal oven. Ivan's collar has a 5-mm-diameter hole in it. It looks like it was designed for the larger-diameter stem. I found lots of copper foil wrapped around the cell stem to make it fit in the collar better. But it wasn't perfect and the cell wobbled slightly.

The plastic collar was very brittle. When I tried to put more foil around the stem, the collar shattered into lots of tiny little pieces. I found another collar in with all the plastic junk in one of the drawers of the storage cabinet. I never knew what it was for. It has an inner diameter of 4mm and an outer diameter of 6.9mm. These numbers are just right. However, when you put the cell in, the collar holds the cell too high.

I will ask Barry to make a new plastic collar to be sent out on the next visit. Figure 11 on the preceding page shows the old collar before it shattered. Figure 12 shows the new collar

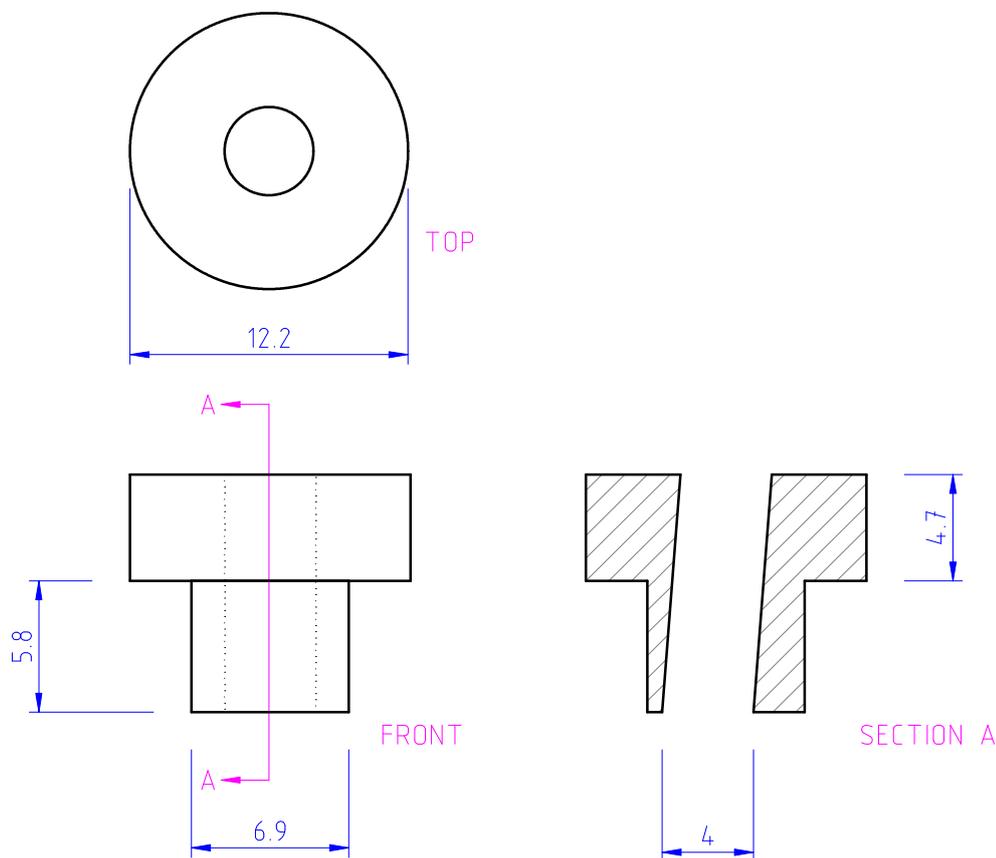
Figure 12: New collar, before changes. 3:1 scale.

The center hole in this new collar is very crooked. When I reassembled the cell and oven, it holds the cell stem up against the side of the temperature control collar. It may be putting lateral pressure on the cell stem. That would be bad.

I filed the new collar down. The cell has a 6.5-mm shoulder around the stem. I used a 6.5-mm drill bit to counter bore the collar. I didn't really counter bore it enough. I think I filed too much off the collar for that. If I counter bore too much, the collar will fall apart.

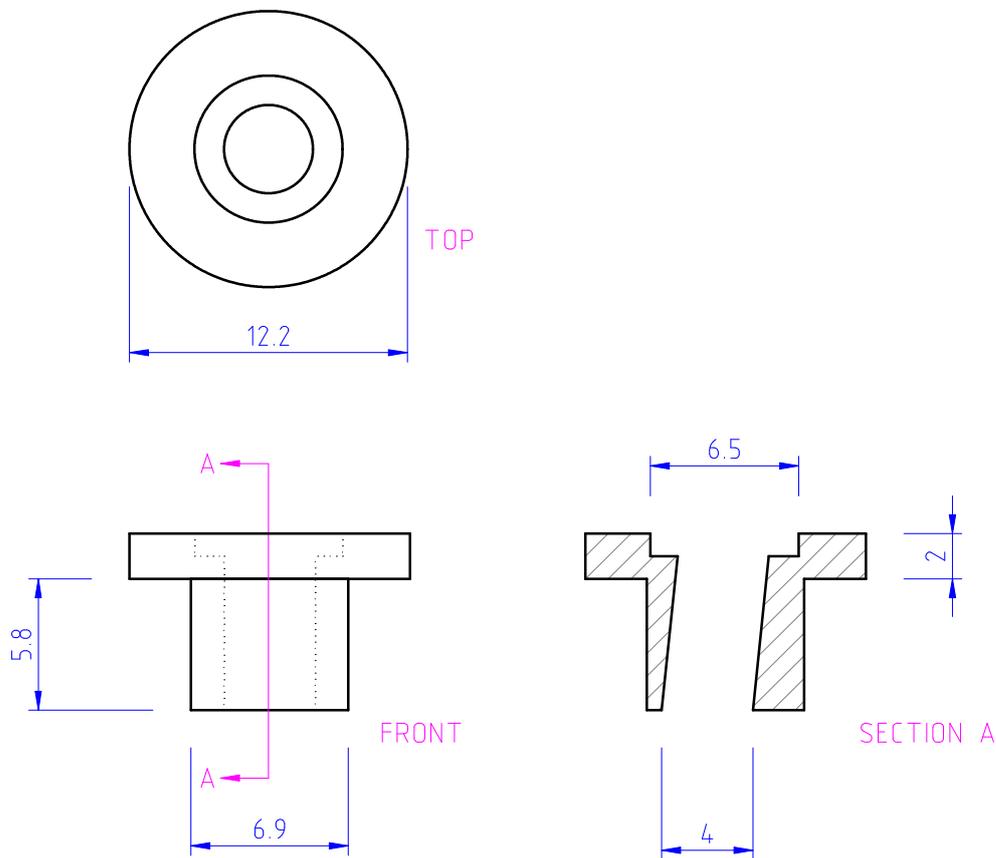
Figure 13: New collar, after changes. 3:1 scale.

before I modified it. Figure 13 shows what the collar looks like now. Notice how the hole has been drilled very badly.

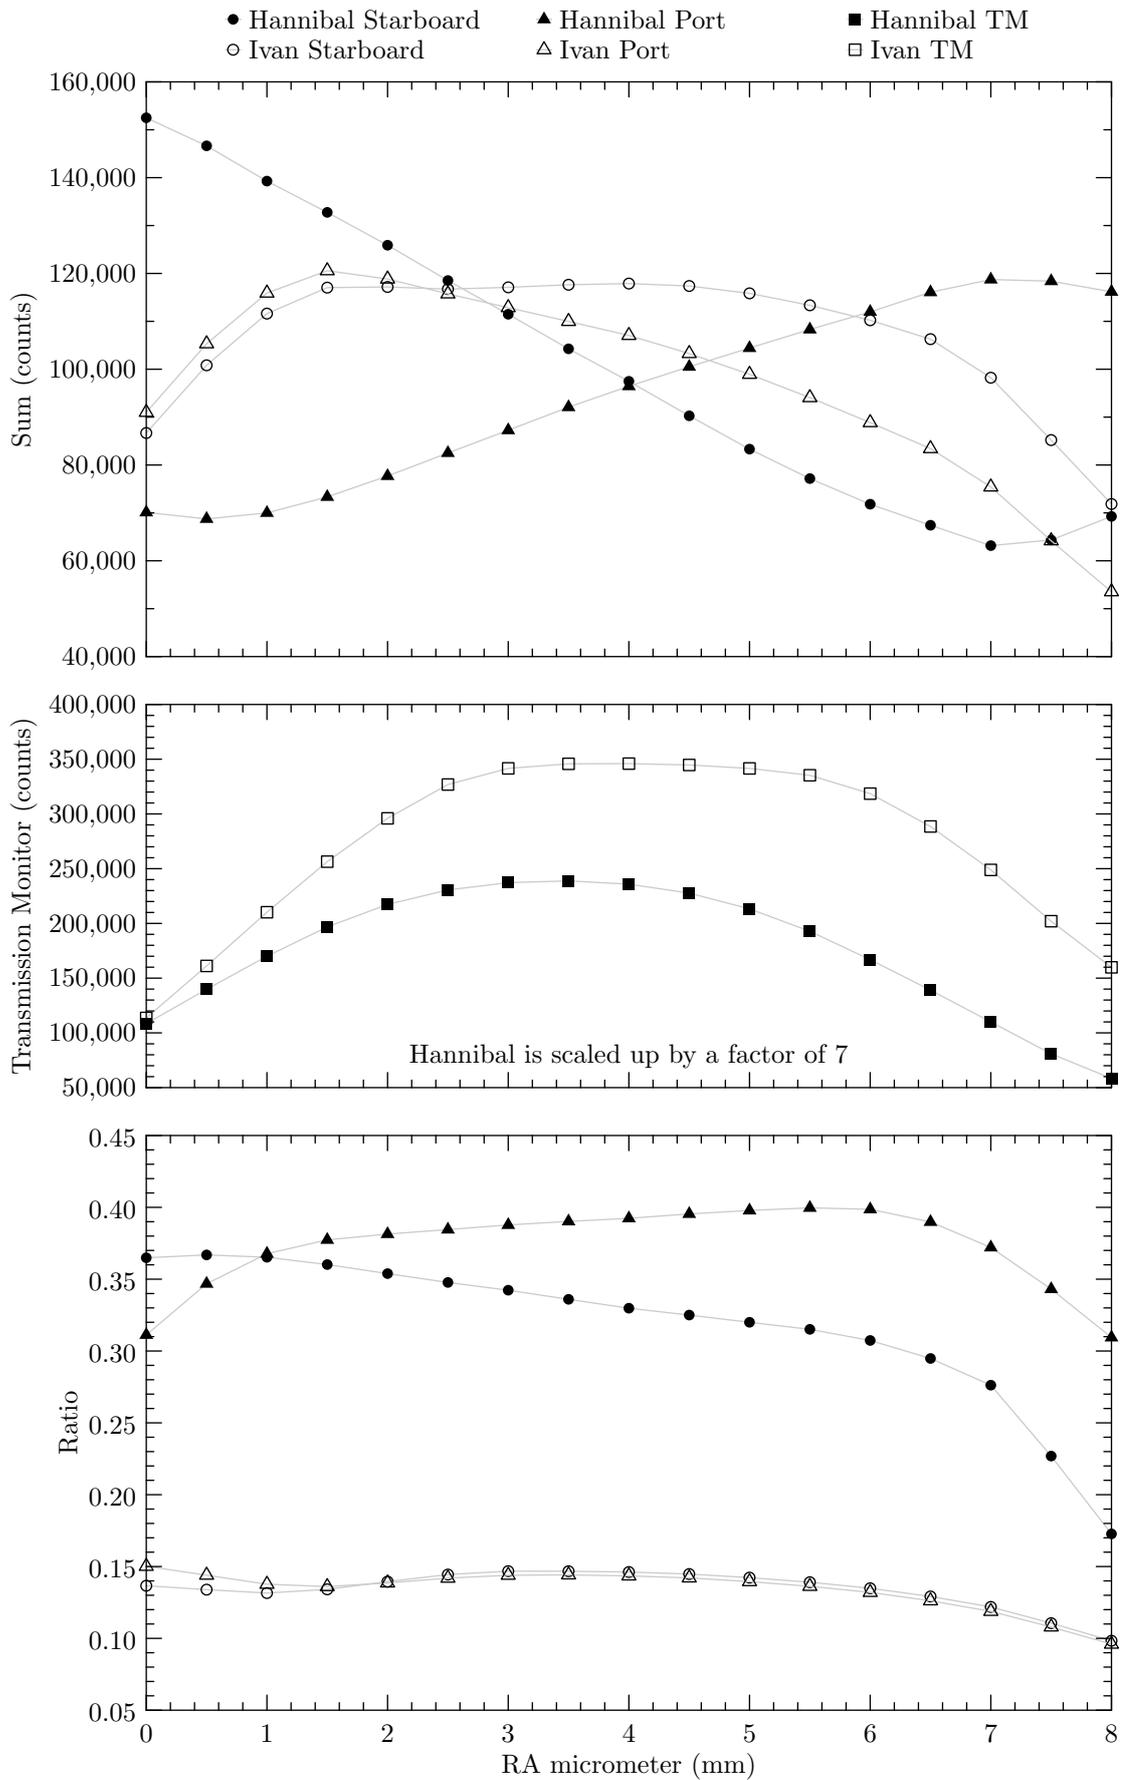
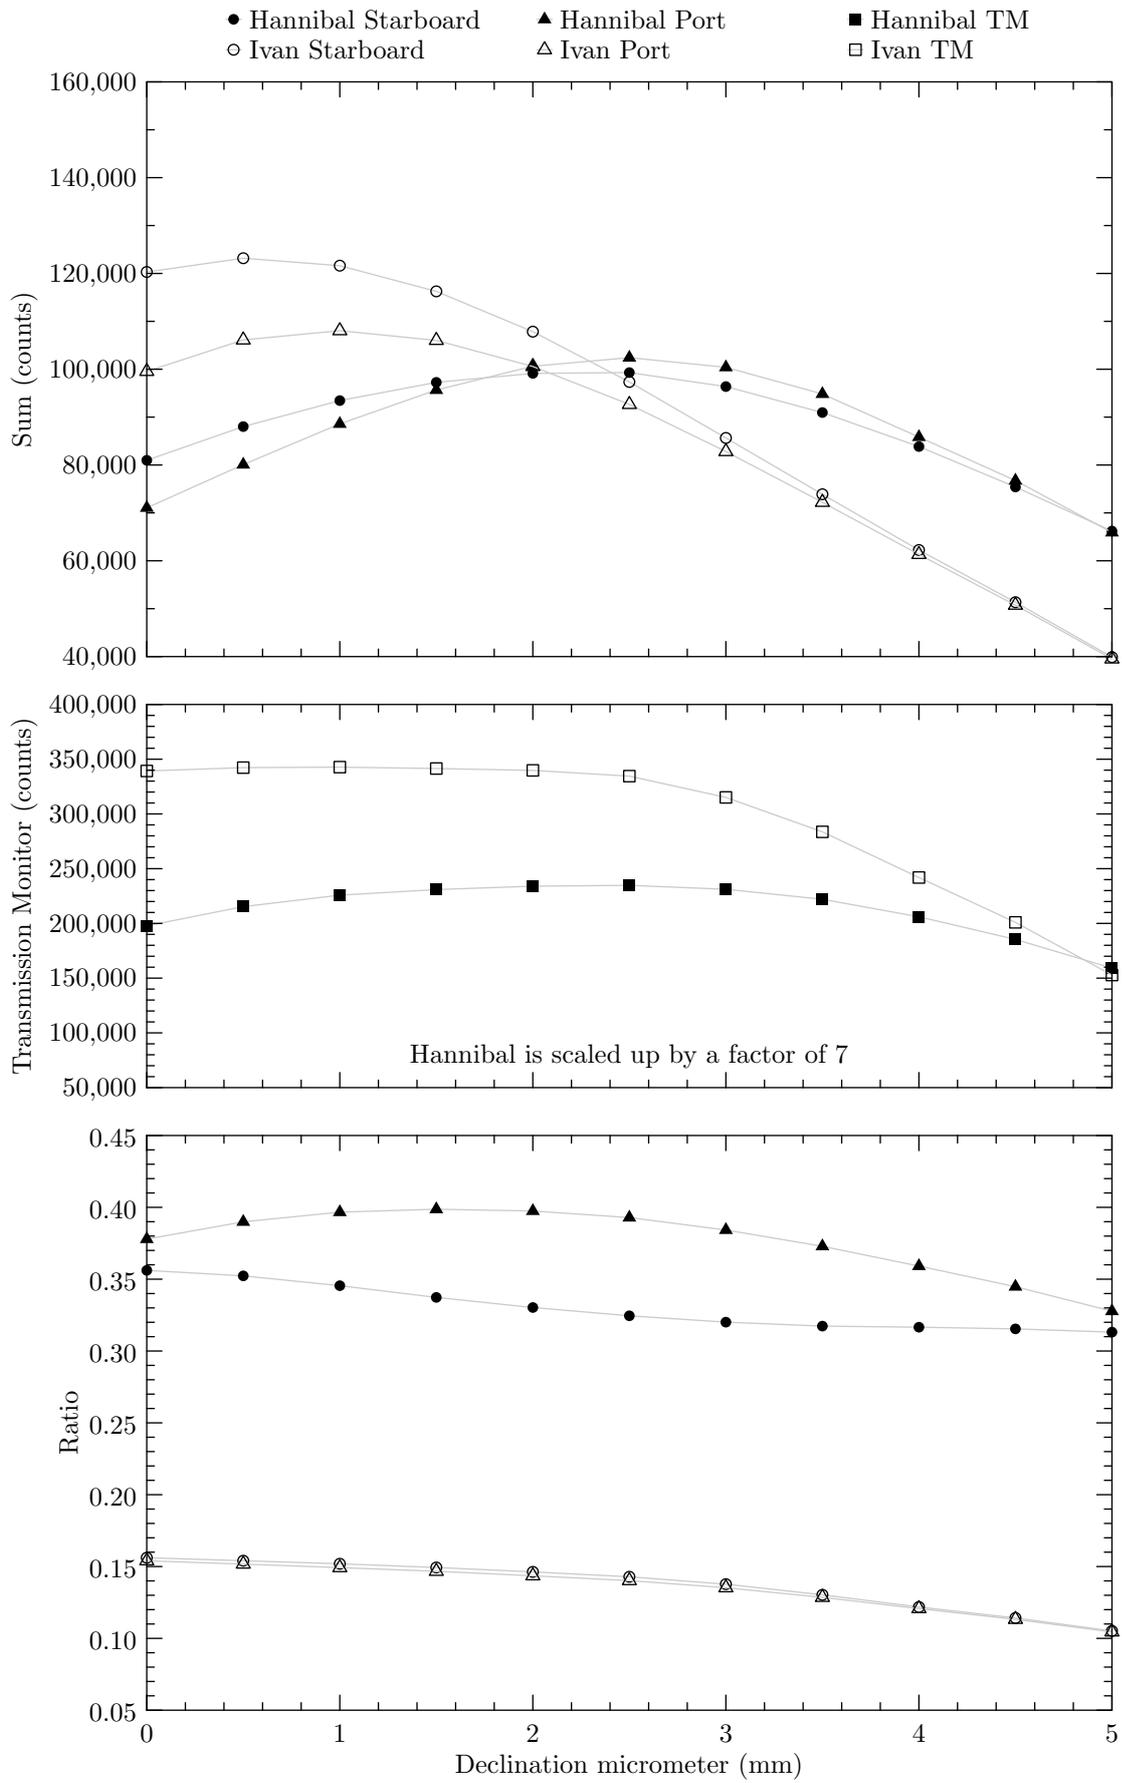
Figures 14 and 15 show autoguider scans taken after Ivan's oven was repaired. The main difference between these scans and the last ones [5] that I took in 1997 December are that Ivan's ratios are somewhat lower. Ivan's sensitivity is not as good as it was before. I suspect this is because the cell is being held at an angle.
