TECHNICAL REPORT NO. 357

Autoguider repairs in Las Campanas in 2012 March

Steven J. Hale

2012 April 5

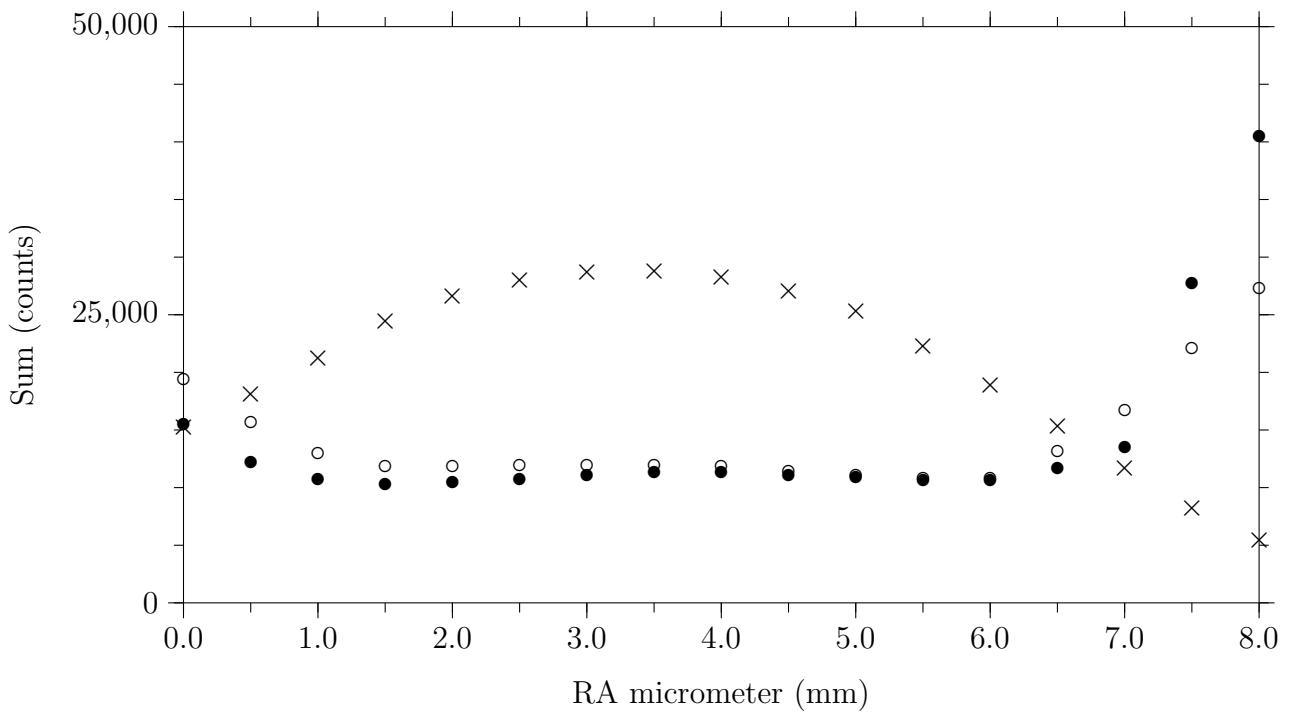
The guider adjustment changed the calibration and so a guider scan was required. Two scans were performed. One with the cells cold and another with the cells hot. The calibration hadn't move too far off since the last trip. The declination micrometer remained set to 2.0 mm and the RA micrometer changed from 4.0 mm to 3.5 mm. The calibration looks good.

Figure 1: RA scan (Hannibal) - The guider was scanned right ascension. The plot shows how the starboard sum (●), port sum (○), and the transmission monitor (×) varied. This scan was done with the declination micrometer set at 2.00 mm and the cell cold.

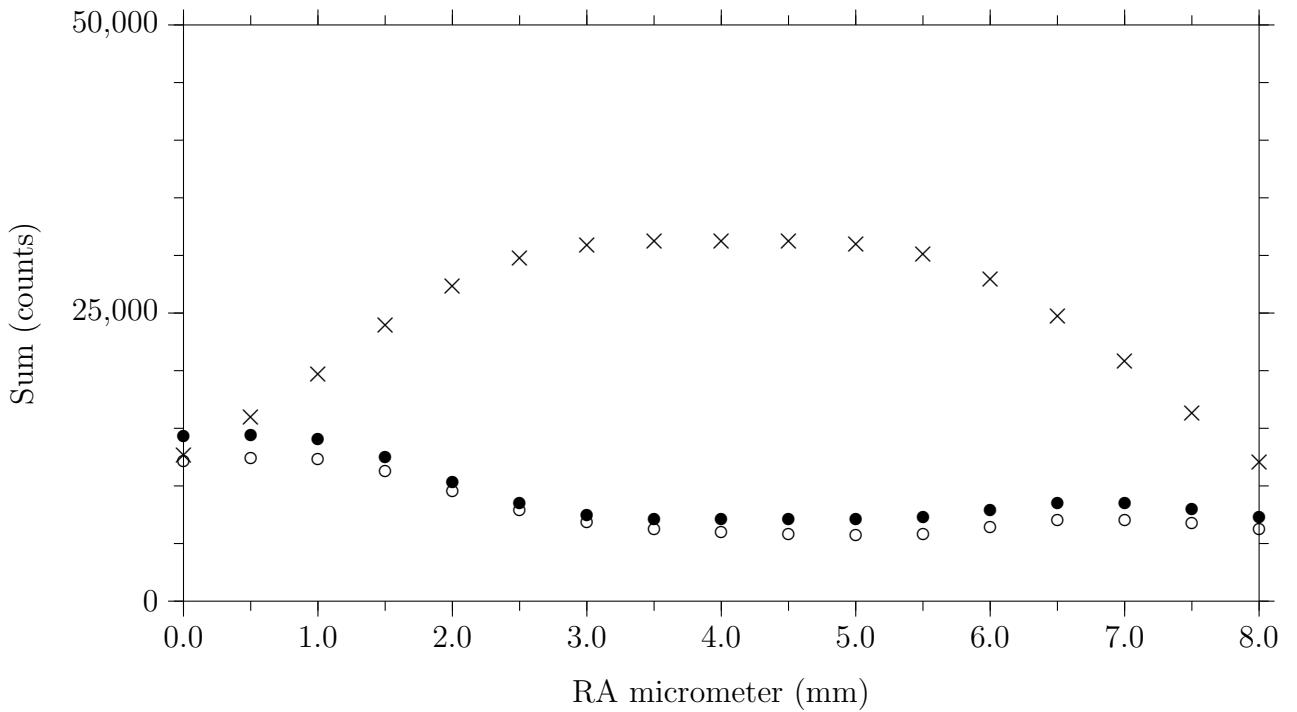
Figure 2: RA scan (Ivan) - The guider was scanned right ascension. The plot shows how the starboard sum (●), port sum (○), and the transmission monitor (×) varied. The transmission monitor data have been divided by ten. This scan was done with the declination micrometer set at 2.00 mm and the cell cold.

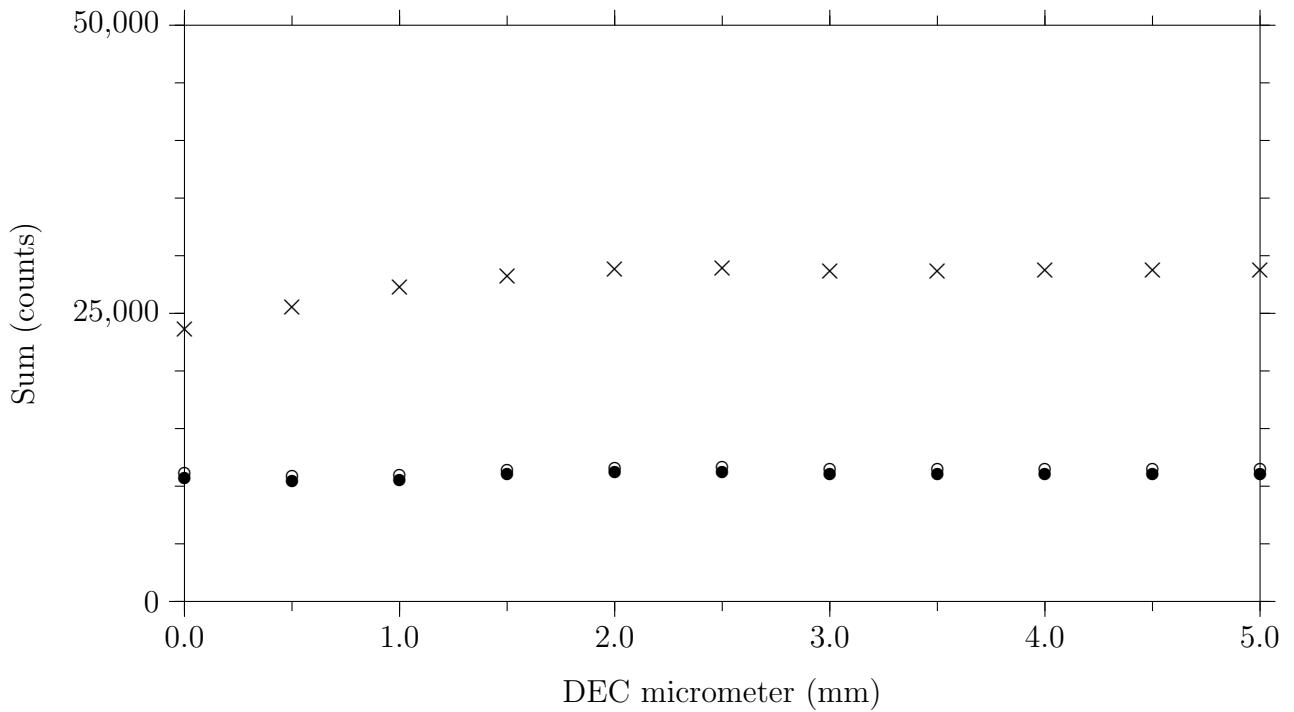
Figure 3: DEC scan (Hannibal) - The guider was scanned declination. The plot shows how the starboard sum (\bullet), port sum (\circ), and the transmission monitor (\times) varied. This scan was done with the right ascension micrometer set at 4.0 mm and the cell cold.

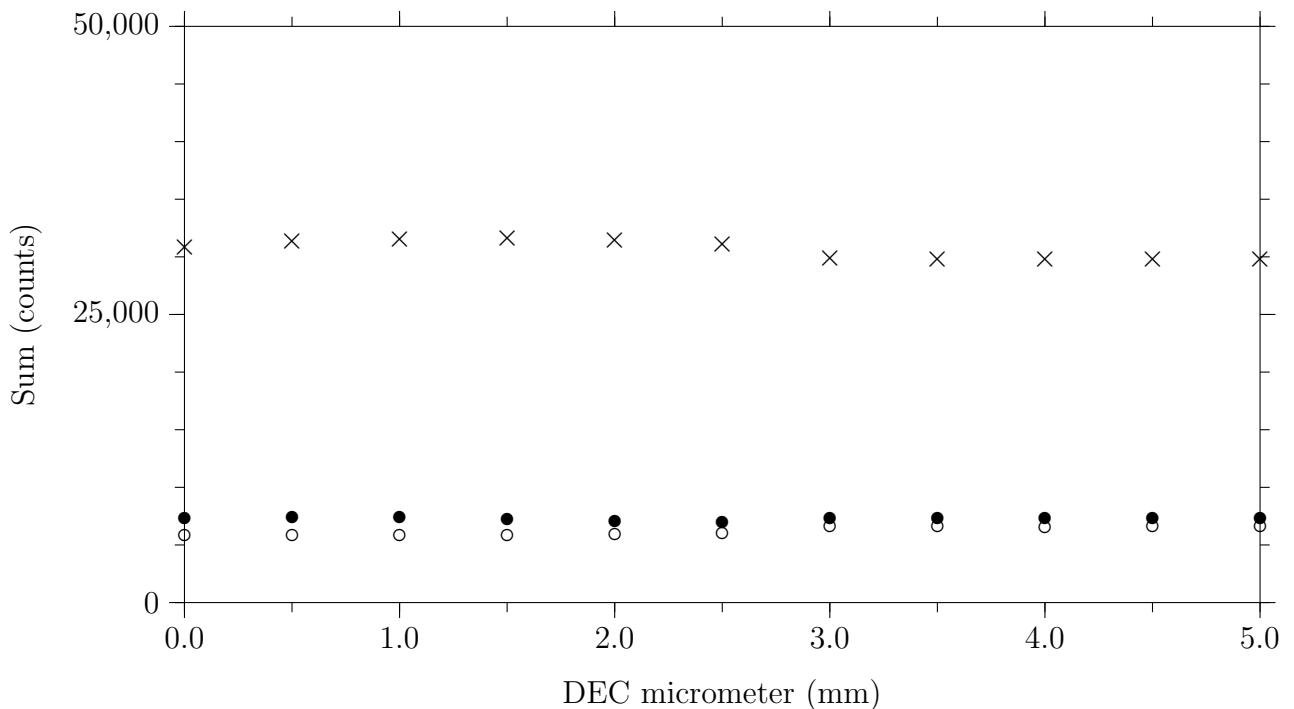
Figure 4: DEC scan (Ivan) - The guider was scanned declination. The plot shows how the starboard sum (\bullet), port sum (\circ), and the transmission monitor (\times) varied. The transmission monitor data have been divided by ten. This scan was done with the right ascension micrometer set at 4.0 mm and the cell cold.

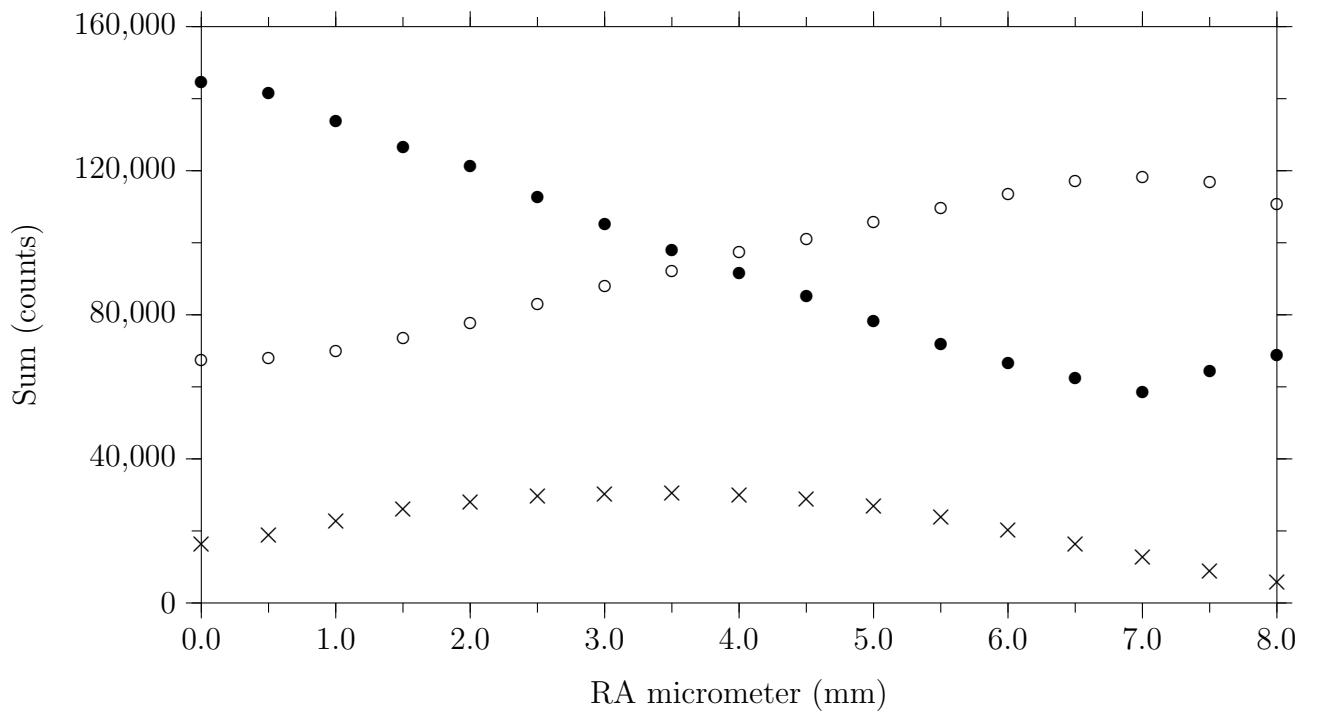
Figure 5: RA scan (Hannibal) - The guider was scanned right ascension. The plot shows how the starboard sum (●), port sum (○), and the transmission monitor (×) varied. This scan was done with the declination micrometer set at 2.00 mm and the cell hot.

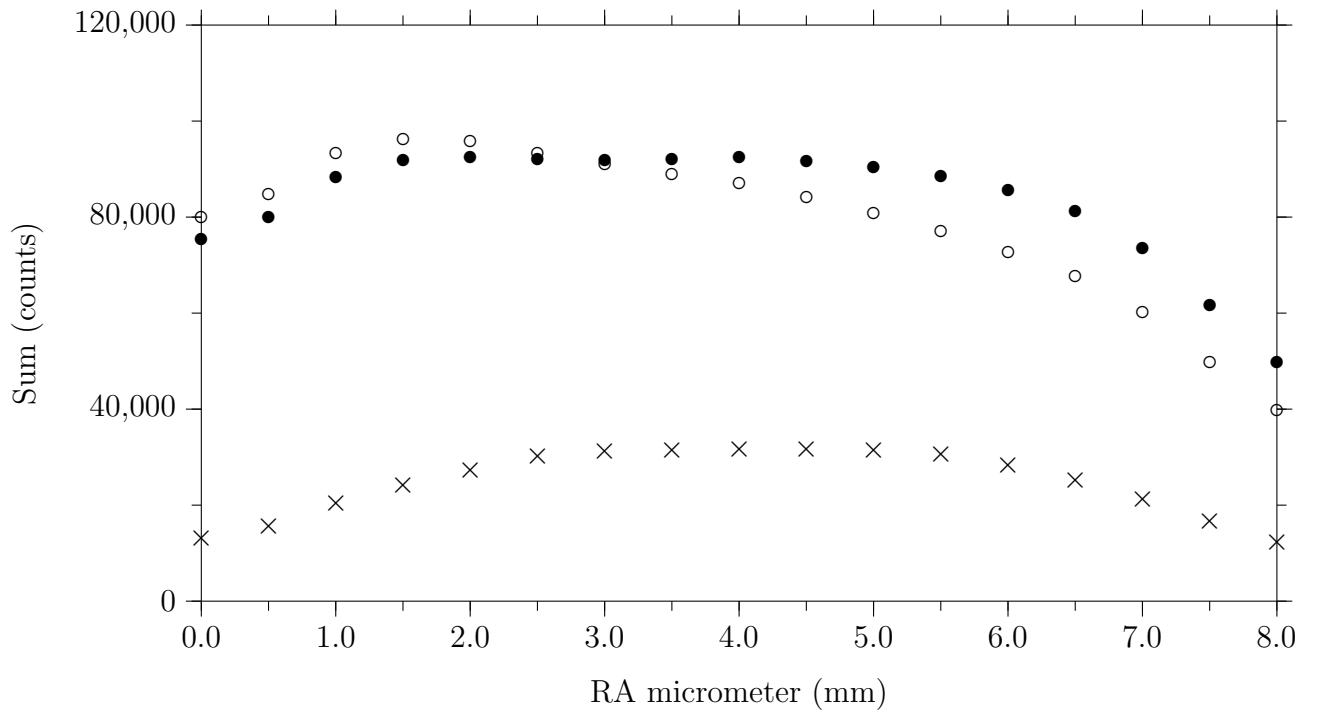
Figure 6: RA scan (Ivan) - The guider was scanned right ascension. The plot shows how the starboard sum (●), port sum (○), and the transmission monitor (×) varied. The transmission monitor data have been divided by ten. This scan was done with the declination micrometer set at 2.00 mm and the cell hot.

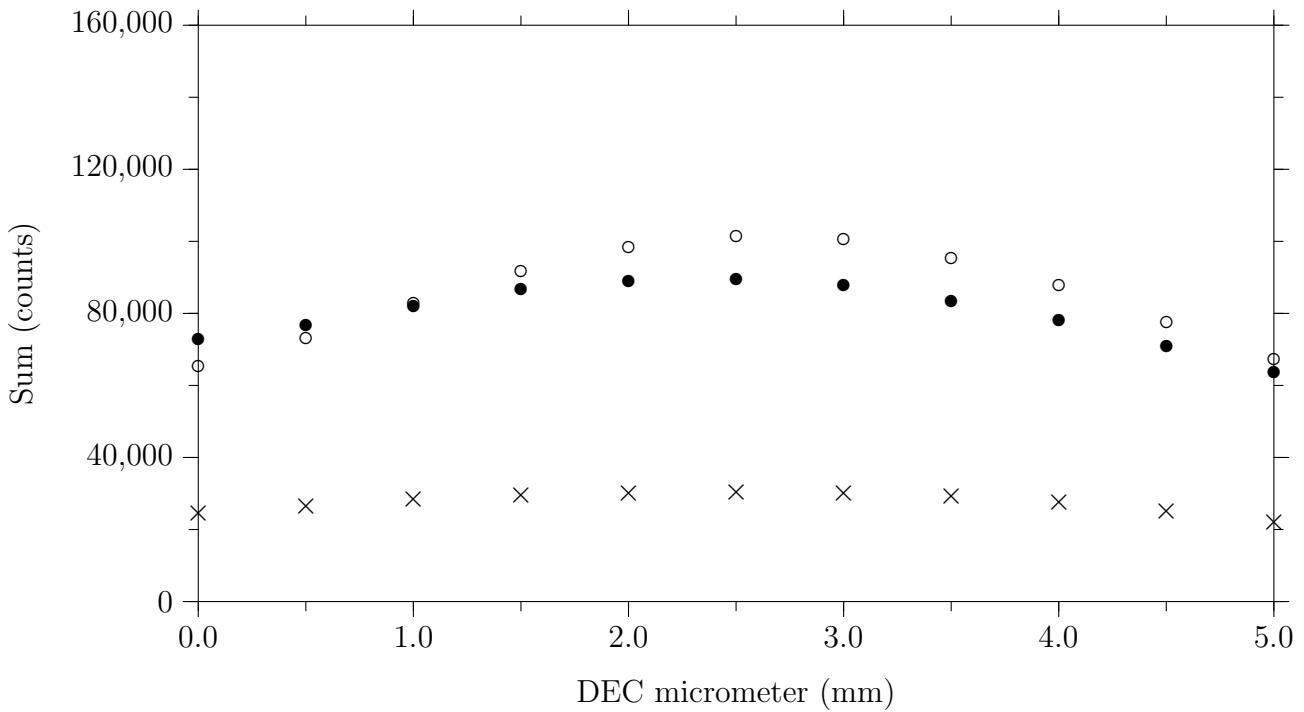
Figure 7: DEC scan (Hannibal) - The guider was scanned declination. The plot shows how the starboard sum (●), port sum (○), and the transmission monitor (×) varied. This scan was done with the right ascension micrometer set at 4.0 mm and the cell hot.

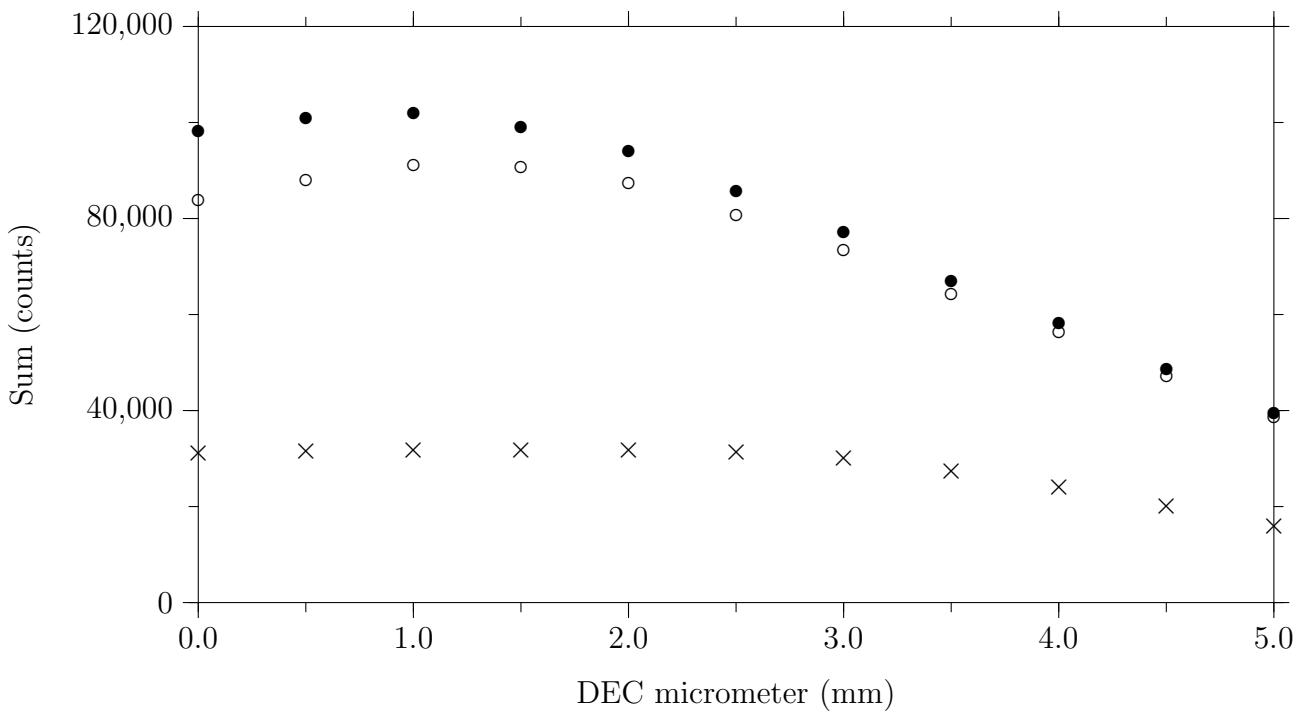
Figure 8: DEC scan (Ivan) - The guider was scanned declination. The plot shows how the starboard sum (●), port sum (○), and the transmission monitor (×) varied. The transmission monitor data have been divided by ten. This scan was done with the right ascension micrometer set at 4.0 mm and the cell hot.
