# BiSON

TECHNICAL REPORT NO. 358

## Sutherland 2012 June Installation of Tiger Counters

2012 July 26

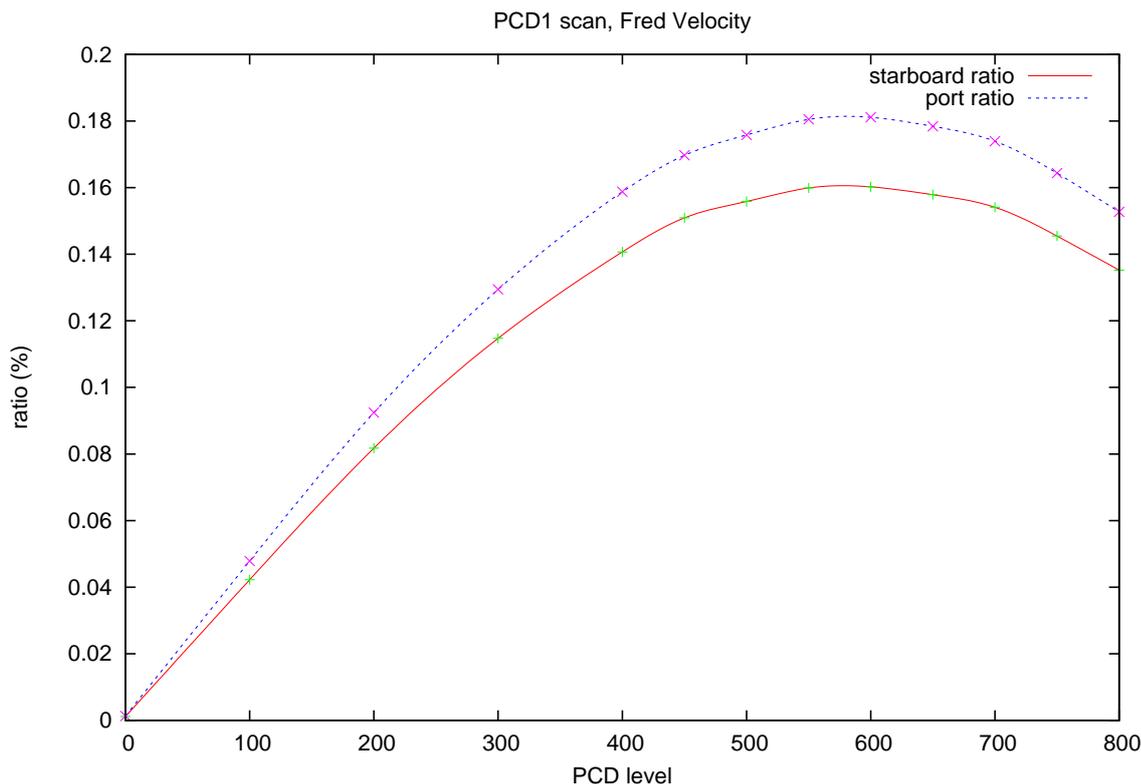
The delta-B was disconnected and the magnetic Pockels cell removed. The driver was scanned over the full range while looking at the velocity ratio output from the detectors. The results are in figure 1. The initial setting was “750”, the new scan suggests the best setting is “575” and so the velocity driver was adjusted to the new optimum.

Figure 1: Velocity PCD scan.

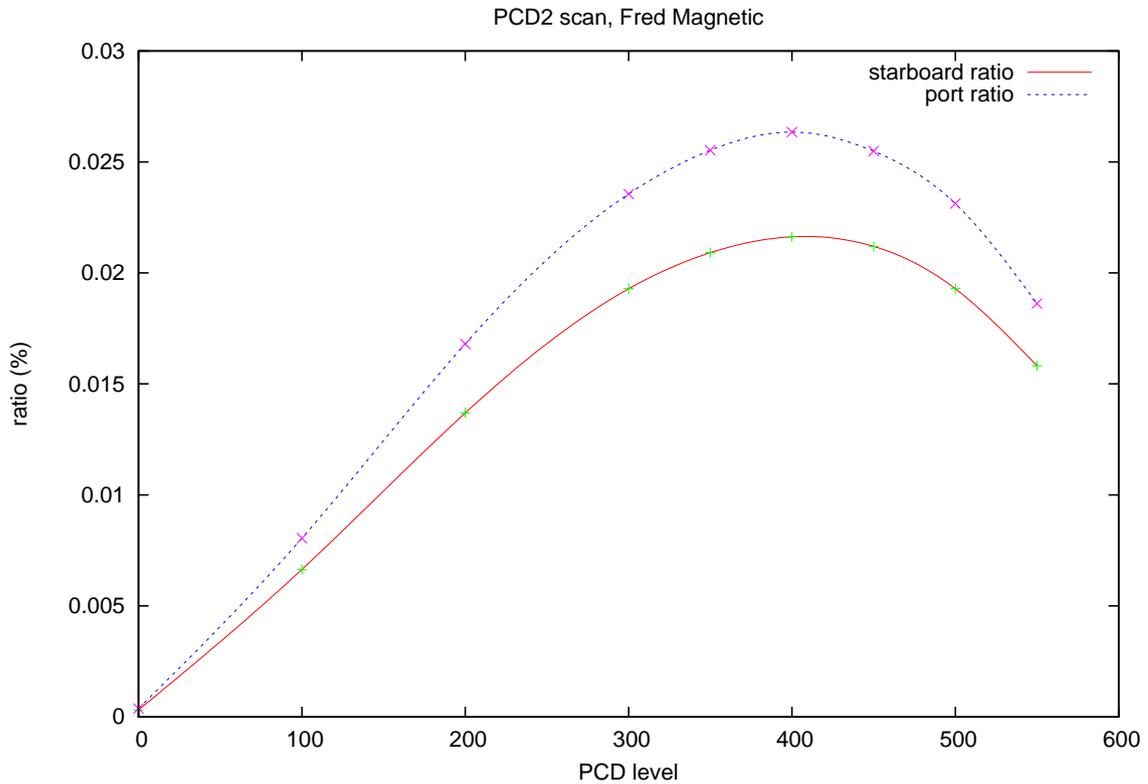
Calibrating the magnetic Pockels cell is slightly more tricky. The magnetic Pockels cell was replaced, and the velocity Pockels cell removed. The magnetic Pockels cell was then moved behind the polariser into the velocity position. The scan was then repeated using the magnetic cell and driver. The results are in figure 2. The initial setting was “375”, the new scan suggests the best setting is “400” and so the magnetic driver was adjusted to the new optimum.

**Figure 2:** Magnetic PCD scan.
