TECHNICAL REPORT NO. 360

**The Installation of a Digital Autoguider and Tiger Counters in  
Narrabri in 2013 April**

Steven J. Hale and Guy R. Davies

2013 May 20

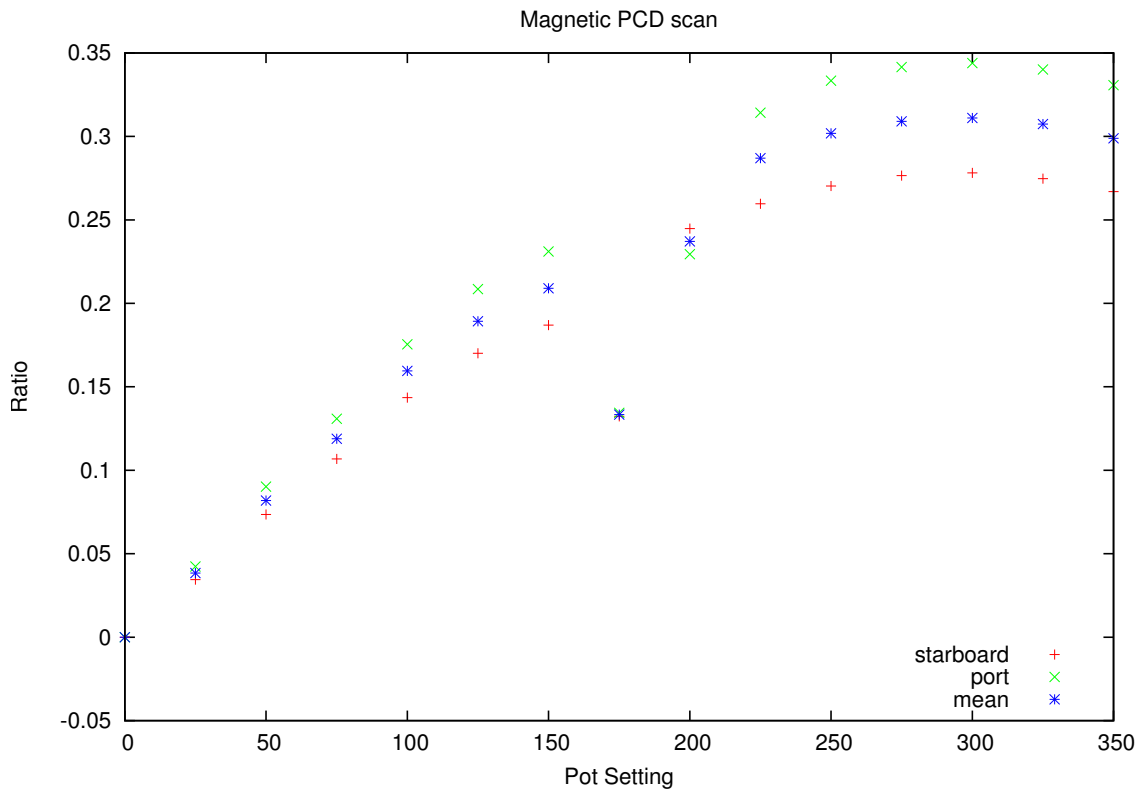
Figure 6: Magnetic PCD scan.

Calibrating the magnetic Pockels cell is slightly more tricky. The magnetic Pockels cell was replaced, and the velocity Pockels cell removed. The magnetic Pockels cell was then moved behind the polariser into the velocity position. The scan was then repeated using the magnetic cell and driver. The results are in figure 6. The initial setting was “250”, the new scan suggests the best setting is “300” and so the magnetic driver was adjusted to the new optimum.
