# **BiSON** Birmingham Solar-Oscillations Network

TECHNICAL REPORT NO. 365

## **Autoguider repairs at Mount Wilson in 2014 April**

2014 May 23

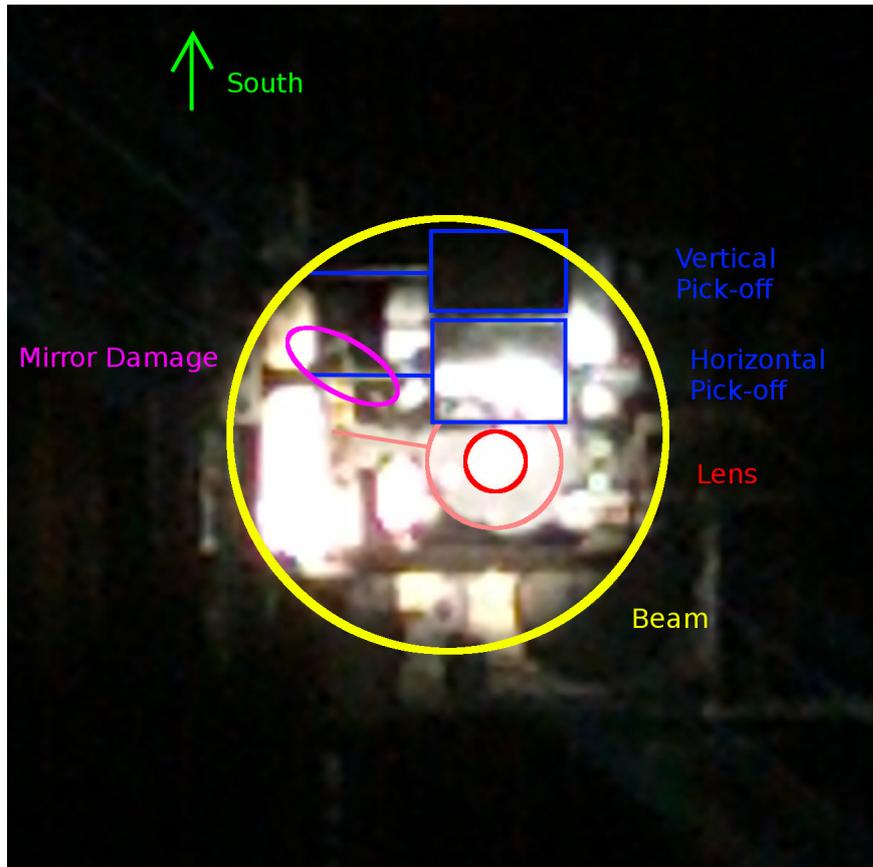
By looking down the tower from the top of the shaft, it is possible to see where the beam of light is falling at the bottom. The beam is currently not correctly centered on the objective lens, figure 1. It is biased to the south-east. The bias to the south is good because it means our pick-off mirrors are closer to the center of the beam. The bias to the east is not good, and the beam needs to be moved west to become more central. However, this can not be done because it would put the damaged part of the mirror directly over the area picked off by our mirrors.

In any case, it appears our pick-off mirrors are well illuminated. The beam would have to drift a long way for our spectrometer to experience vignetting. No adjustment to the guider-head position was made. This could be revisited once the first-flat has been repaired, and some improvement then made to the beam position.

Figure 1: Beam position, looking down the tower shaft.

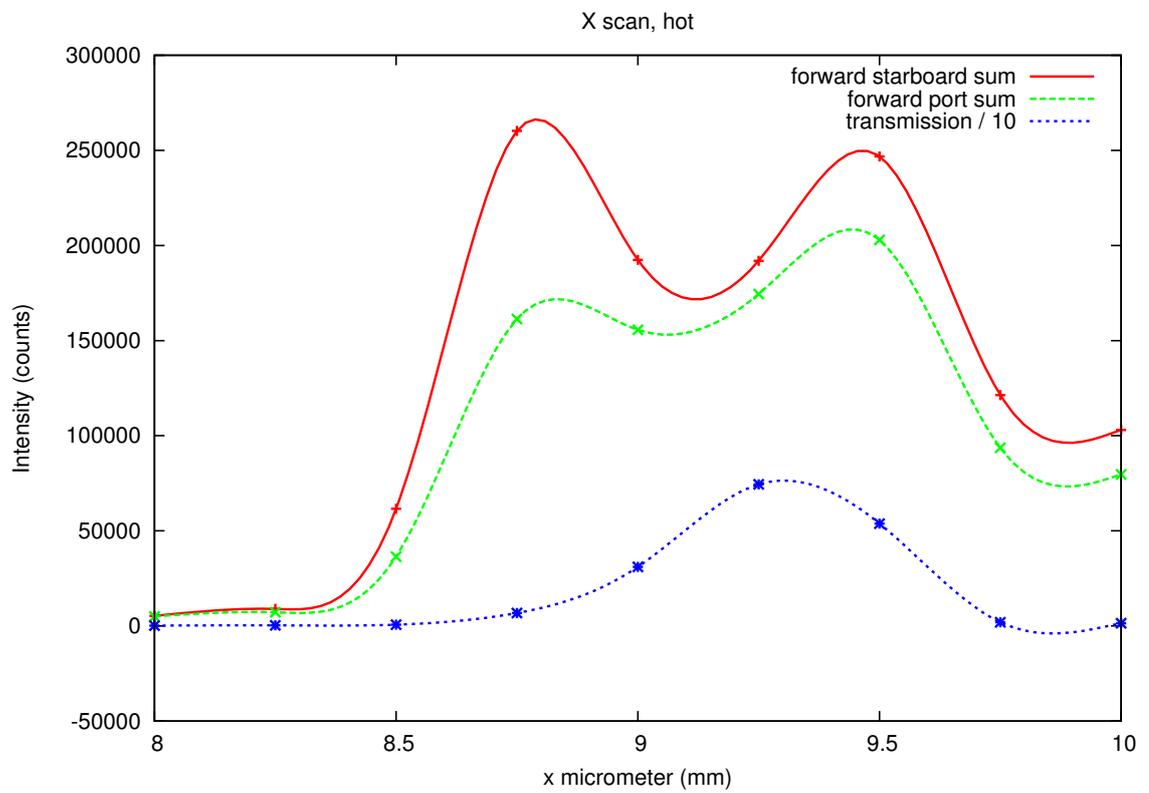
Later, a more quantitative alignment was performed by scanning the fifth-mirror in 0.25 mm increments and plotting the resulting data. These plots are shown in figures 2, 3, 4, and 5. These plots suggest that the basic alignment was almost perfect, with only a small change required on the x-micrometer.

Figure 2: X Hot Sum

The final settings were confirmed as 9.15 mm on the x-micrometer, and 5.85 mm on the y-micrometer. It is suggested that the basic visual alignment is sufficient for future trips.

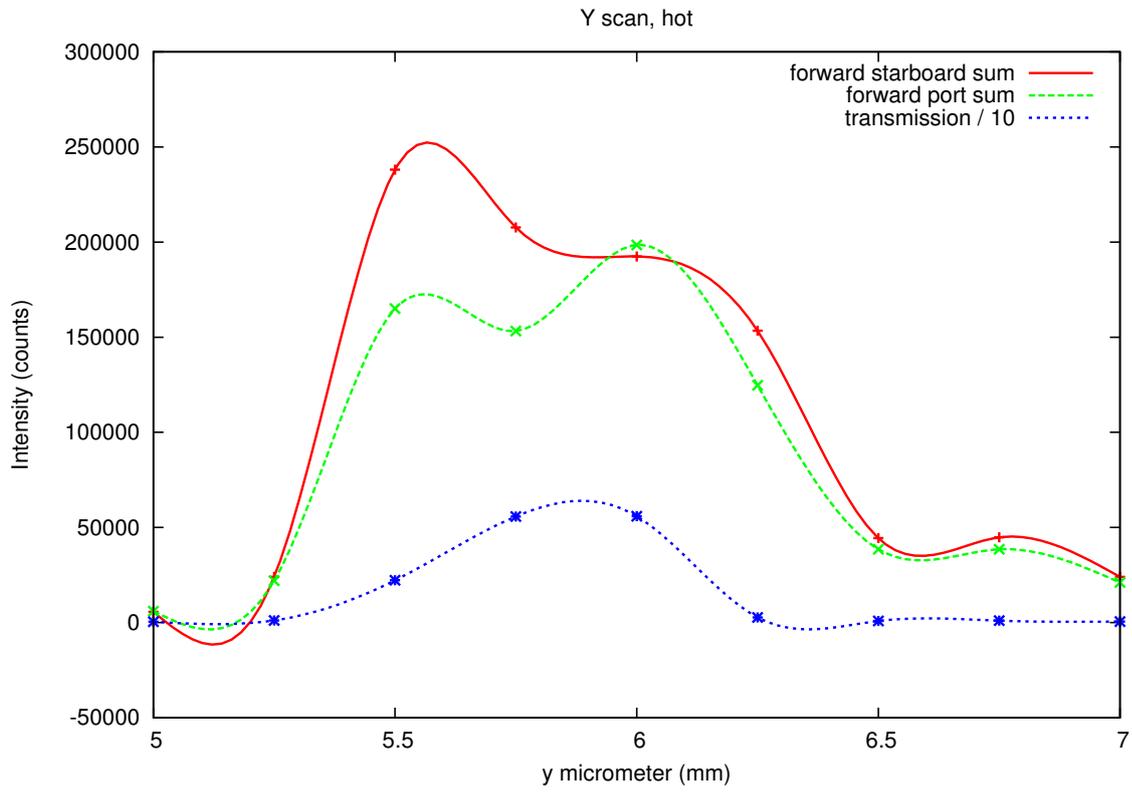
Figure 3: Y Hot Sum

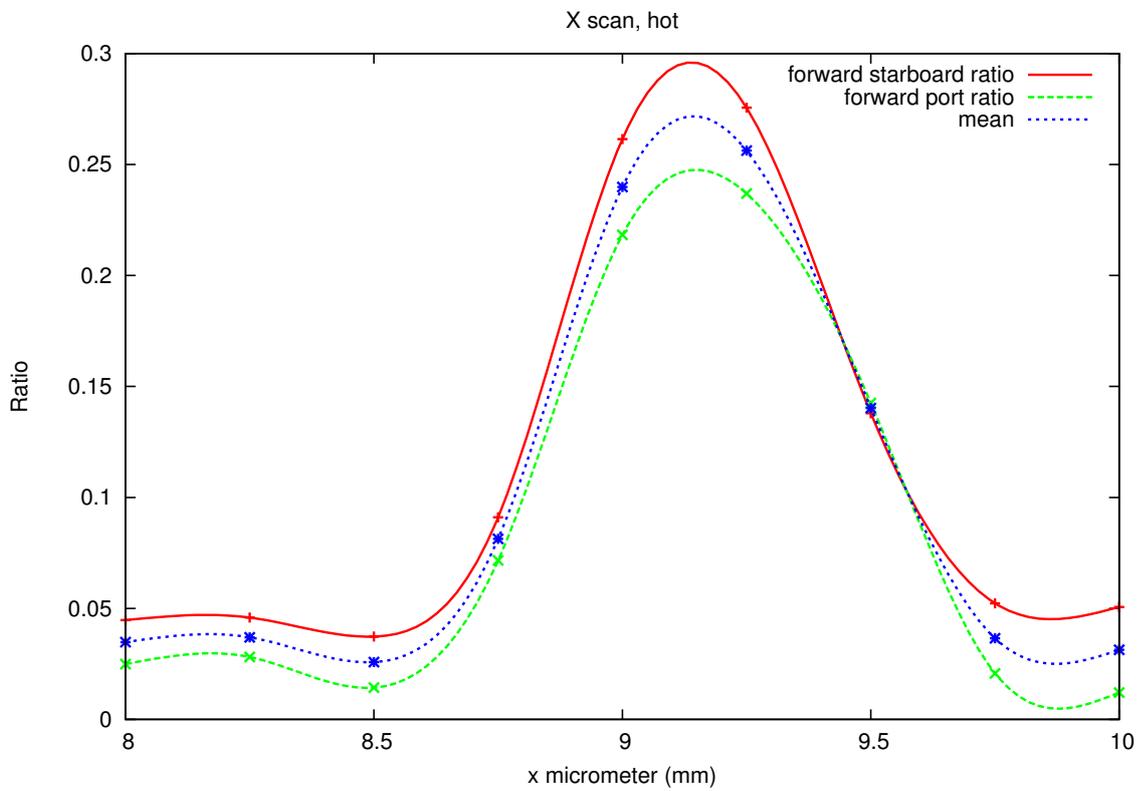
Figure 4: X Hot Ratio

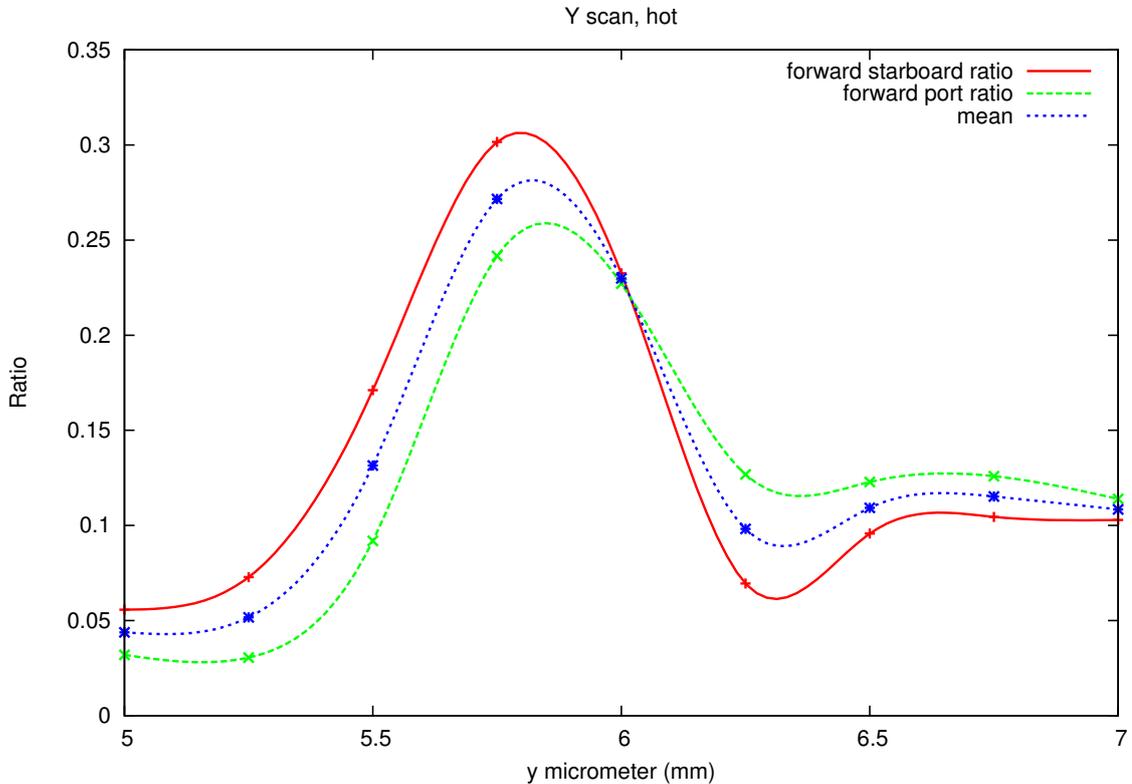
Figure 5: Y Hot Ratio

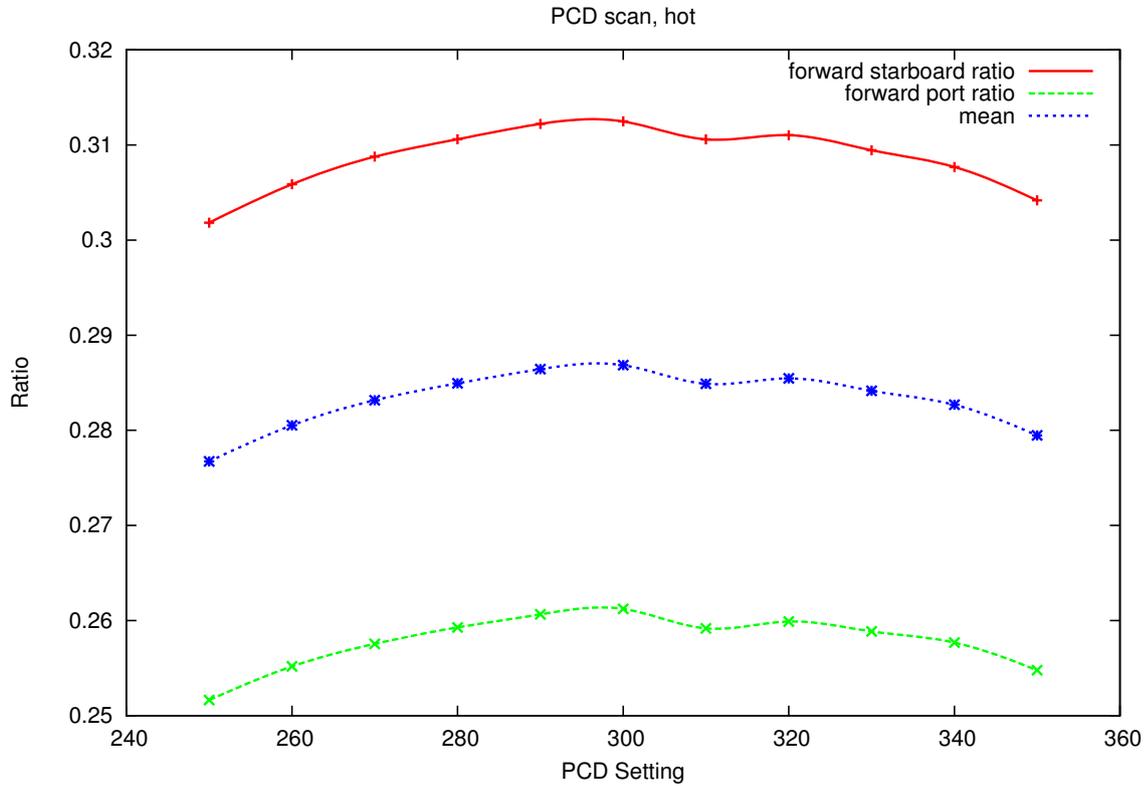
The initial dial setting was 330 units on the front of the PCD. This was swept in increments of 10 units and the ratio plotted against these values. The result is shown in figure 6.

There was unfortunately some brief intermittent cloud during this test, which explains the slight drop-out for the 310 unit value. Nevertheless, it is clear that the optimum ratio is found at the slightly reduced power setting of 300 units.

**Figure 6:** Pockels' Cell Driver Power Setting

The final setting was confirmed as 300 units on the dial.
