TECHNICAL REPORT NO. 367

A check on Carnarvon in 2014 November following NBN construction.

Steven J. Hale

2014 December 5

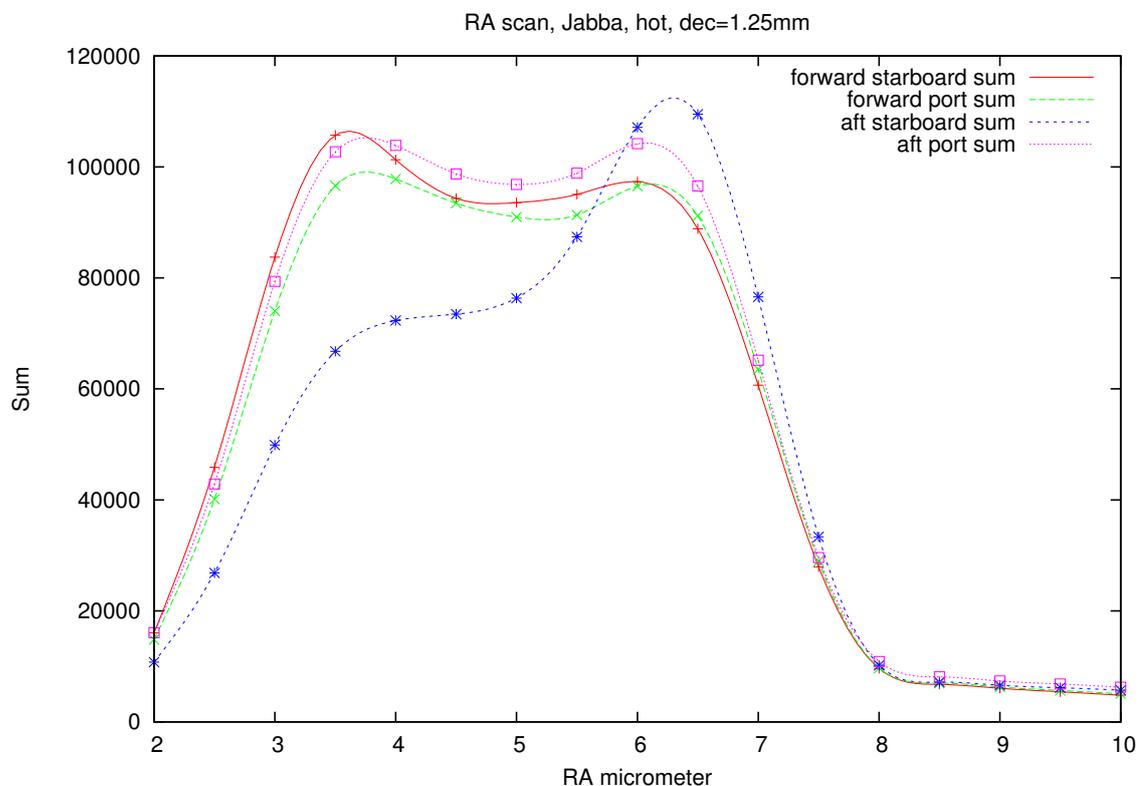
Figure 1: RA Hot Sum

The initial autoguider micrometer settings were 5.0 mm in RA and 1.25 mm in Declination, determined on the site visit in 2011 September [2]. A scan was performed in RA with the cell ovens hot. The results are shown in figures 1 and 2. The best alignment was determined to be at 5.0 mm in agreement with the initial setting. It would appear that no movement has taken place during the NBN works and so no further scans were performed.
