TECHNICAL REPORT NO. 373

New temperature controller for Hannibal in Las Campanas in 2015 April

Steven J. Hale

2015 May 18

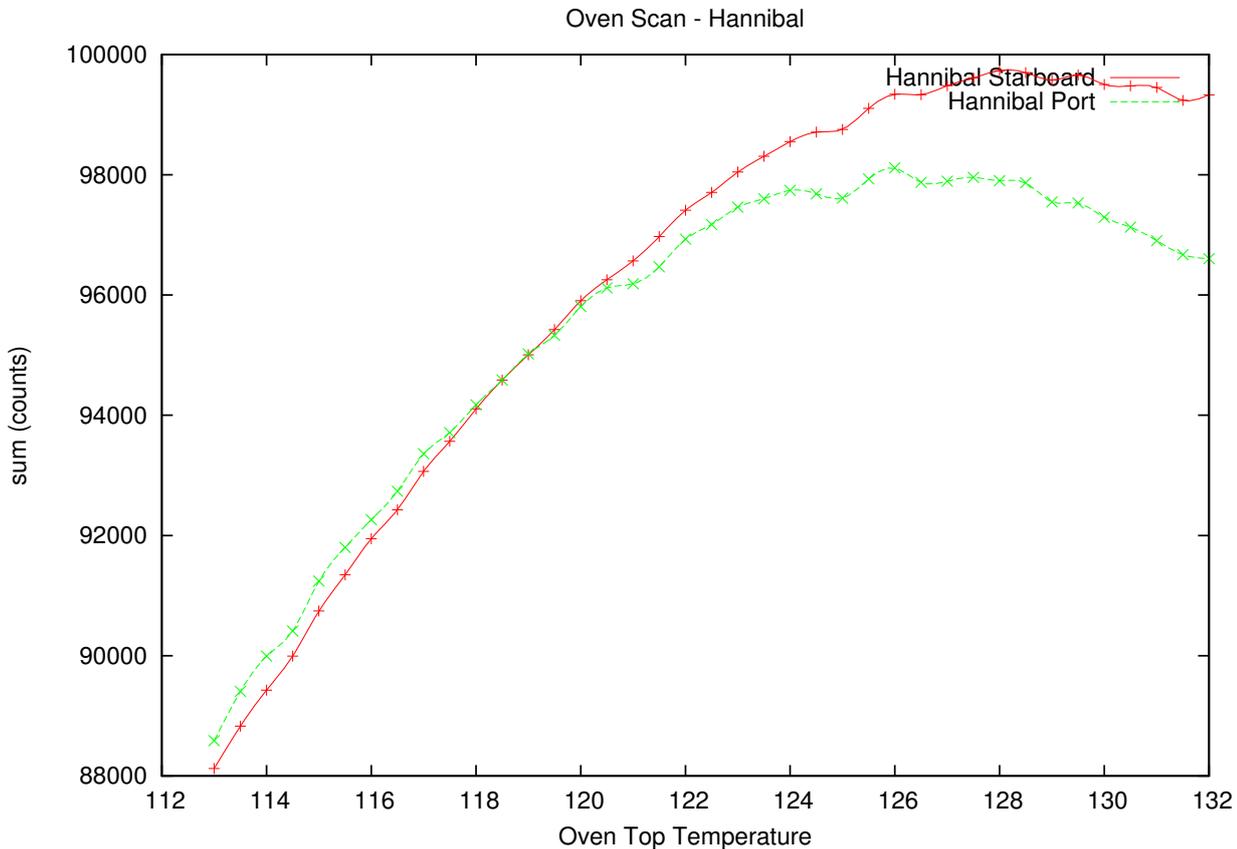
An oven temperature scan was performed, figure 1. A temperature of 128°C appears to be optimal. This is 3°C higher than used previously.

Figure 1: Hannibal oven temperature scan.
