TECHNICAL REPORT NO. 378

## Repairs to Jabba at Carnarvon in 2016 March

Steven J. Hale

2016 March 31

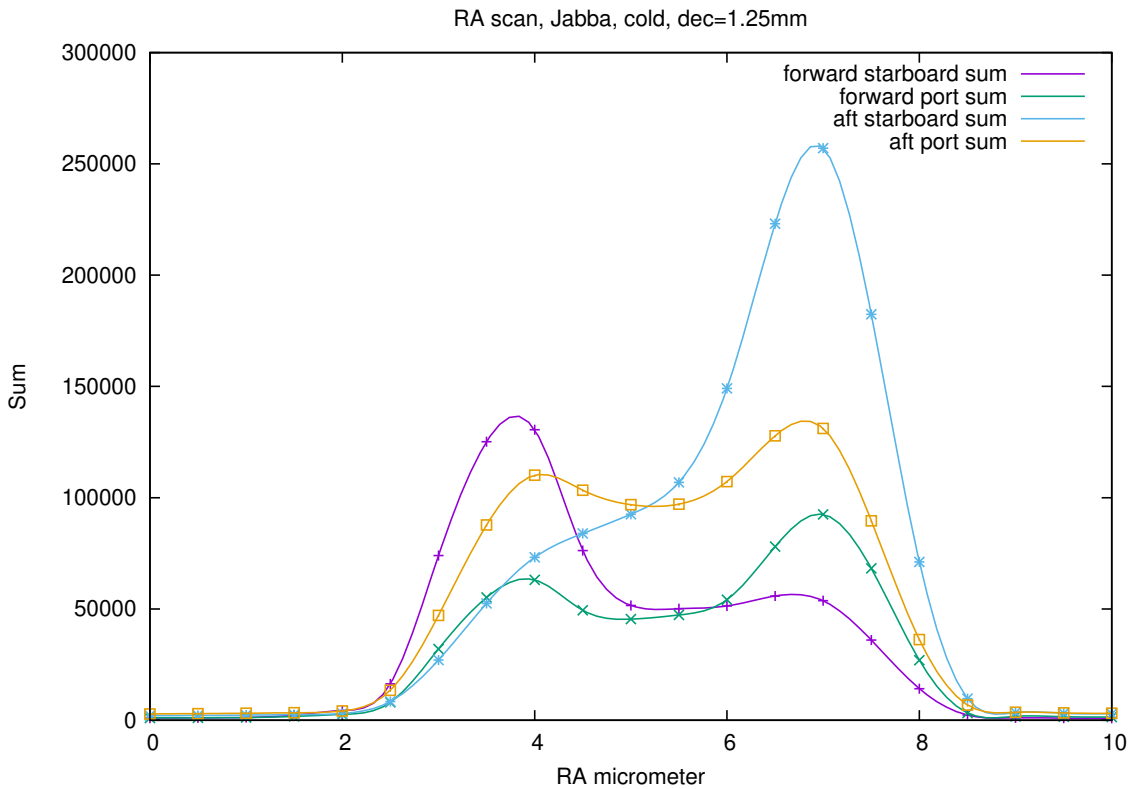
Figure 1: RA Cold Sum

The initial auto-guider micrometer settings were 5.0 mm in RA and 1.25 mm in declination, determined on the site visit in 2011 September [6]. A scan was performed in RA and dec with the cell ovens cold. The results are shown in Figures 1 and 2. The best position is found where the cold counts are minimised. The intensity increases at the sides of the cell due to direct reflection from the glass walls. This means that the ideal position is in the middle of the two intensity peaks.

The best alignment in RA was determined to be at 5.0 mm in agreement with the initial setting. The dec micrometer was changed from 1.25 mm to 1.5 mm, but there is really not much difference between the two positions.

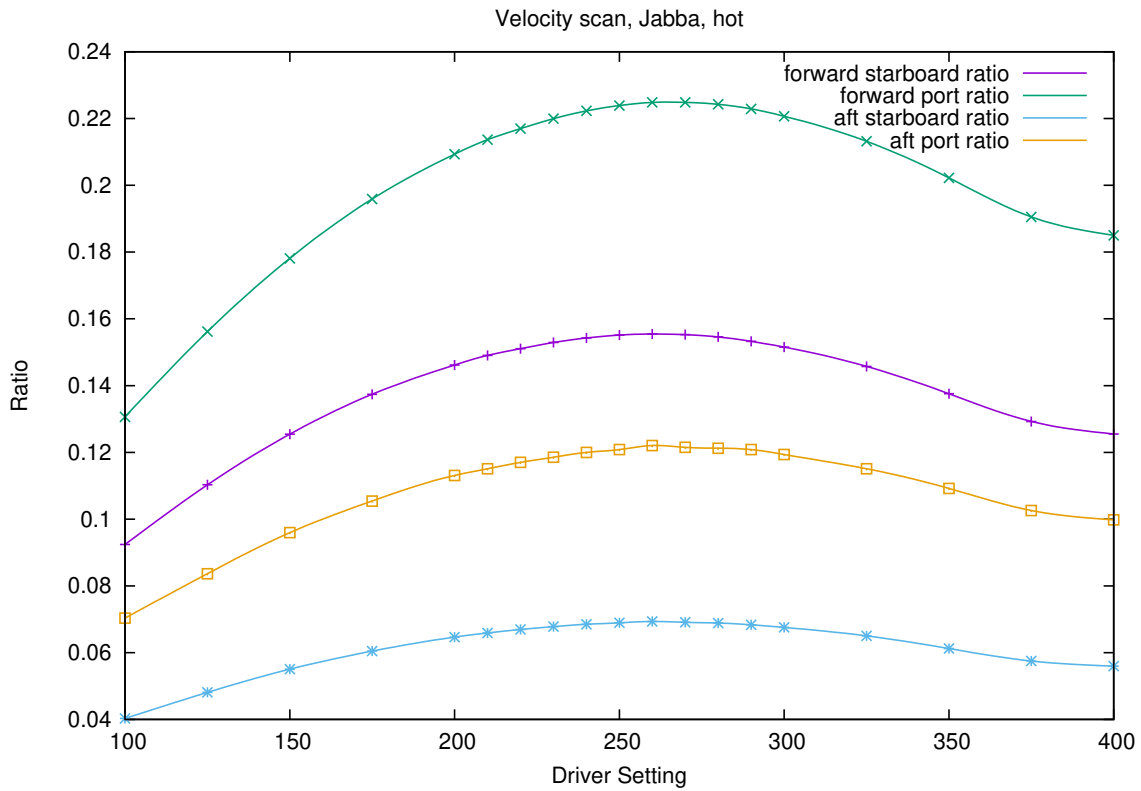
Figure 3: Velocity Pockel's Cell Scan

The power level of the velocity Pockel's cell was checked. The results are shown in Figure 3. The driver setting was initially at 250 units on the dial. This was increased slightly to 260 units. The magnetic Pockel's cell was not checked, since this requires the velocity cell to be removed, and the magnetic cell moved to the velocity position. This can not be done inside Jabba without also removing the linear polariser between the two cells, and so after the initial polariser alignment it was considered more important to avoid disturbing the polariser position again. The shape setting on both cell drivers is set at 300 units, and this was not changed.
