TECHNICAL REPORT NO. 380

Autoguider repairs at Mount Wilson in 2016 April

Steven J. Hale

2016 June 17

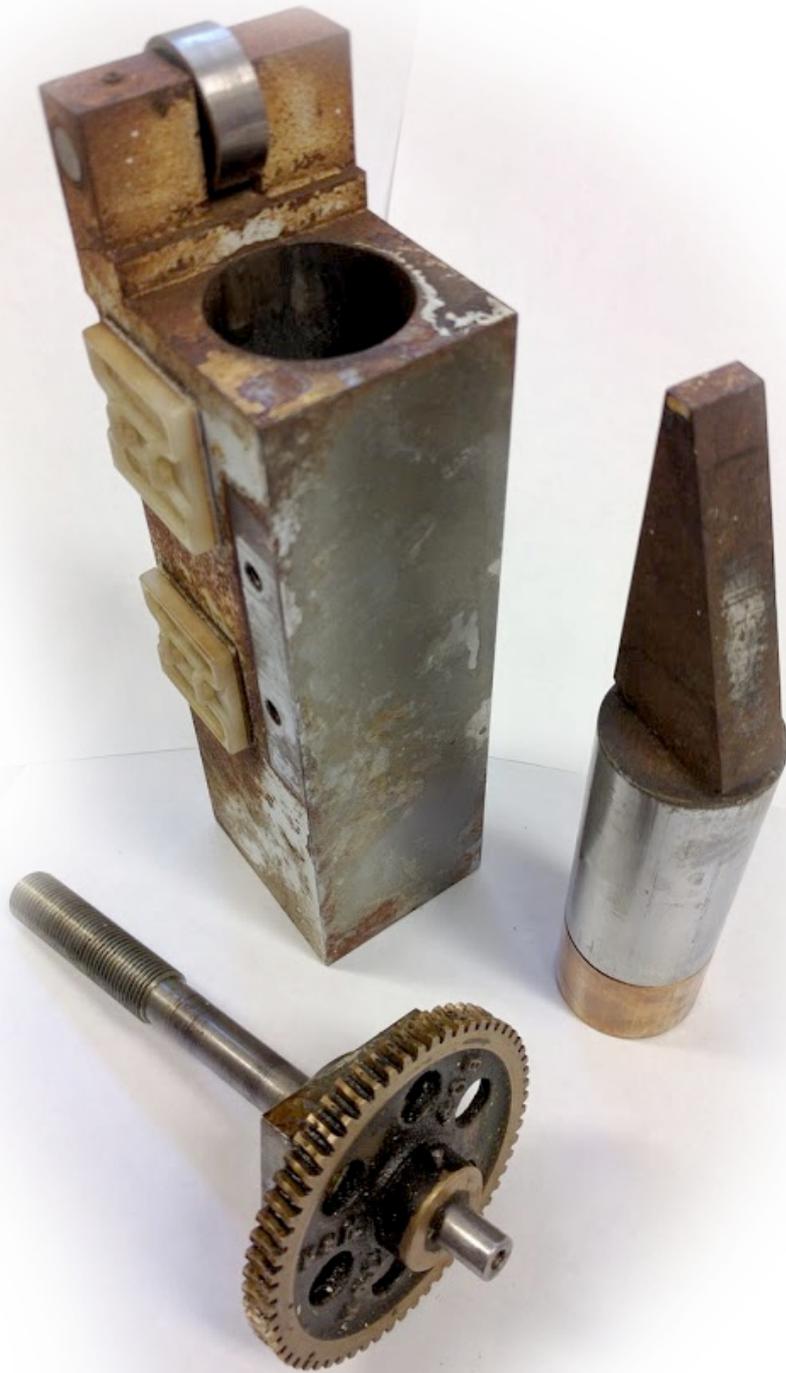
The mechanical drive for the east/west axis on the second-flat had almost seized. The whole assembly was removed and cleaned with engine degreaser, shown in Figure 1. It was reassembled with a light application of general purpose grease, and the tilt-cam had a much smoother action upon re-installation. This should improve the guiding performance in the east/west axis. The north/south axis already turned freely and was not disassembled.

Figure 1: The east/west drive cam for the second-flat.
