TECHNICAL REPORT NO. 389

## Jabba fibre conversion at Carnarvon in 2018 April

Steven J. Hale and Eddie Ross

2018 June 22

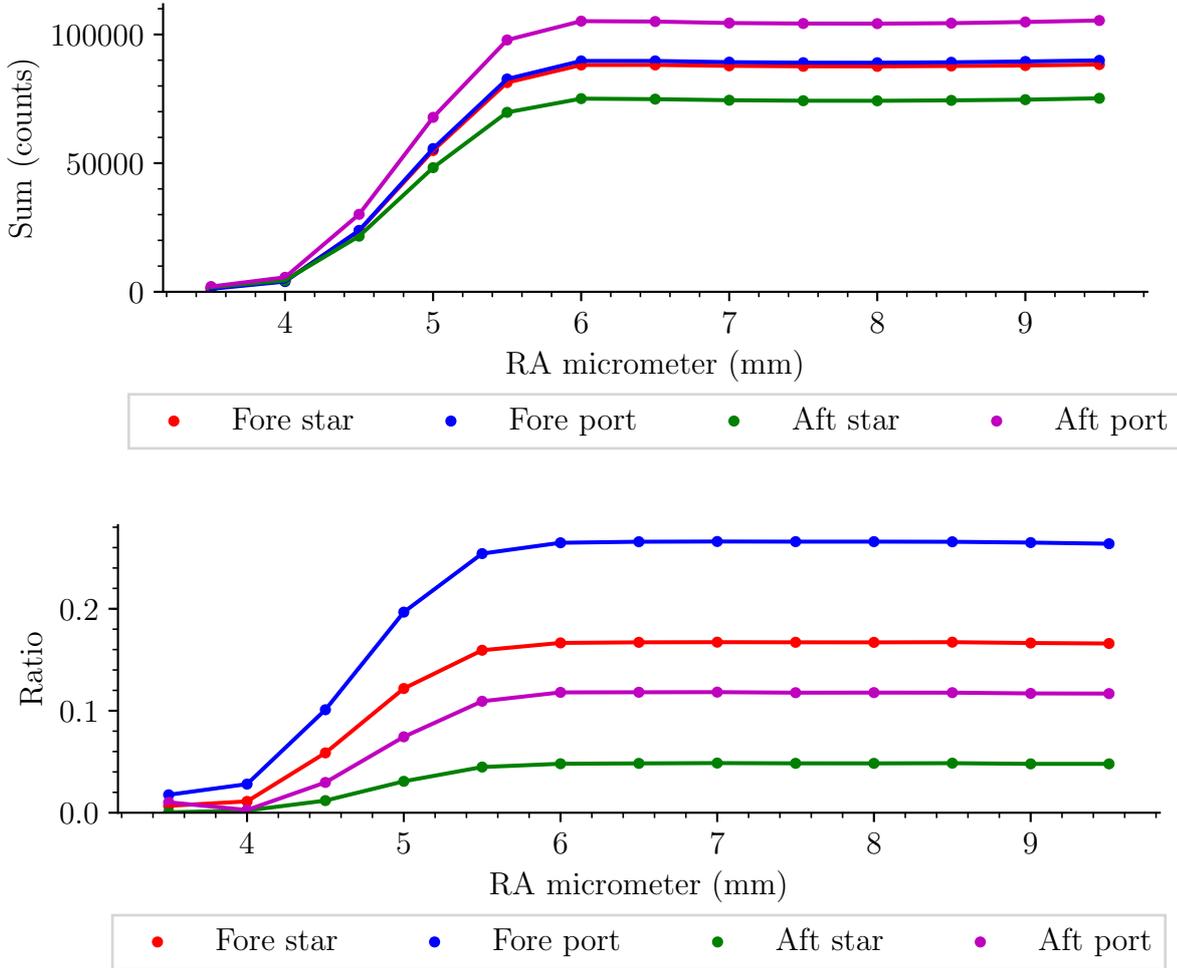
**Figure 2:** RA guider micrometer scan. 1 mm of micrometer travel is approximately  $0.3^\circ$  change in angle. The final setting was selected as 8.0 mm.

the fibre in both RA and declination respectively. The final micrometer values were selected as 8.0 mm in RA and 3.0 mm in declination, close to the initial estimates. Part of the RA scan is lost off the end of the micrometer travel. We can assume that both RA and dec are symmetric with approximately 2.0 mm of travel either side of the centre of the fibre, making the total unvignetted field of view  $1.1^\circ$  as expected for the 30 mm focal length objective lens.

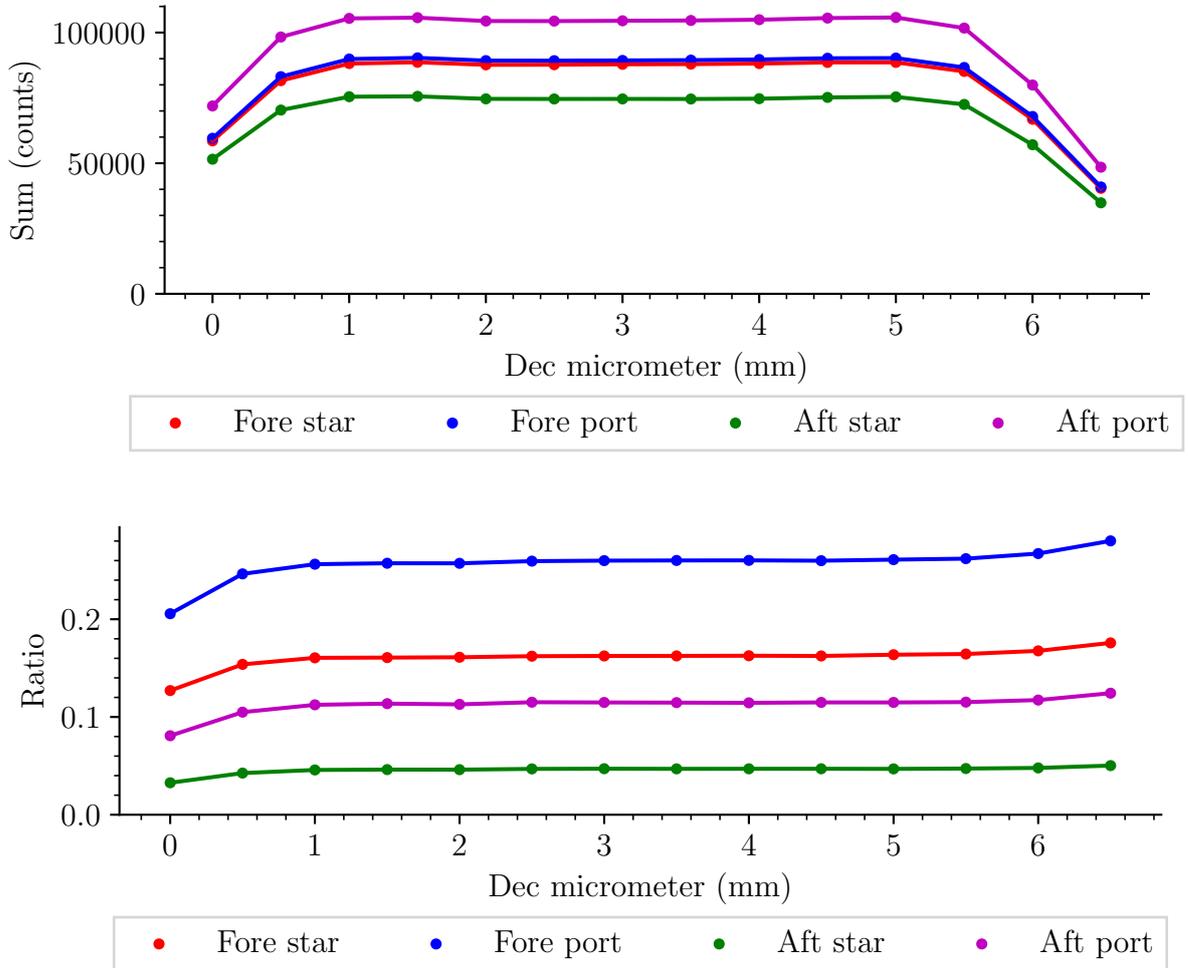
**Figure 3:** Declination guider micrometer scan. 1 mm of micrometer travel is approximately  $0.27^\circ$  change in angle. The final setting was selected as 3.0 mm.

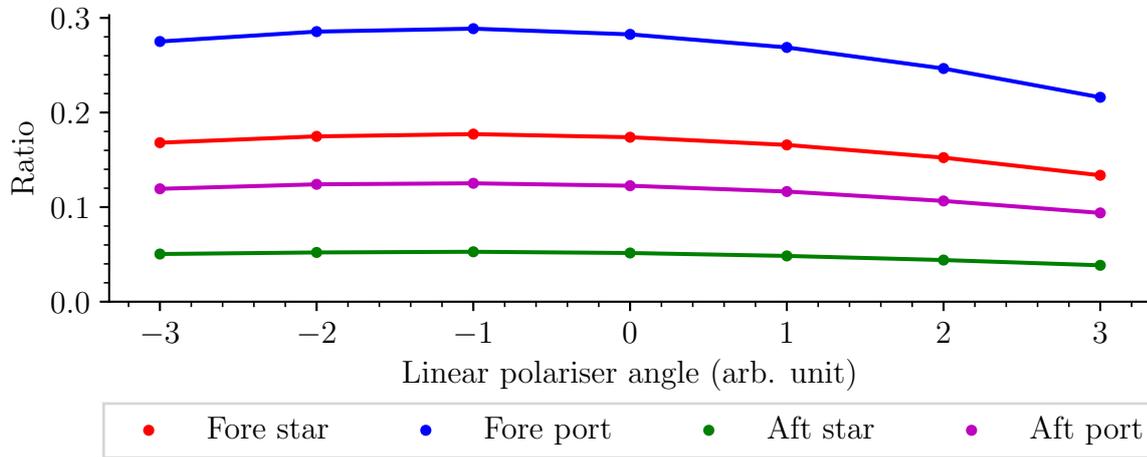
The linear polariser, mounted between the two Pockels cells in Figure 1 on page 5, failed by becoming a piece of plain clear plastic and was removed in 2016 August [1]. A spare was not available for replacement, and so a temporary part was fabricated from the “lens” of a pair of polarising sunglasses. On this visit, the sunglasses filter was removed and a new piece of HN32 installed. It is not clear what caused the original polariser to fail. In 2016 March a fault with

**Figure 4:** Linear polariser alignment. The final setting was selected as  $-1$  on the marked scale.

The mount for the polariser has a small rotational adjustment with a total of seven major tick marks. These were considered to be  $\pm 3$  units either side of the centre position. The ratio from each detector was logged at each major tick mark, and the results are shown in Figure 4. The ratio was maximised at the  $-1$  position, and this was selected as the final set point for the polariser alignment.

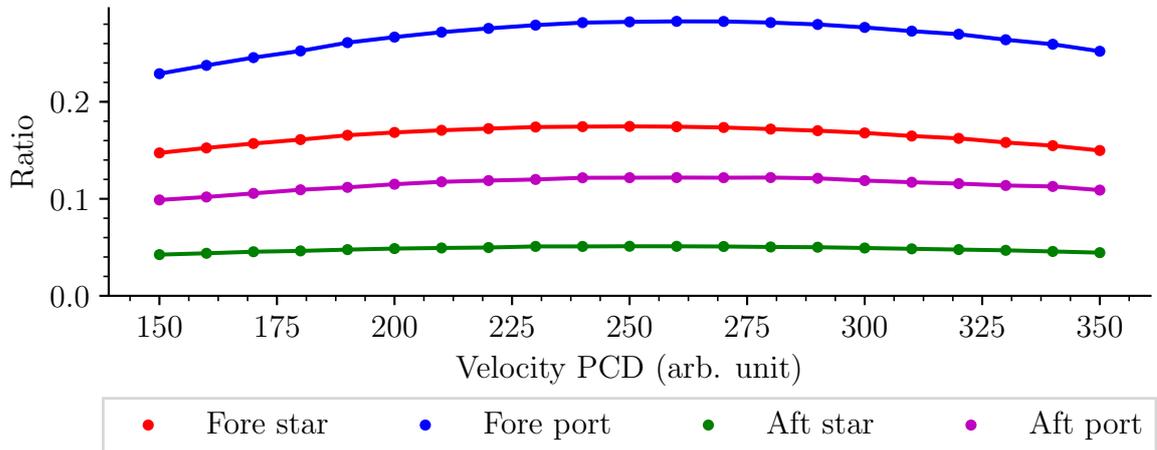
**Figure 6:** Velocity Pockels cell calibration.

The voltage scan of cell L14 in the velocity position is shown in Figure 6. The initial setting was 260, and the ratio was found to be maximised at this same value. No change was made to the velocity cell voltage.

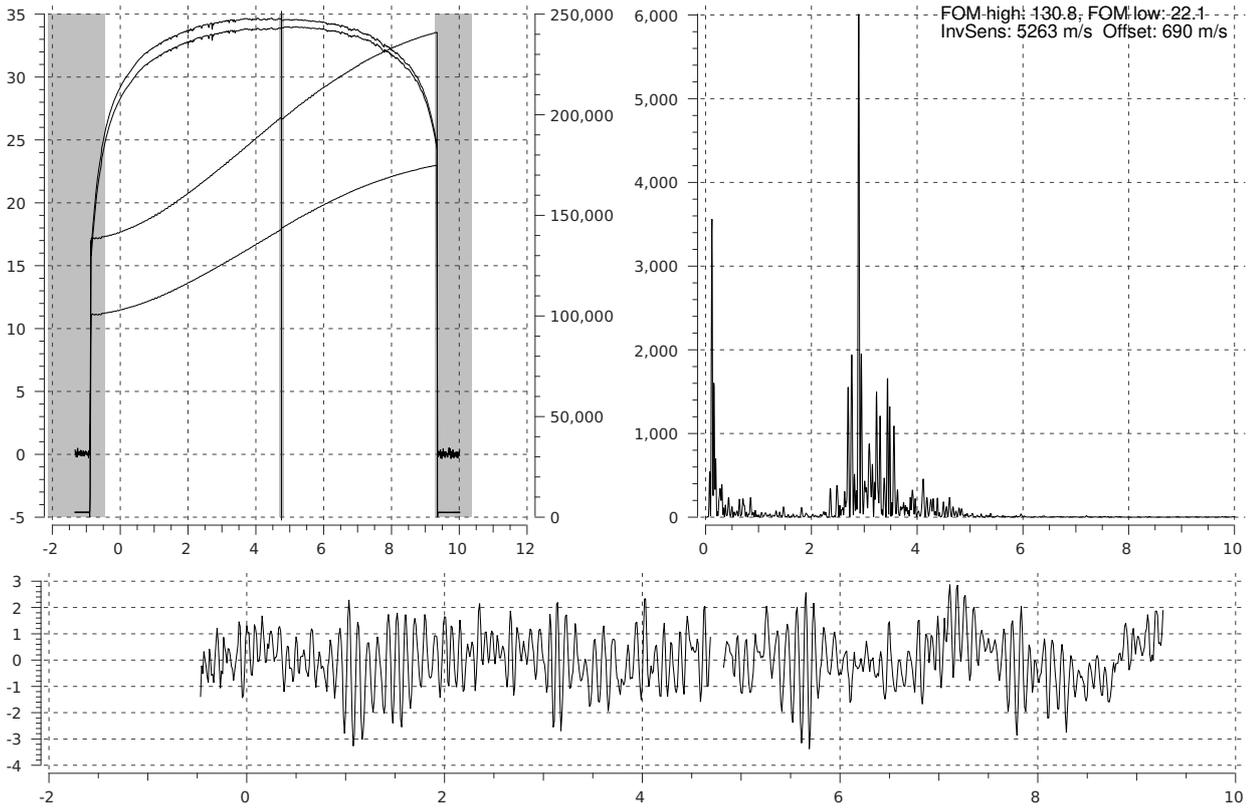
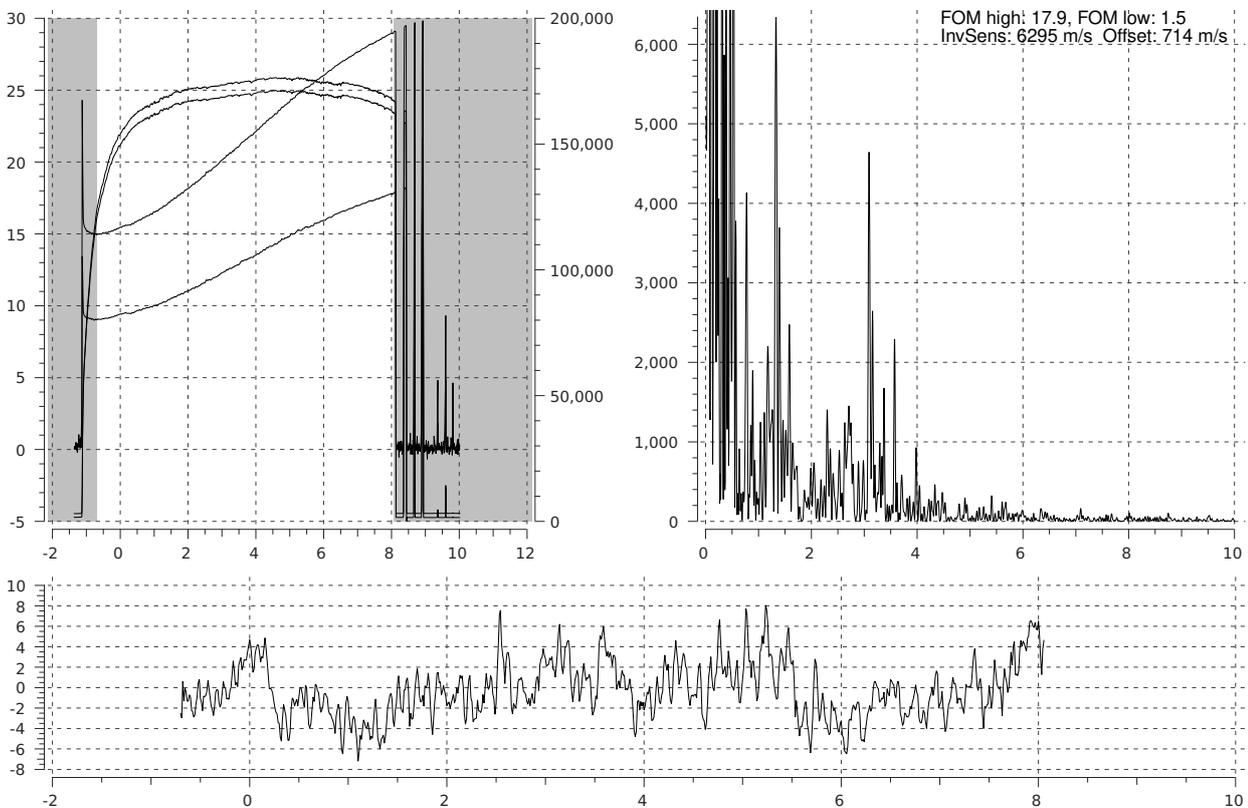
**Figure 7:** Data from the forward cell. Top: 2010 April 26, shortly after Jabba was reinstalled in 2009. This can be considered a quality benchmark to be achieved. Bottom: 2018 April 26, collected via the fibre conversion.

Clearly the data are poor. The inverse sensitivity is much higher (i.e., worse) and the noise levels are poor. There are a number of possible reasons for this, which are discussed below.

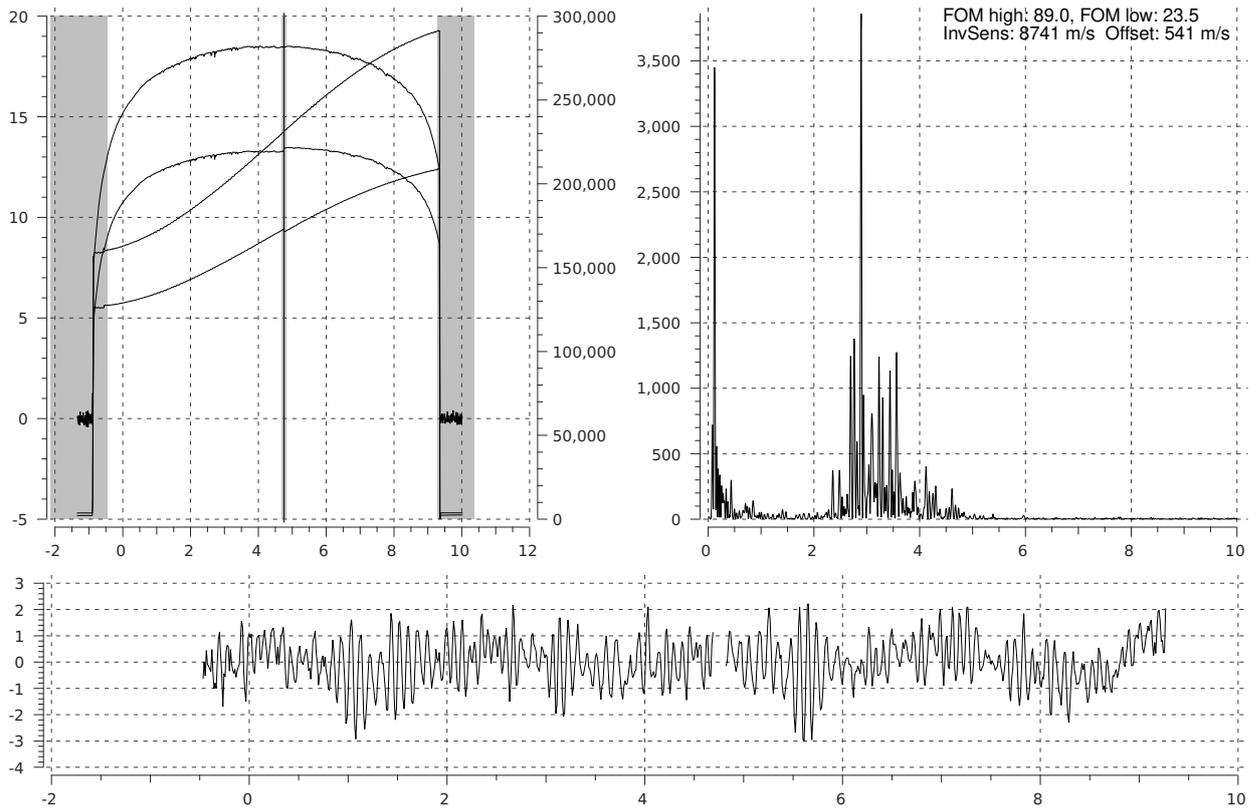
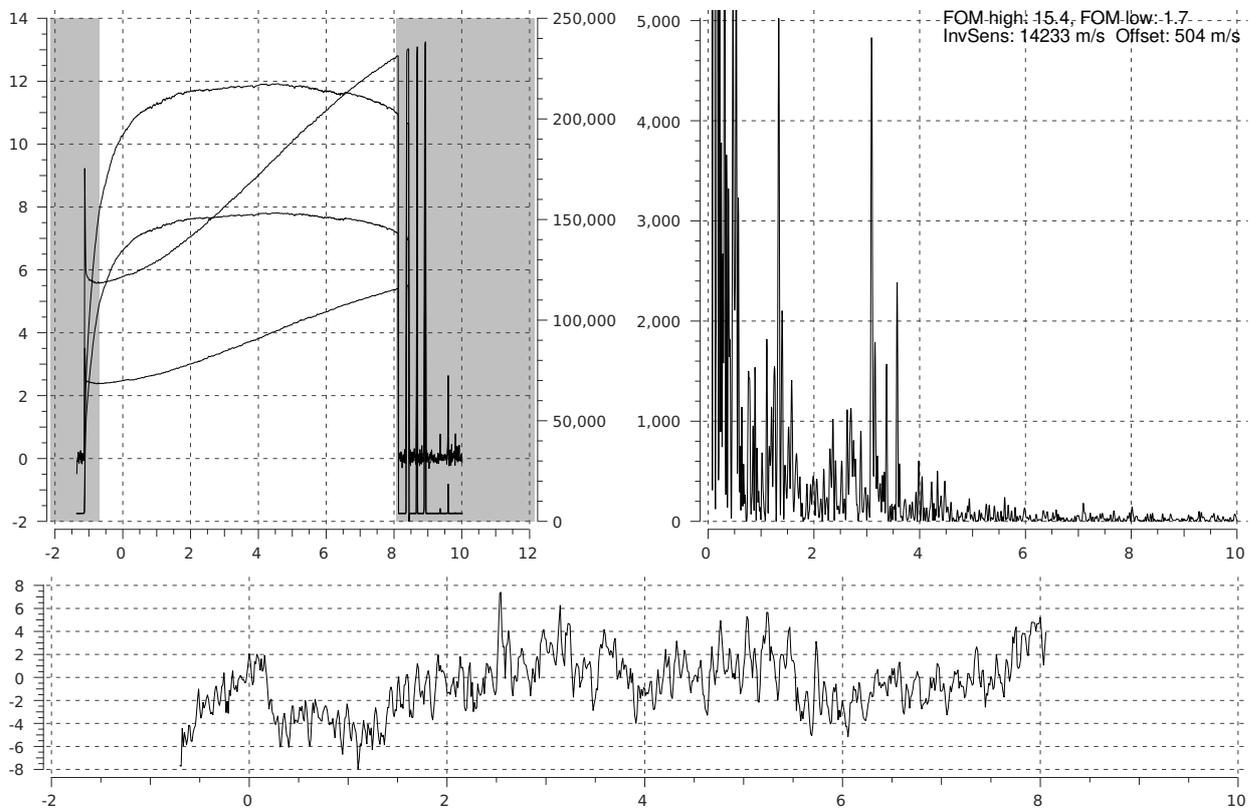
**Figure 8:** Data from the aft cell. Top: 2010 April 26, shortly after Jabba was reinstalled in 2009. This can be considered a quality benchmark to be achieved. Bottom: 2018 April 26, collected via the fibre conversion.
