BiSON

TECHNICAL REPORT NO. 391

Hannibal vapour cell replaced at Las Campanas in 2018 October

2018 November 5

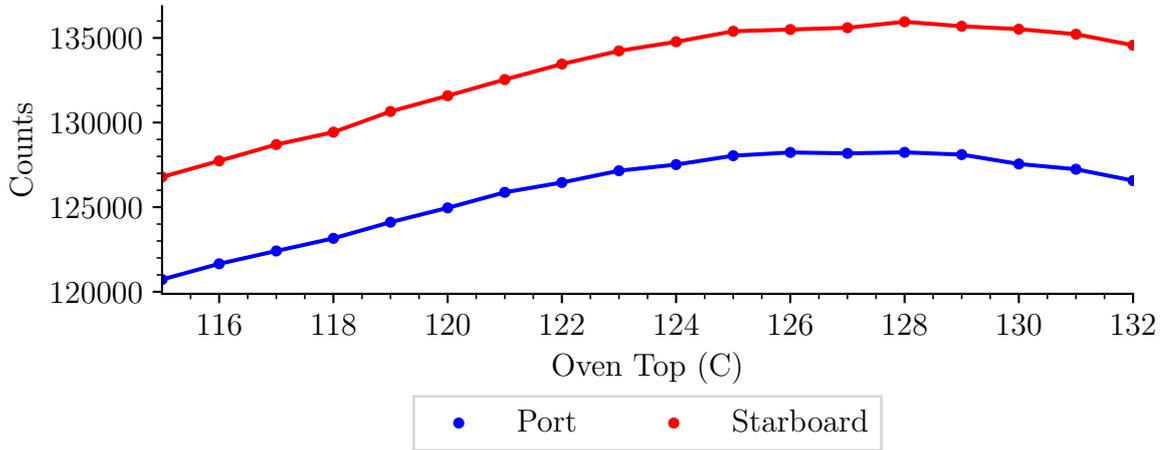
Figure 1: Hannibal oven top temperature scan completed on 2018 October 17.

Previously the cell has been operated at 128°C at the cube, and between 96°C to 99°C at the stem varying with ambient temperature. At other sites the cells are typically operated between 110/90°C and 120/100°C with the optimum depending on scattering detector aperture size. A scan over a range of temperatures was completed, with the results shown in Figure 1. The scan suggests that 127°C for the cube, resulting in 97°C at the stem is the ideal temperature, and this matches what was determined previously with the old cell. The cell cube temperature is higher than usually expected due to the 30°C thermal gradient between the cube and the stem and the lack of direct stem thermal control. A lower gradient would allow the 97°C stem temperature to be achieved at a reduced cell top temperature. Many attempts were made at adjusting the stem collar to change the gradient, but 30°C was the best gradient achieved with all other attempts being either much too low or much too high.

The new cell was installed and the oven reassembled. There were no spare thermocouples available, and also no stock of LM35 or AD590 sensors to replace them. The oven stem thermocouple was able to be reused. A second thermocouple was recovered from the Hannibal baseplate sensor channel, and used as the oven top sensor. The Hannibal oven is of the older design where only the cell cube top is thermally controlled. The stem of the cell floats with a temperature gradient that is partially determined by a metal collar around the stem that is in contact with the oven base. The thermal gradient across the cell is adjusted by moving the position of the collar; further down and the stem temperature is lower (larger gradient), further up and the stem temperature is higher (smaller gradient). The process to optimise the gradient is time consuming because the oven has to be removed and everything disassembled to adjust the collar. It then takes an hour or so when reassembled for the oven to heat and come to thermal equilibrium before the new gradient can be determined. The thermal gradient between the cell cube top and the stem is typically of the order of 20°C. The most critical temperature is the cell stem since this controls the potassium vapour pressure. The cell cube simply needs to be hotter than the stem to ensure the solid potassium remains in the stem and does not undergo deposition onto the cell windows. This means the old style spectrometer design is poor, since the wrong part of the cell is thermally controlled. The newer designs have both top and stem control, meaning it is possible to directly define the desired temperature gradient and obtain better stabilisation of the vapour pressure.

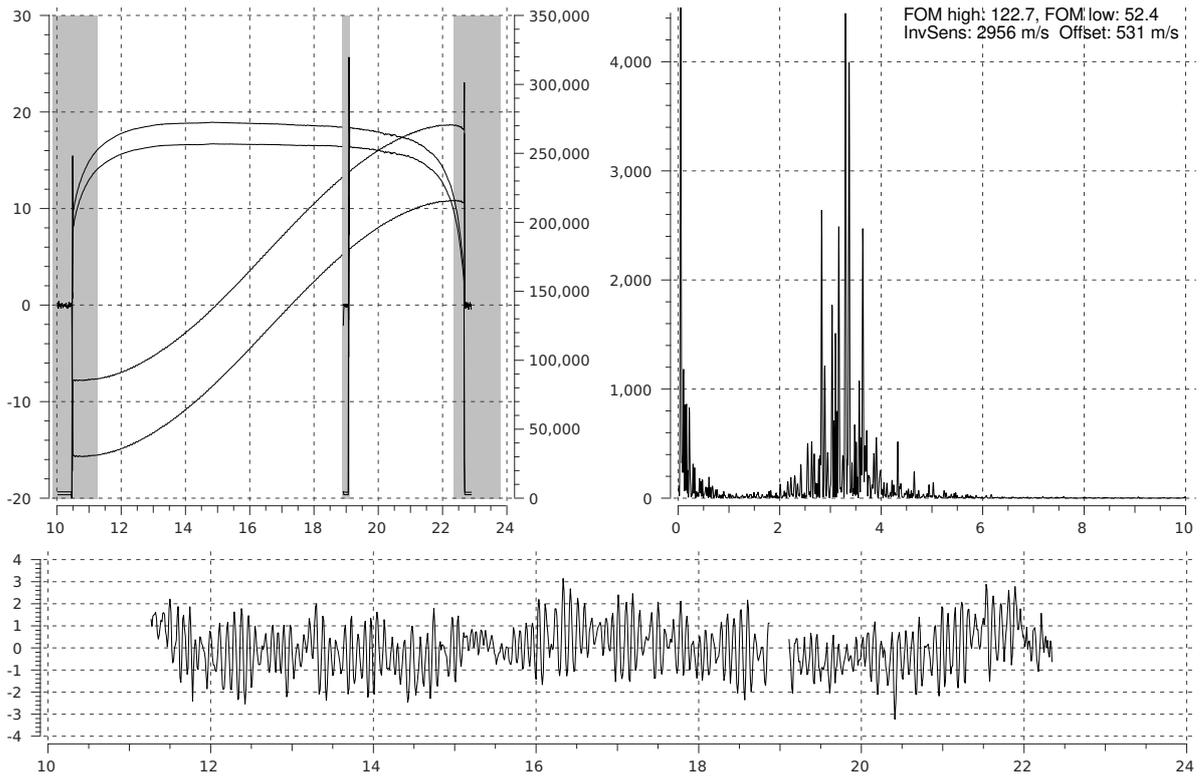
Las Campanas/Hannibal - 2018 October 18

The hot to cold ratio is 14 for the starboard detector and 13.6 for the port detector, which is exceptionally good. Figures 2, 3, 4, and 5 show data from the last four days of the site visit. The five-minute Figure-of-Merit (FOM) is greater than 100 and this is better than has typically been achieved since 2012, producing a noticeable improvement in data quality.

Figure 2: Data from Hannibal for 2018 October 18.

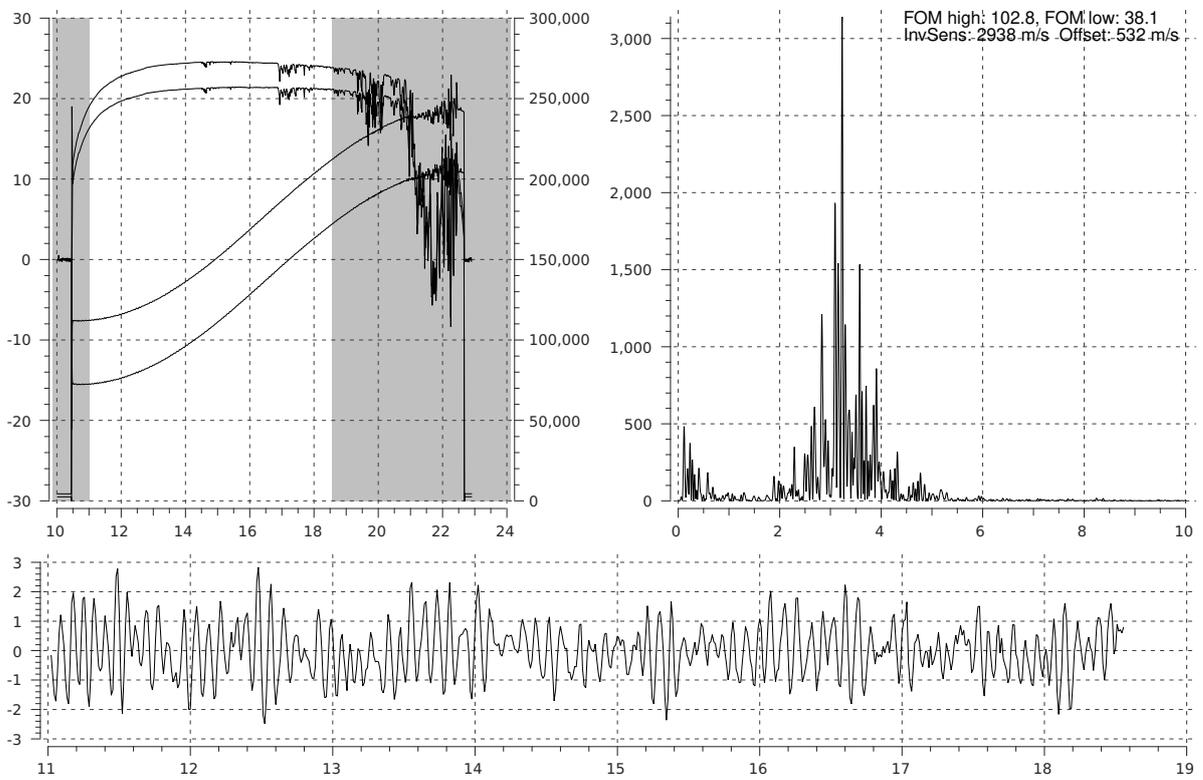
Las Campanas/Hannibal - 2018 October 19

Figure 3: Data from Hannibal for 2018 October 19.

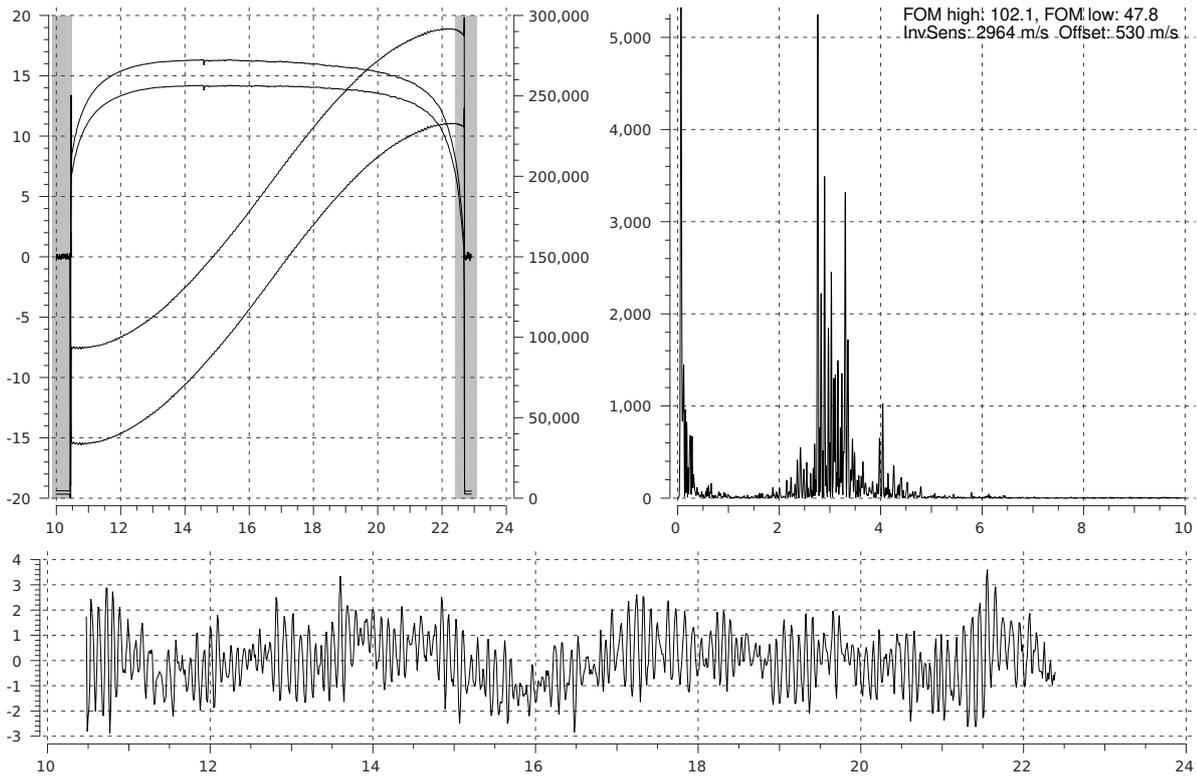
Las Campanas/Hannibal - 2018 October 20

Figure 4: Data from Hannibal for 2018 October 20.

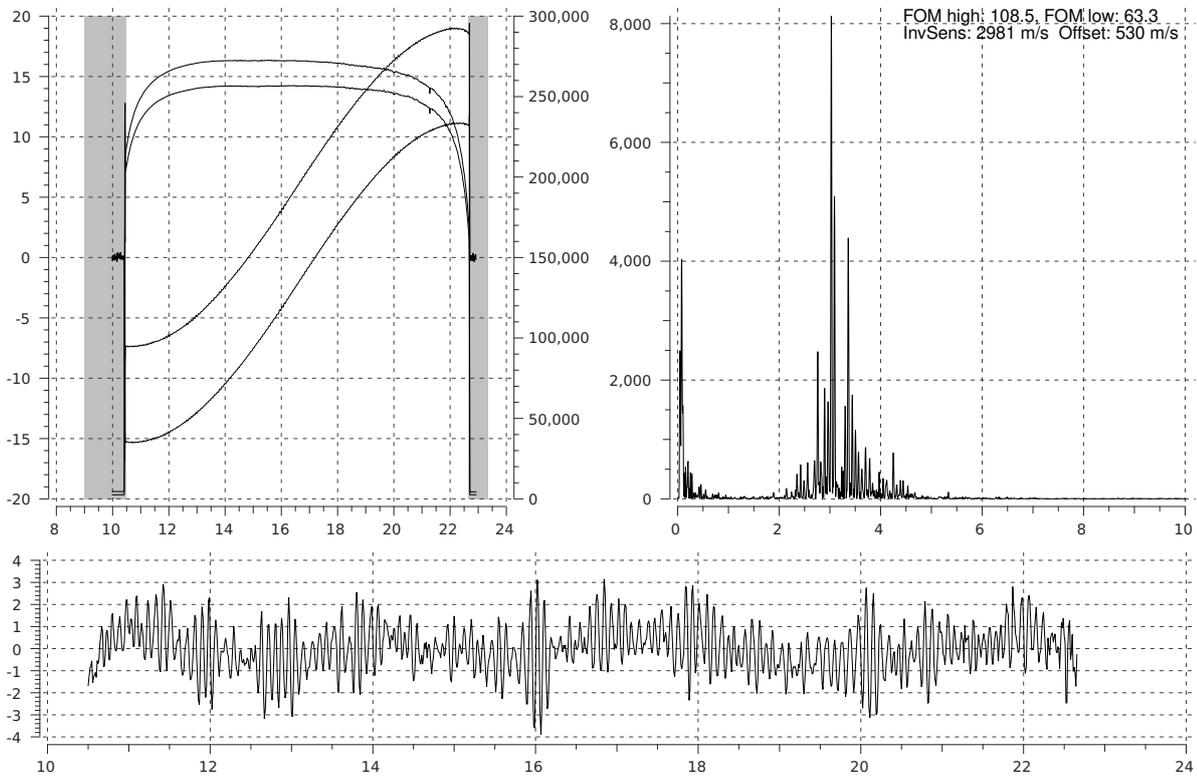
Las Campanas/Hannibal - 2018 October 21

Figure 5: Data from Hannibal for 2018 October 21.
