TECHNICAL REPORT NO. 393

**Shutter repairs and updated fibre conversion at Carnarvon in
2019 February**

Steven J. Hale

2019 March 27

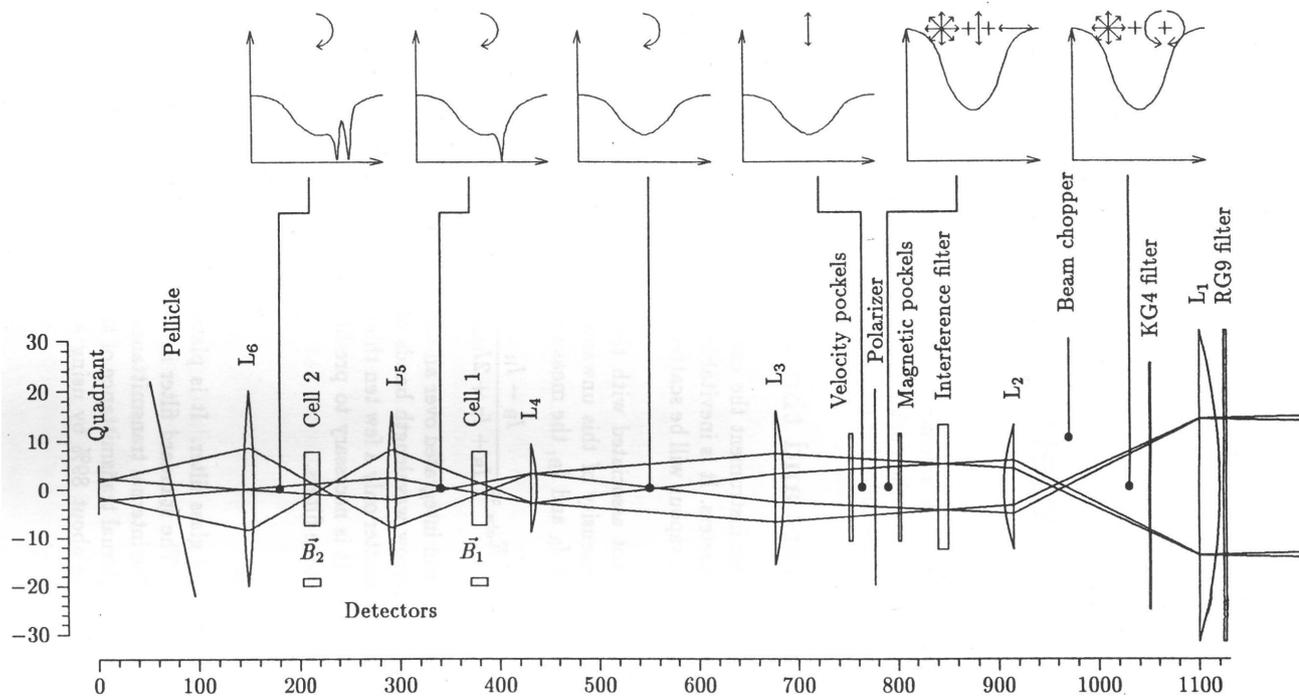
The original Jabba double-field spectrometer optical configuration is shown in Figure 1. The lenses, labelled L1 through L6, are defined in Table 1. During the site visit in 2018 April [1], both L1, L2, and the filters were removed, and the fibre output mounted at the shared focal plane between the original L1 and L2 lenses. The new L2 fibre collimating lens is a Thorlabs AC254-030-B-ML with focal length of 30 mm and diameter 25.4 mm, the same lens as used at the input of the fibre.

Lens L3 originally produced a solar image on L4 immediately before the first magnet assembly. L4 is a Fabry lens intended to change the imaging of the system such that the image formed in the vapour cell is of the objective aperture rather than the Sun. The Fabry lens partially scrambles the solar image and reduces the effect of so-called Doppler Imaging inside the vapour cell. Whilst the image scrambling effect is no longer required when using an image-scrambling optical fibre, these two lenses were maintained as originally installed in order to minimise the changes to the instrument. Unfortunately it was later found that the data quality had deteriorated due to a lower signal-to-noise (i.e., cell hot-to-cold) ratio, and this was believed to be caused by an increase in the non-resonantly scattered light from within the cell ovens. The change in initial collimation optics produces a beam that has a slightly larger diameter than the original design, and this may have been causing the increased illumination of the inside of the ovens.

Figure 1: The Jabba double-field spectrometer optical configuration. Dimensions are in millimetres. The spectral intensity and polarisation state in the vicinity of the incident Fraunhofer line is shown at various locations along the optical path. The lenses are defined in Table 1. Reproduced from Lewis (1996) [4].

On this visit, both L3 and L4 were removed. Lens L4 was replaced by a Thorlabs AC254-100-B-ML lens with focal length of 100 mm and diameter 25.4 mm, which focuses the collimated beam into the vapour cell and ensures that the beam is sufficiently converged to clear the magnet entrance aperture. The effect of the Fabry lens is no longer required since image scrambling is achieved via the optical fibre. Only lens L5 between the two ovens is now original to the design of Jabba. Lens L6 is no longer present since the transmission monitor was not reinstalled following the 2009 spectrometer refit [2]. The beam collimation, focus, and alignment was checked by removing the 1.5 nm interference filter and both the ovens. A 770 nm fibre-coupled LED was used to provide a beam through the instrument, which could be viewed and optimised. This same optical configuration is in use successfully with the fibre-conversion of Klaus at Mount Wilson [3], and so no further issues are expected with the optical design.

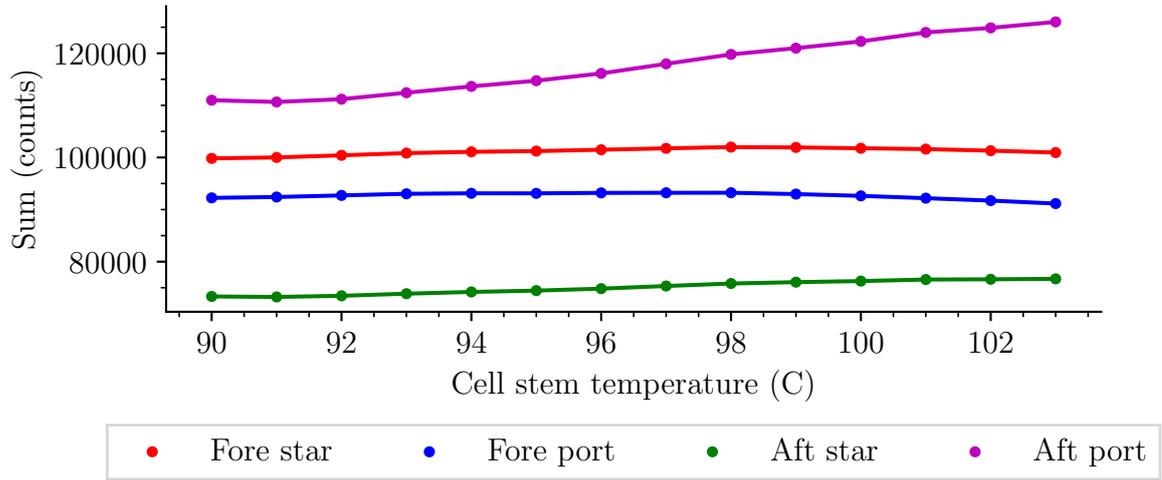
A heating curve to optimise the temperature set-point for both cells was produced on February 9. The results are shown in Figure 2. The optimum cell stem temperature was selected as 98°C. The cell cube/top temperature was defined at the standard 20°C above the stem temperature, resulting in a set-point of 118°C. At these temperatures the hot-to-cold ratios achieved with sunlight were 2.5 and 2.8 for forward starboard and forward port, and 1.6 and 2.2 for aft starboard and aft port. The values from the forward cell have decreased to 60% of that when using the LED, and this is about the reduction expected due to the depth of the solar absorption line. Both the cells show low hot-to-cold ratios suggesting that there is little potassium remaining in the cells, and they will likely need to be replaced soon. The cells were not replaced on this visit since very few spares are available in HiROS stock, and so replacements are restricted to only when absolutely necessary.

Figure 2: Oven stem temperature scan for both forward and aft cells. The optimum set-point was selected as 98°C for the stem, and 118°C for the cube/top.

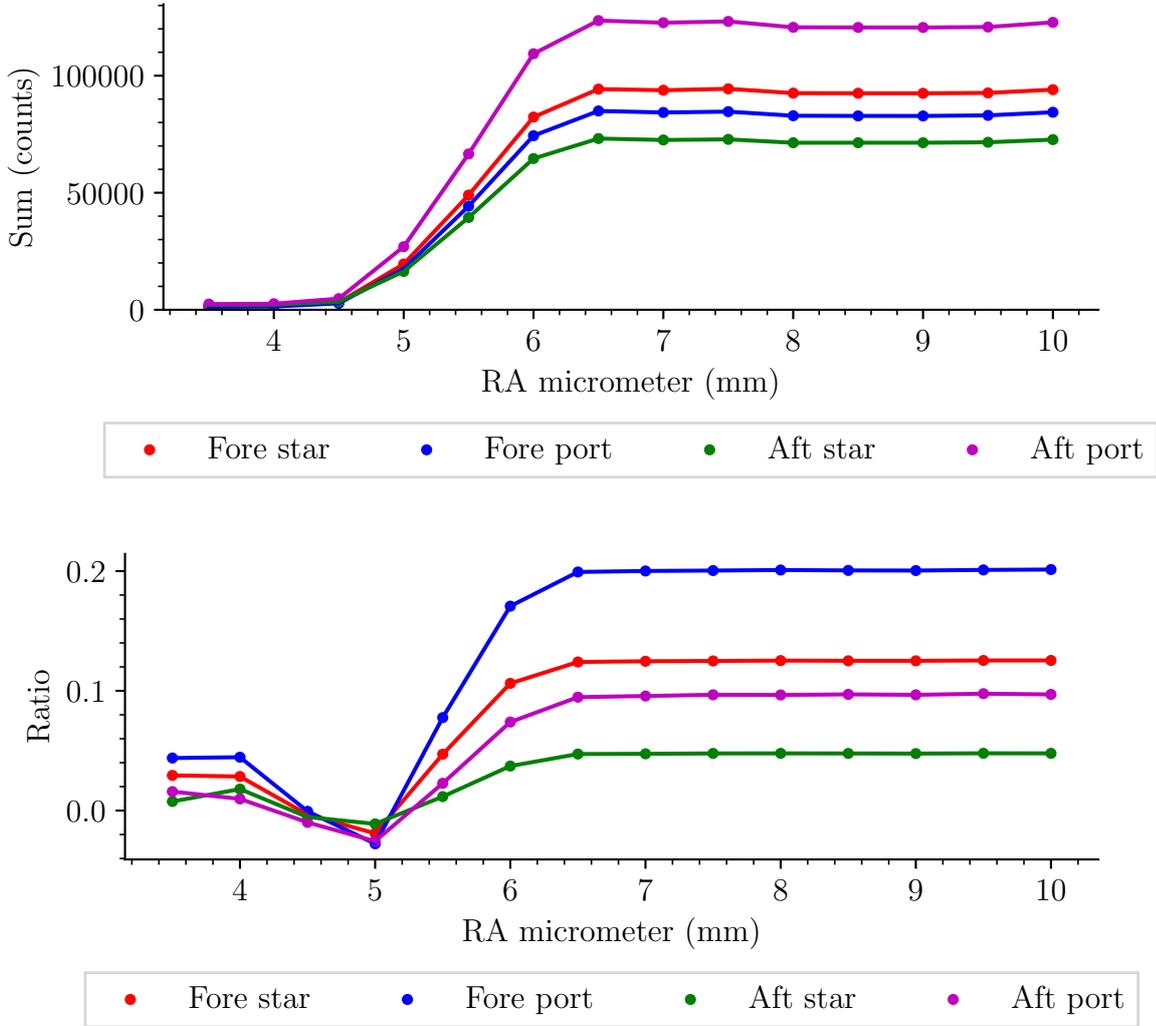
The fibre input was aligned on the mount during the initial installation in 2018 April [1]. On this visit, some mechanical adjustments were made and another guider scan completed. The results are shown in Figures 3 and 4. These results are not as clean as from the last visit due to slight haze and occasional cloud. The final micrometer values were selected as 9.0 mm in RA and 3.25 mm in declination. The scan was performed near solar noon to ensure that any guiding drift should be symmetric about the centre of the fibre core and so minimise the chance of vignetting towards the edge. It is interesting to note in Figure 3 that the ratio begins to increase again as the solar image drifts far off the edge of the fibre, below a micrometer setting of 5.0 mm, and this could be another cause of low frequency offsets in the ratio. Perhaps a lens hood should be installed to limit the off-axis field-of-view.

Figure 3: RA guider micrometer scan. 1 mm of micrometer travel is approximately 0.3° change in angle. The final setting was selected as 9.0 mm.

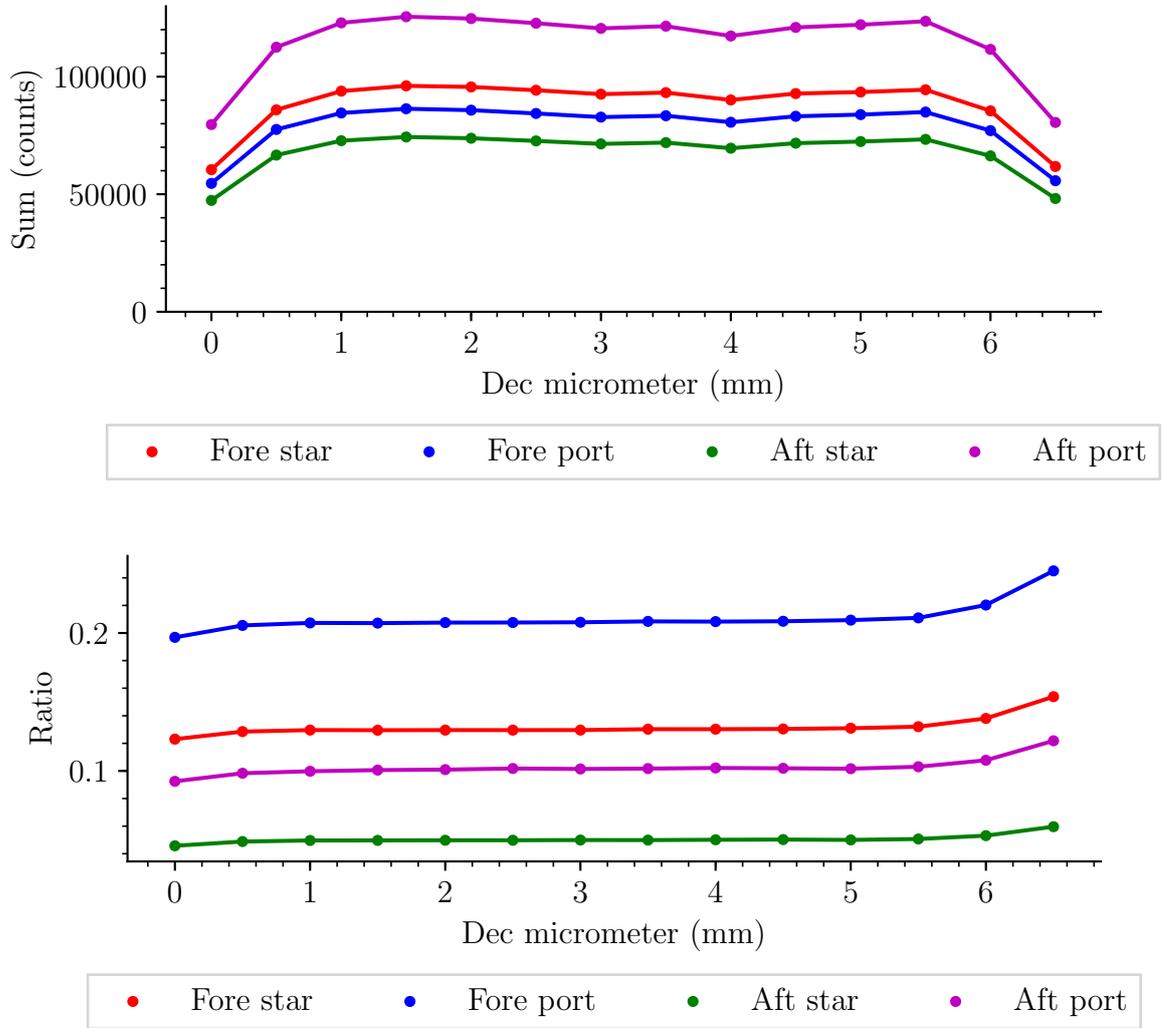
Figure 4: Declination guider micrometer scan. 1 mm of micrometer travel is approximately 0.27° change in angle. The final setting was selected as 3.25 mm.

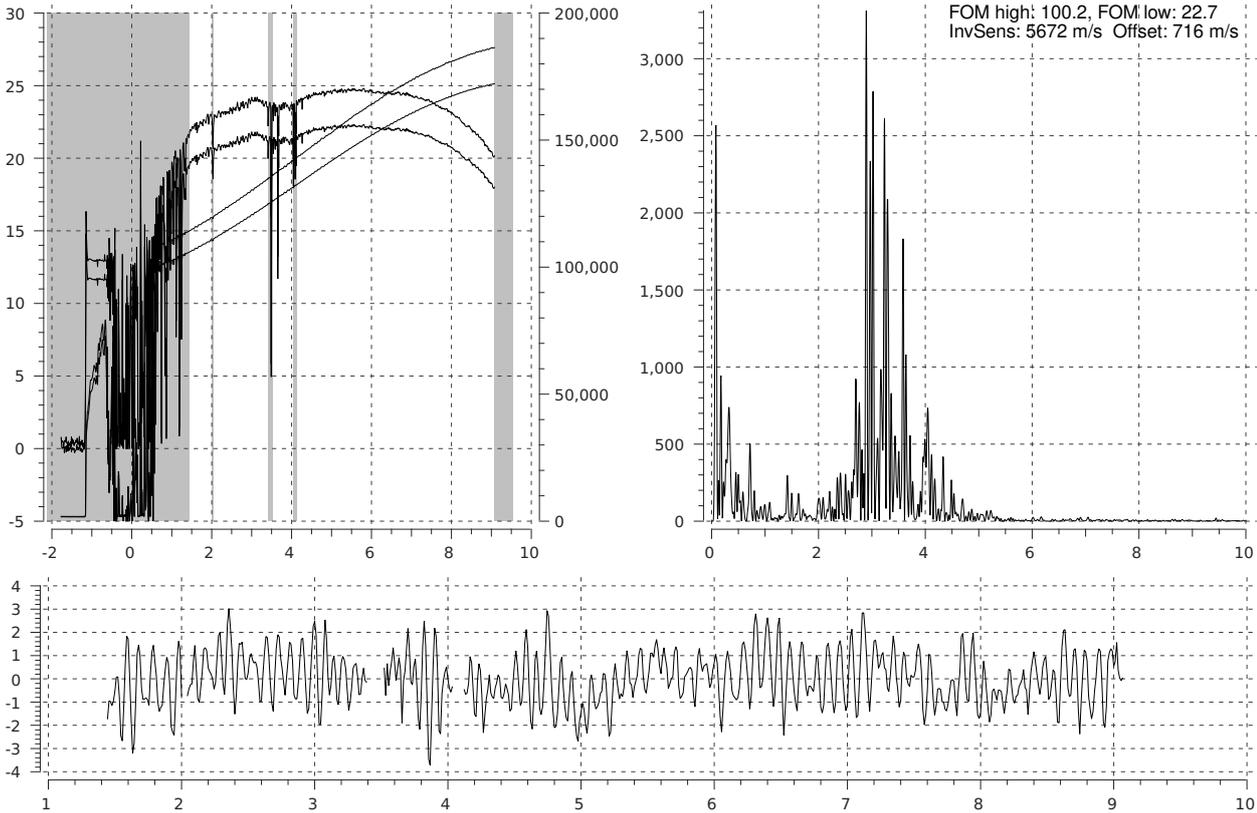
Carnarvon/Jabba - 2019 February 28

Figure 5: Data from Jabba with the counters reconfigured to use a 2.5 ms front porch and 47.6 Hz switching rate. The low frequency drifts have been almost completely removed, and the white noise visible at high frequency also shows a noticeable improvement.

Shortly after this site visit, the above changes were made to the counter configuration on February 27. Figure 5 shows data from February 28. The weather is rather hazy/dusty and so the results are not ideal, but the low frequency issues have been almost completely resolved and there is a noticeable improvement at high frequency. The ratios from the forward port and starboard detectors now show similar sensitivity, and so this resolves a problem that has been observed since 2009 [5]. However, the calibration inverse sensitivity is still low at 5.6 km s^{-1} rather than the typical expected 3 km s^{-1} , and the reason for this is still under investigation.
