TECHNICAL REPORT NO. 362

The Installation of a Digital Autoguider in Sutherland in 2013 November

Steven J. Hale

2013 December 10

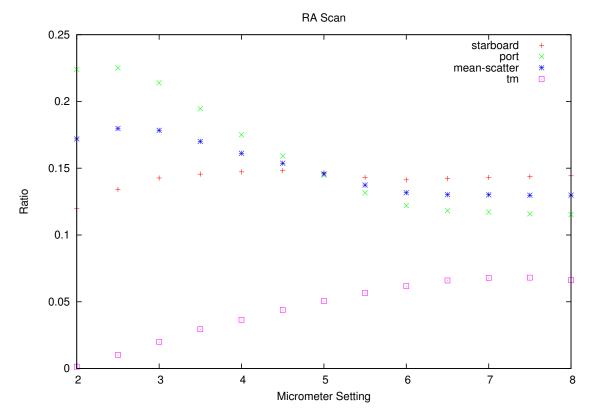
Only one autoguider scan was performed. The RA micrometer was scanned while the cell was hot. The Dec micrometer was not scanned because it is completely seized and could not be rotated no matter which position the locking ring was adjusted. The results from the RA scan are shown in figures 1 and 2.

Initially the RA micrometer was set to 7.0 mm and the Dec micrometer set to 7.5 mm. The guider scans from this instrument are not that clear, but it appears that the ideal alignment is when the RA micrometer is at 7.0 mm as currently configured.

Figure 1: RA Ratio.

There is no reason to believe the spectrometer or telescope alignment would have changed, and so the micrometers were left in their initial positions and no further guider scans were performed.

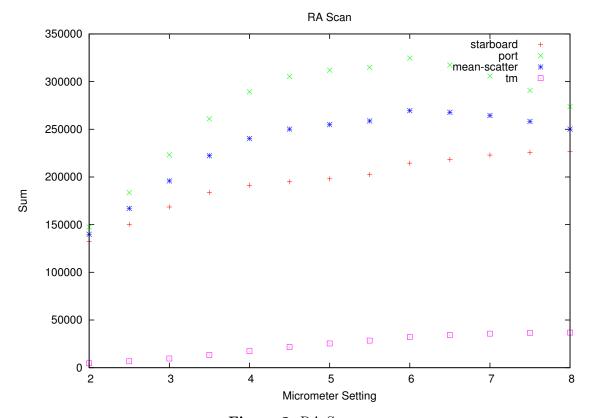
Figure 2: RA Sum.
