TECHNICAL REPORT NO. 294

The Installation of the Sutherland Temperature Controllers in 2007 August

Details of the trip to Sutherland to install new temperature controllers and replace the damaged water tank are presented.

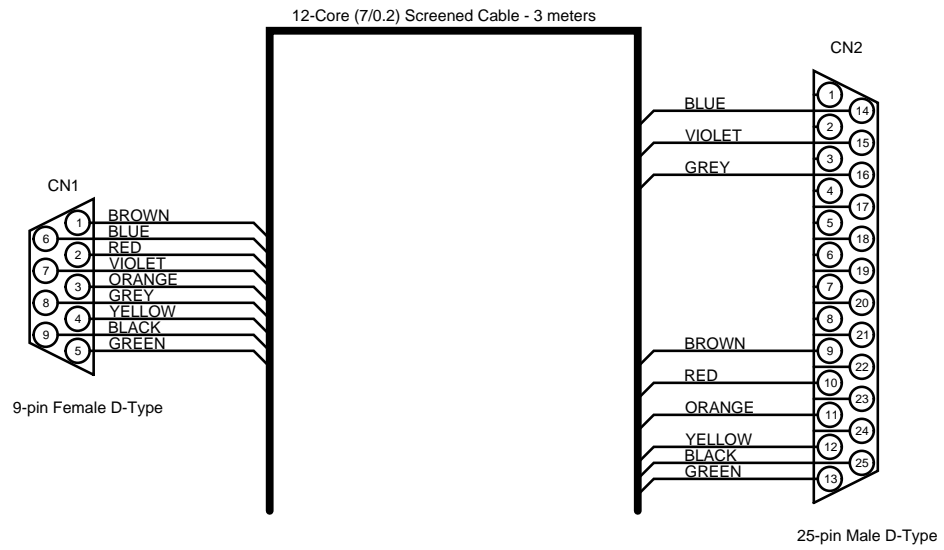
Figure 1: The Mains Controller Cable.

The Mains Controller Cable connects the Mains Controller to the DIO Splitter Card. Figure 1 shows the cable that is used in Sutherland.

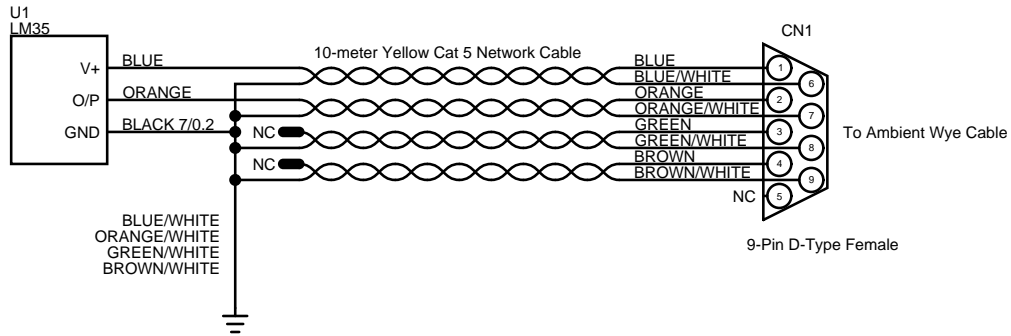
Figure 3: The External Temperature Probe.

The LM35 was potted inside a thermocouple pocket which makes the probe water resistant. A mounting bracket and cover was also made and these were used to mount the temperature probe on the exterior wall of the dome.

When the Sutherland Temperature monitor was installed an LM35 was used to measure the ambient temperature outside the dome. At the time concern was expressed as the LM35 was only protected from the elements by heat-shrink. It was expected to get damaged by water at some point. However the LM35 managed to survive but it was replaced on this trip.

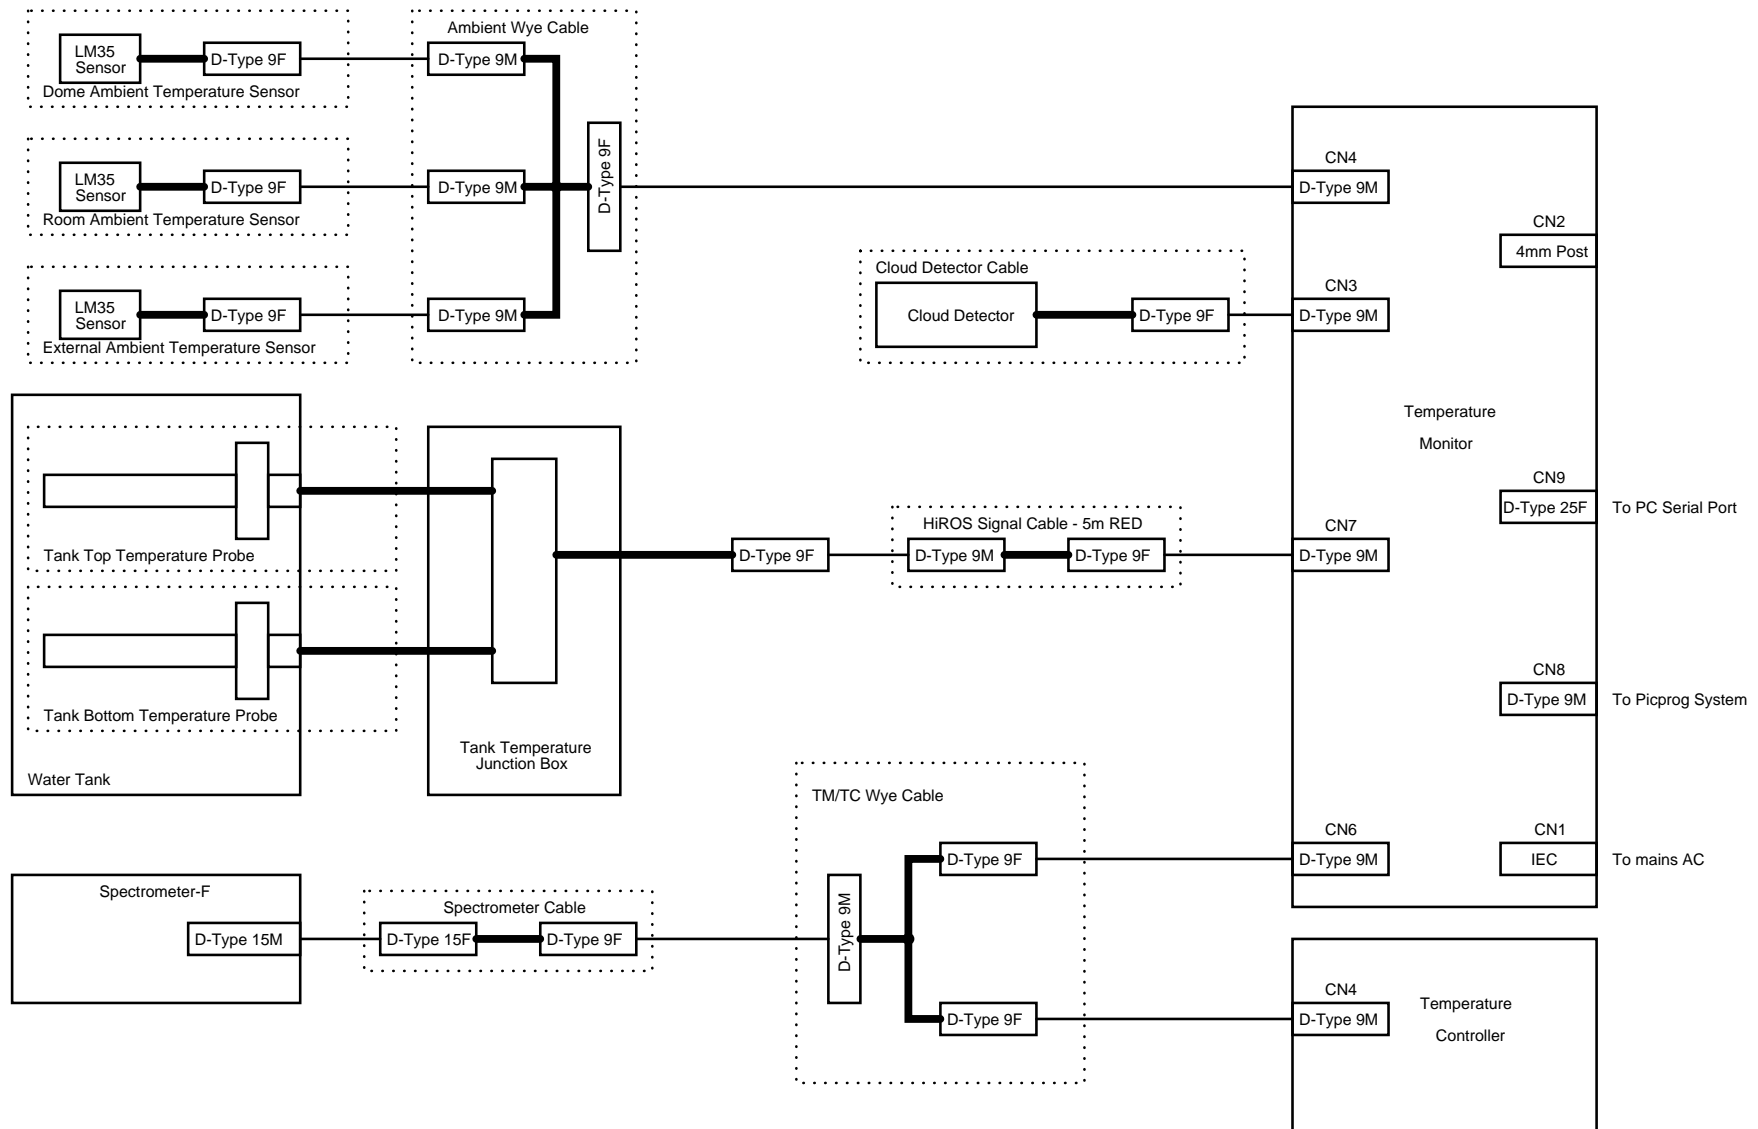
Figure 4: The Sutherland Temperature Monitor System.

Following the changes to the Sutherland Temperature Monitor the system diagram as shown in BTR-277 is now incorrect. Figure 4 shows the system diagram for the Sutherland Temperature Monitor System.

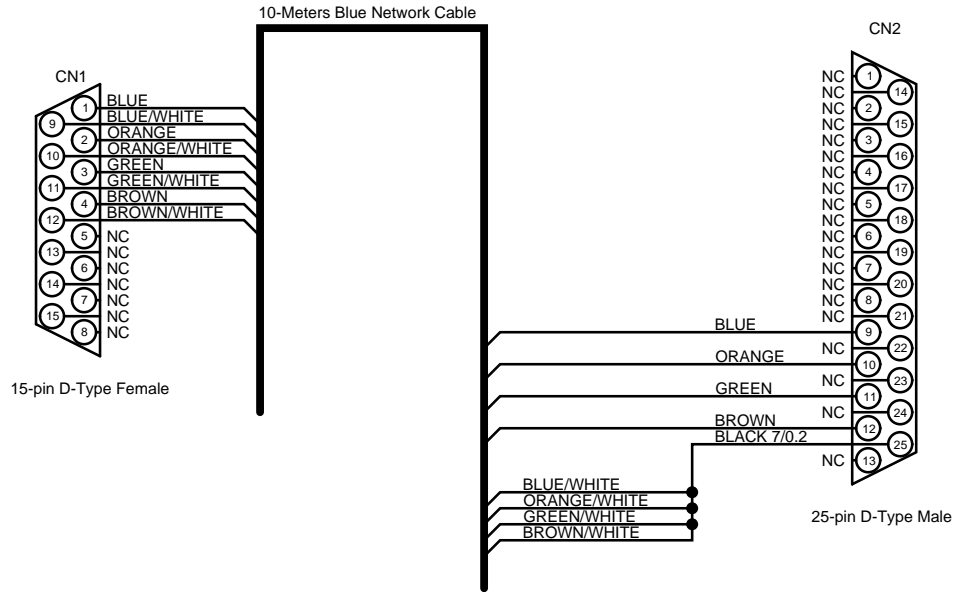
Figure 5: The Tank Relay Box Cable.

The Tank Relay Box cable carries the control signals from the computer via the DIO splitter card to the tank relay box. The tank relay box controls the extractor fans, water heater, water cooler unit and water pump.

Figure 5 shows how the tank relay box cable is wired.

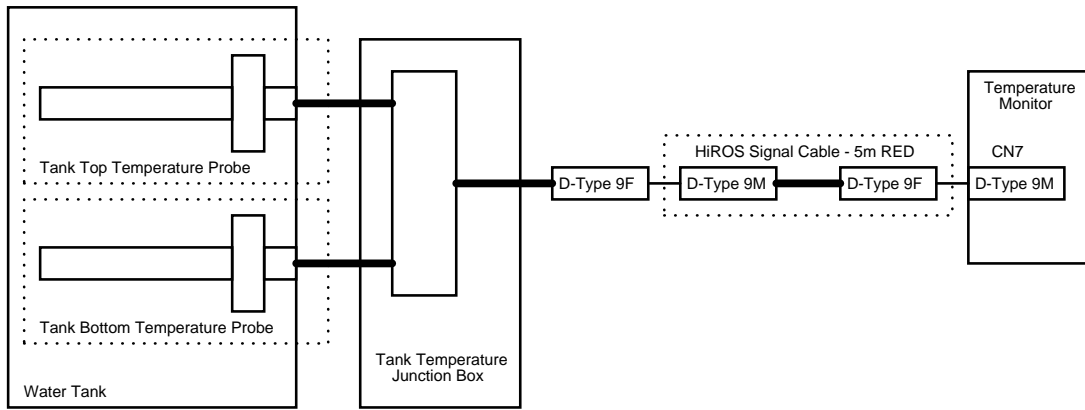
Figure 6: The Tank Temperature System Block Diagram.

On the original water tank the temperature sensors were fitted into the side of the tank. This meant that changing the probes due to failure was a tricky operation. Whilst removing the probes from the old tank it was also noticed that the turning motion needed to unscrew the probes from their fittings was damaging the cable where it came out of the thermocouple pocket.

In order to make changing the probes easier and to prevent damage to the cable, it was decided to mount the probes from the top of the tank and use the cable to hang the probe at the correct depth.

Figure 6 shows the tank temperature system block diagram.

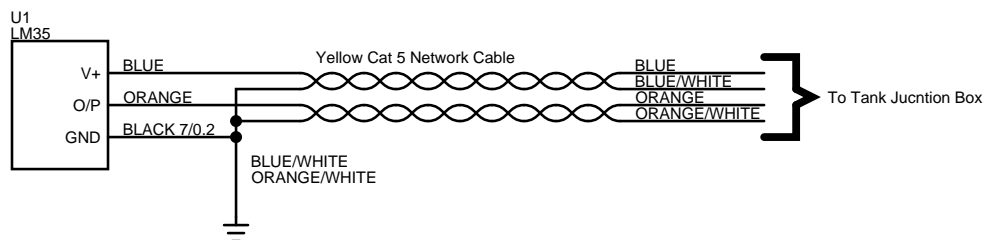
Figure 7: The Tank Temperature Probe Wiring.

Both of the temperature probes have identical wiring and this is shown in Figure 7.

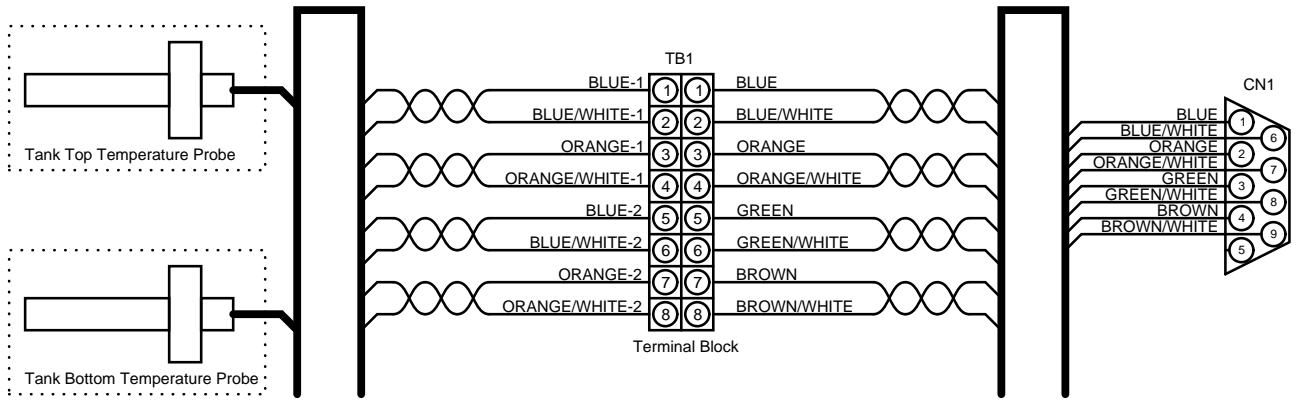
Figure 8: The Tank Temperature Probe Junction Box Wiring.

The Tank Temperature Junction Box is simply a die-cast box mounted on the top of the water tank that contains the wiring for the temperature probes. A separate cable gland for each temperature probe secures the cable allowing the depth that the probe sits to be set.

Each temperature probe uses two of the four twisted-pairs of a network cable. All of the signals from both probes can therefore be combined and transmitted down a single network cable.

In order to combine the signals into one cable terminal block was used. Figure 8 shows the internal wiring of the temperature junction box.

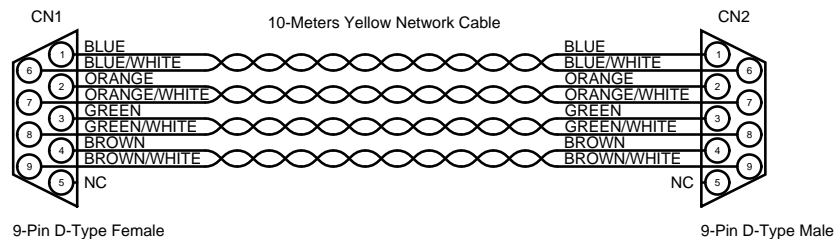
Figure 9: The HiROS Signal Cable.

The HiROS signal cable is this standard cable. It is basically a network cable that has D-Type connectors fitted on each end. The cable is made up of 4 twisted pairs of 7/0.2 wires. The cables come in a variety of different lengths and several different outer sheath colours are available including yellow, blue and red.

Figure 9 shows how the cable is connected internally.

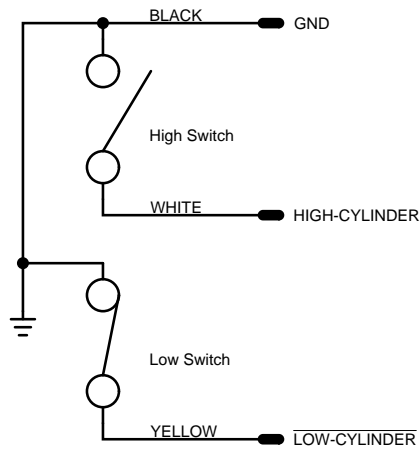
Figure 10: The Cylinder Float Switch — Internal Circuit Diagram.

The cylinder float switch has two switches inside as shown in Figure 10. The upper switch indicates that the water in the tank is at a high level whilst the other switch indicates a low water level. The inputs on the DIO card are pulled high by pull-up resistors and when the appropriate contact on the float switch is opened by the float passing the corresponding level, the signal goes low.

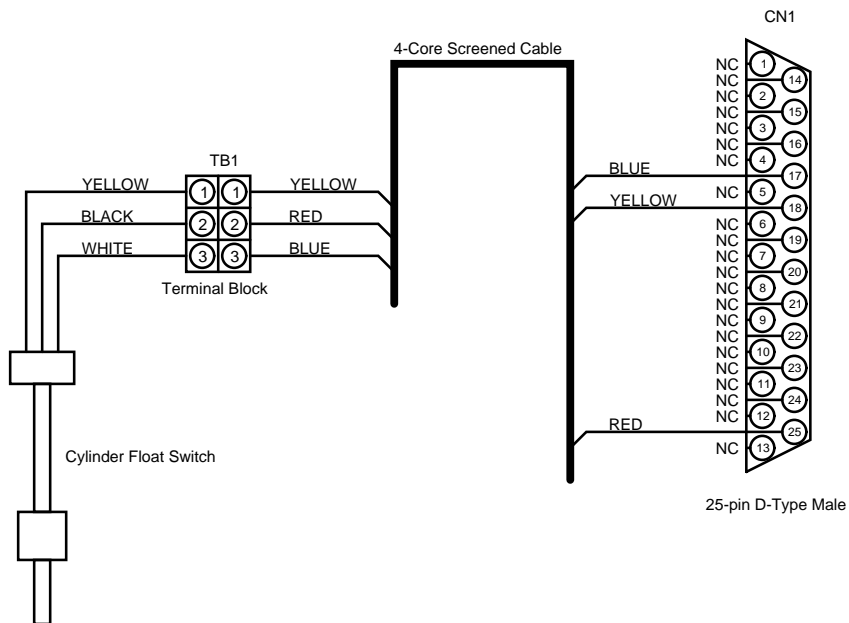
Figure 11: The Cylinder Float Switch Wiring.

The old tank used a float switch to indicate that the water was low. However this sensor did not sense that the water had leaked out of the tank and thus the tank was melted by the heater element which was trying to heat the water that wasn't there.

It was expected that the float switch had failed however when the unit was tested it was found to be working properly. The reason for the failure of the float switch was eventually found. There was a wiring mistake and the sensor was connected to the wrong input on the DIO card, this is why the computer did not see that the water level was low.

Even though the sensor that was fitted to the old tank was still working perfectly the metal ring that acts as a mechanical stop was badly corroded and disintegrated when touched. The sensor was scrapped and a new one was fitted to the replacement tank.

The sensor is mounted through the top of the tank and a die-cast box. Figure 11 shows the wiring of the cylinder float switch.

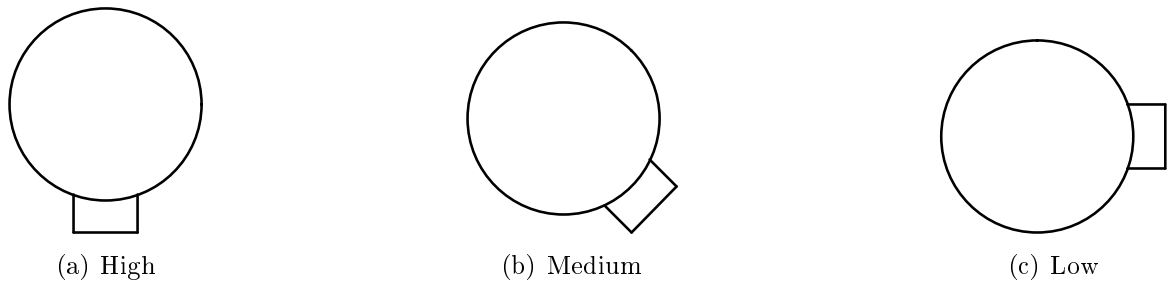
Figure 12: The three different states of the Ball Float Switch.

The ball float switch looks like the ballcock out of a toilet with a cable coming out of it. The cable is tethered at a specific length and the ball will float on the water with the cable just hanging loose. As the water drops the cable gets pulled tight and eventually it tips the ball past its horizontal axis and the switch changes state.

Figure 12 shows how the position of the ball switch changes as the water level decreases towards the alarm point. In Figure (a) there is plenty of water in the tank and the ball switch is floating on top of the water, this is the “high” water position. In Figure (b) the water level has dropped and the ball is now starting to pull the cable taught. This state can be called the “medium” water position. In Figure (c) the water level has dropped even further and the cable has pulled so tight as it has pulled the ball to the horizontal position. This causes the changeover switch to change state and this can be detected by the computer.

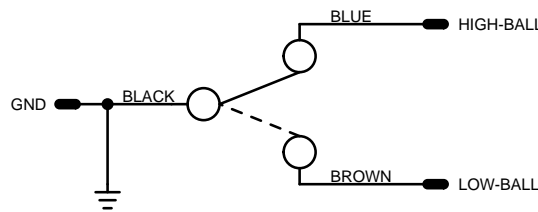
Figure 13: The Ball Float Switch — Internal Circuit Diagram.

Figure 13 shows the equivalent circuit for the ball switch that is fitted in the tank at Sutherland.

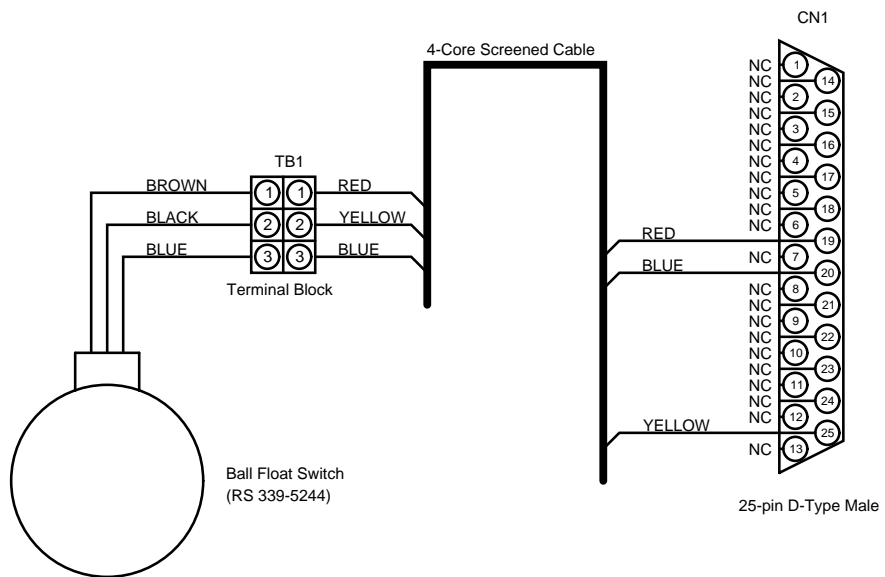
Figure 14: The Ball Float Switch Wiring.

The sensor is mounted through a die-cast box on the lid of the water tank. Inside the box there is a cable clamp which is used to clamp the cable of the sensor at the appropriate alarm point. Figure 14 shows the wiring of the ball float switch.

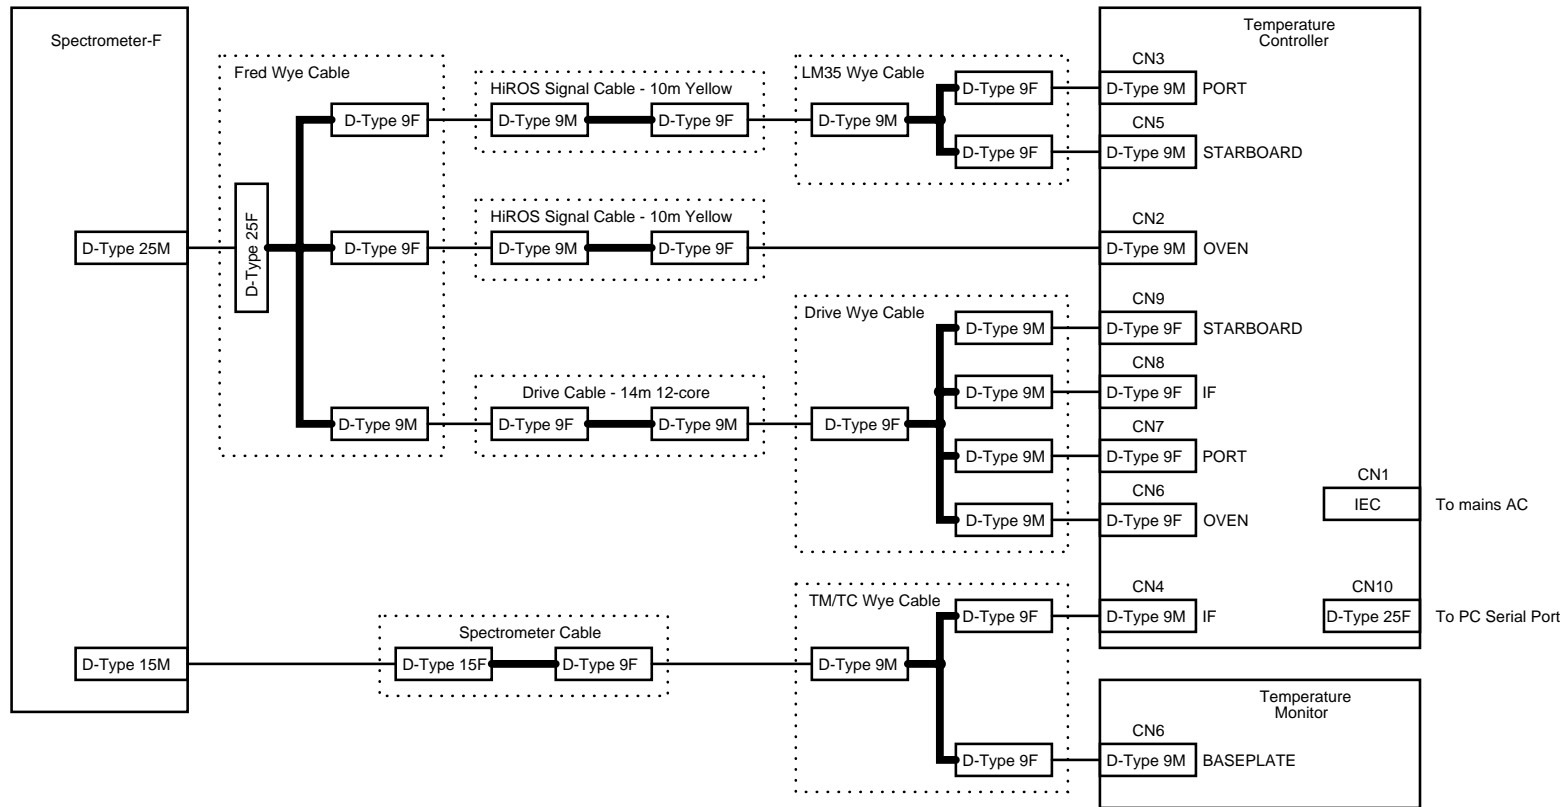
Figure 15: The Sutherland Temperature Controller System.

Figure 15 shows the system diagram for the Sutherland Temperature Controller System.

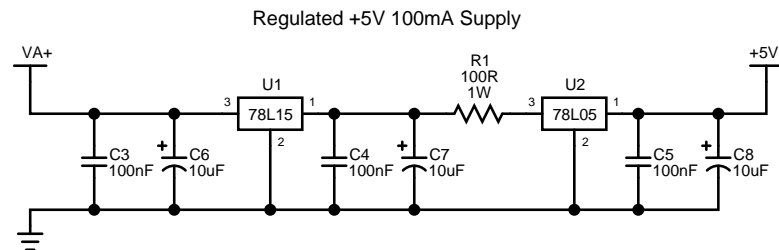
Figure 16: The +5 V Regulated Power Supply as used on the POWER-1 PCB, which is used within the Sutherland V/F Power Box.

The V/F Power box was left in-situ for a day and the data was analyzed. The data had gone completely haywire. The fault was traced to a problem with the +5V rail. Basically a 100-mA regulator was used to provide the +5V rail for the electronics inside Fred, and this device could not provide enough current and hence the voltage was dropping too low at around +3.5V. Figure 16 shows the +5V regulated supply as it was designed on the Power board within the V/F Power Box.

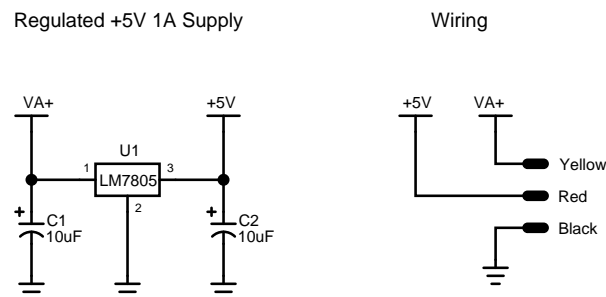
Figure 17: The new 1 A +5 V regulated power supply built to replace the on-board circuit.

To fix the V/F Power Box a new +5V regulated supply was created on a small piece of veroboard and connected to the POWER-1 PCB. The new circuit used a voltage regulator that can supply a maximum current of 1 A. Figure 17 shows the circuit diagram of the new circuit that was used.

The modifications to the POWER-1 PCB are given below:-

- Depopulated U1, U2 and R1.
- Connect yellow wire on veroboard to U1-3.
- Connect black wire on veroboard to U1-2.

- Connect red wire on veroboard to U2-1.

The veroboard circuit was tested and tested with no load and also with the V/F converters connected and the output of the voltage regulator was steady at a constant +5 V. A new PCB should be designed for the Sutherland V/F Power Box and installed on the next visit to the station.
