TECHNICAL REPORT NO. 382

## Fibre-feed tests at Mount Wilson in 2016 September

### High-Resolution Optical-Spectroscopy Group

## Abstract

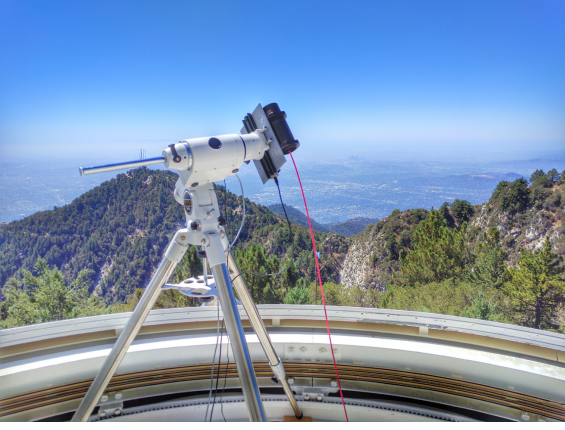
(a) Skywatcher HEQ5-Pro mount.

**Figure 1:** Fibre-feed mount and telescope. The guider image has been inverted for printing.

After arriving on-site on September 13, the first four days of the visit were occupied entirely with installation of the new hardware. The mount is a *Skywatcher HEQ5-Pro* with a standard tripod. The fibre-collector and guider head attaches to the mount as a binocular arrangement. Both use 80 mm focal length objective lenses to form an image of the Sun approximately 0.7 mm in

diameter, with one focussing onto a 1.0 mm diameter optical-fibre and the other onto a *Starlight Express Superstar* CCD camera. The mount and telescope system are shown in Figure 1.

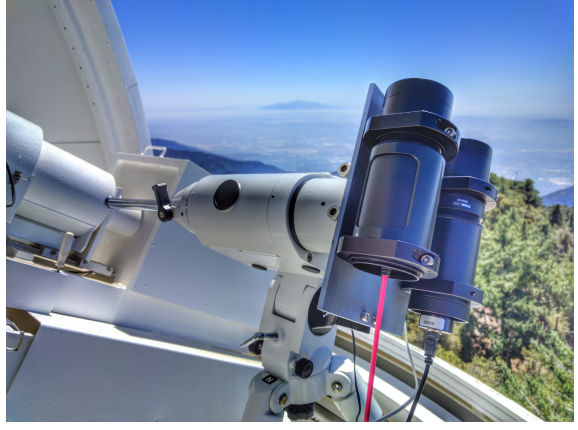
(b) Fibre-collector and CCD camera.

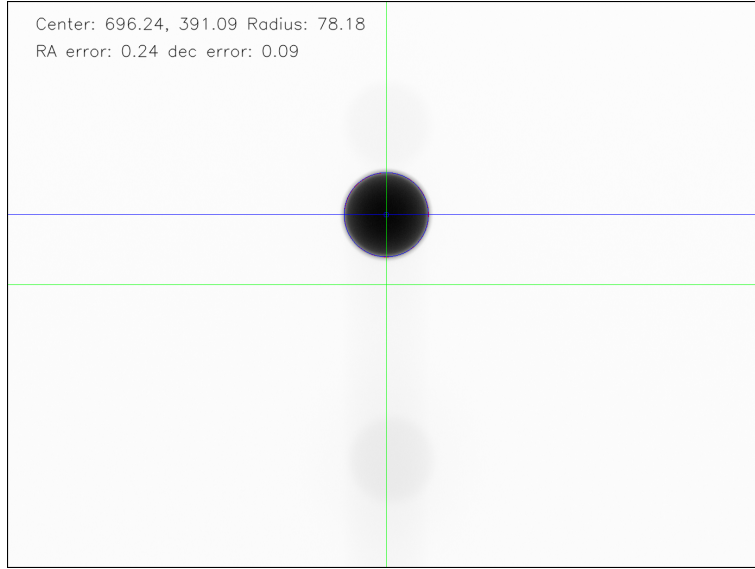
(c) Guider image processing with OpenCV.

The mount was guided throughout the day by capturing images from the CCD camera and processing the position of the Sun using the OpenCV (Open-source Computer-Vision) library. An example of the image captured by the camera is shown in Figure 1c. Images were read from the camera as fast as possible — approximately once per second. The image exposure time is 79 ms. The image cadence limit is due to the CCD read-out time and USB transfer rate. The centroid position of the solar disc was found using OpenCV by applying a black and white threshold, finding the contours in the image, and subsequently reading out the contour centroid position. A measure of guiding error was determined by comparing the current solar position

with the pixel values found when the solar image was observed to be directly on the centre of the fibre. The position error for each axis was then passed through a PID controller in order to determine the correct mount drive rate, and the mount updated with the new rate. The optics when mounted are short enough to allow the mount to move from the east horizon to the west horizon without requiring a meridian-flip at solar-noon, and so this greatly simplifies the mount control algorithm.

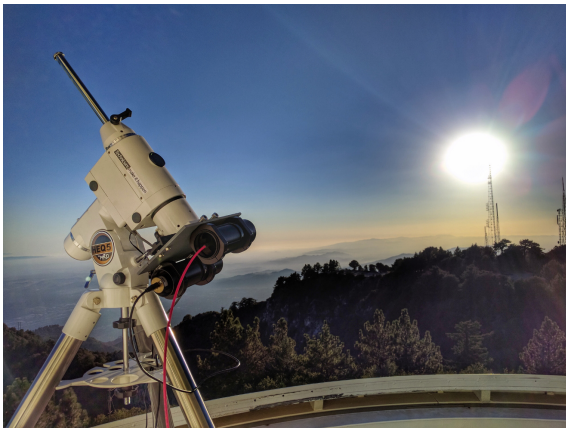
(a) Radio antenna

(b) Guider shadow

**Figure 3:** Radio antenna shadowing.

The first test of the new system was on September 17. Most of the day was taken finalising the PID guiding functions, and so only three hours of data were collected in the afternoon. The data, shown in Figure 4, suffer a oscillation at 8.165 mHz but otherwise look very good. Shortly before sunset, the Sun passed behind one of the radio towers to the west of the observatory, shown in Figure 3, causing a temporary issue with guiding.

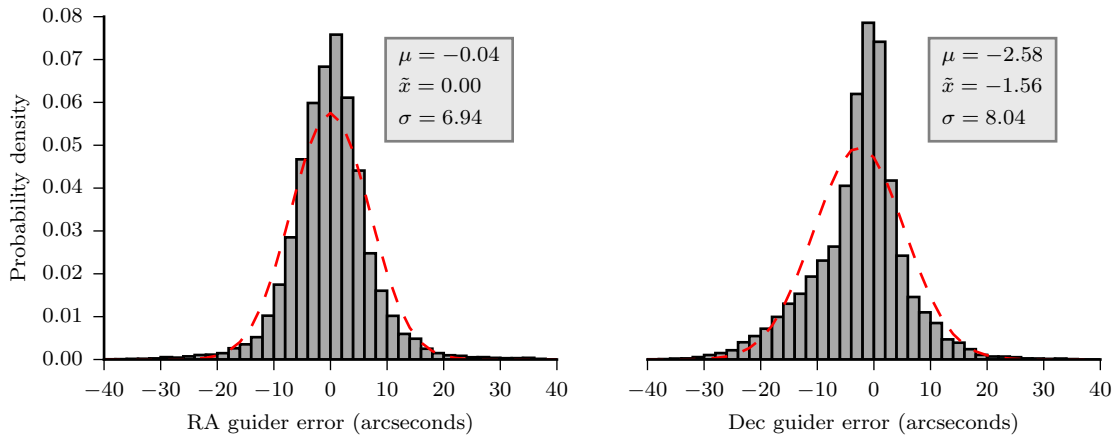
**Figure 10:** Guider performance histogram on 2016 September 24. The dashed red line indicates the equivalent Gaussian for the measured median and standard deviation.

A further four days of data were acquired before it was time to restore Klaus to the original mirror-fed configuration. Additional guider telemetry logging was also added in order to assess the guider performance and stability. Results from September 24 are shown in Figures 11. The cause of the low-frequency drifts in the residuals is not clear. It is possibly a footprint-like problem which has been previously solved by tilting the front coarse red filter, and so the cause is most likely back-reflections somewhere in the system. The RA proportional gain was reduced which eliminated the 8.165 mHz guider oscillation. The jumps in RA position error shortly after sunrise and shortly before sunset, shown in Figure 8, are due to backlash in the RA drive-train as the telescope weight shifts on the axis. Both axes have a minimum drive rate of 6 microsteps-per-second, and this is visible in the declination drive rate, Figure 9, where the PID control becomes essentially an on/off switch at minimum-rate around zero-error. The distribution of position-error for both axes, calibrated in arcseconds, is shown in Figure 10.

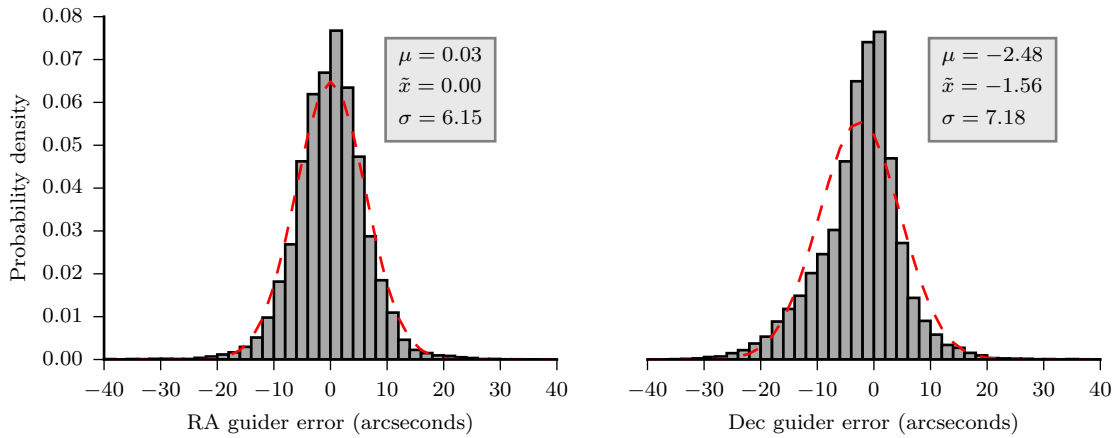
**Figure 14:** Guider performance histogram on 2016 September 25. The dashed red line indicates the equivalent Gaussian for the measured median and standard deviation.

Several different guider PID coefficients were tested over the next few days. Results from September 25 are shown in Figure 15, 12, 13, and 14.

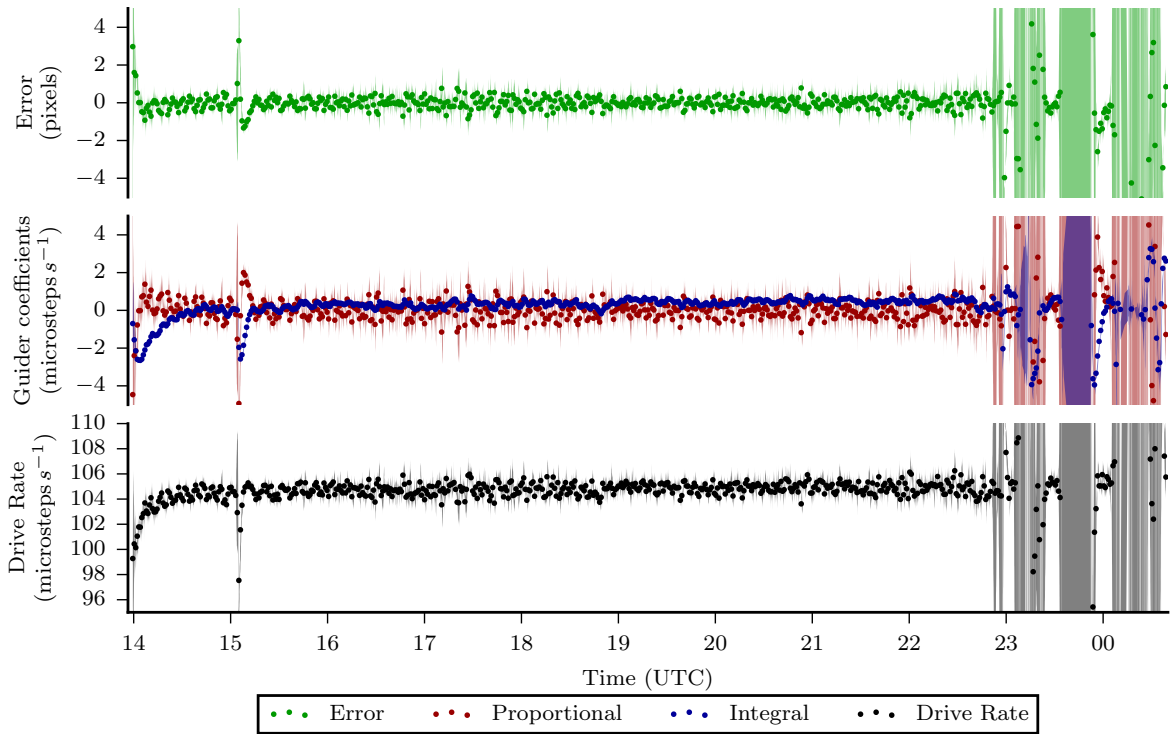
Figure 16: Guider RA performance on 2016 September 26. Each dot represents the median of 50 points, and the banding represents  $\pm 1$  sigma on each median value.

Results from September 26 are shown in Figure 19, 16, 17, and 18. At the end of the day the movement of the declination axis was found to be very notchy. The movement cleared as the axis was manually exercised several times through the full range of motion. This is possibly the cause of the slightly asymmetric error distributions on the declination axis.

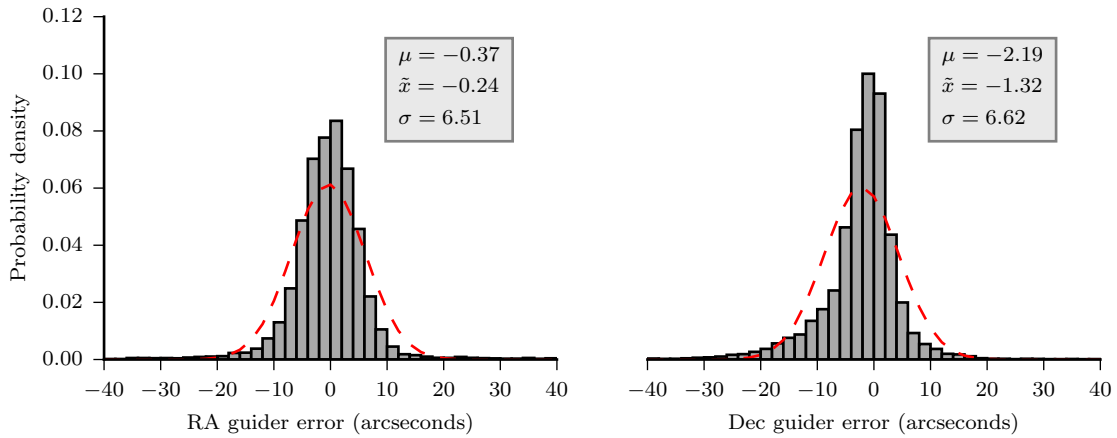
**Figure 18:** Guider performance histogram on 2016 September 26. The dashed red line indicates the equivalent Gaussian for the measured median and standard deviation.
