BiSON
Birmingham
Solar-Oscillations
Network

TECHNICAL REPORT NO. 276

The Grand Opening of the Sutherland Zoo

2006 October 16

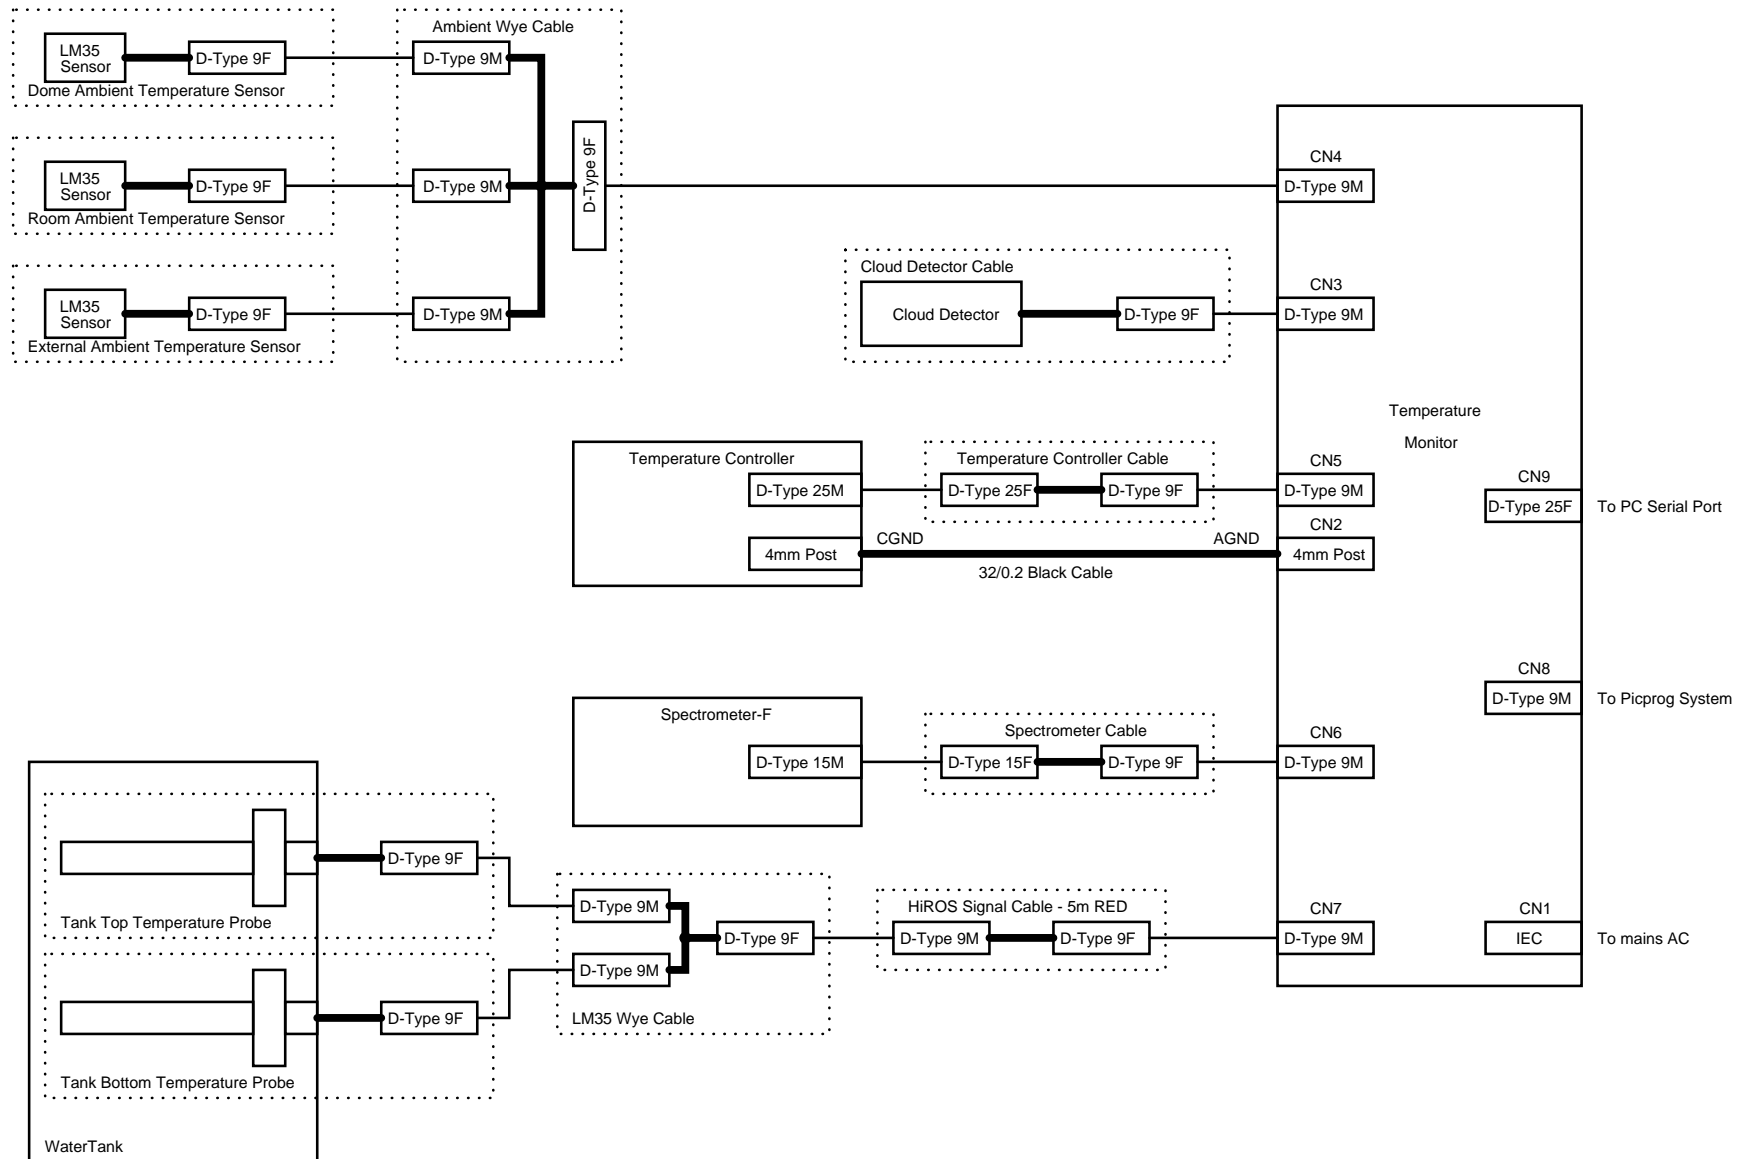
Figure 1 shows the entire temperature-monitor system as installed in Sutherland. For more detailed information on the Sutherland Temperature Monitor, consult BTR-277.

Figure 1: The temperature monitor system diagram.
