TECHNICAL REPORT NO. 332

The Installation of New Temperature Controllers at Narrabri in 2010 February

Ian Barnes and Steven Hale

2010 November 9

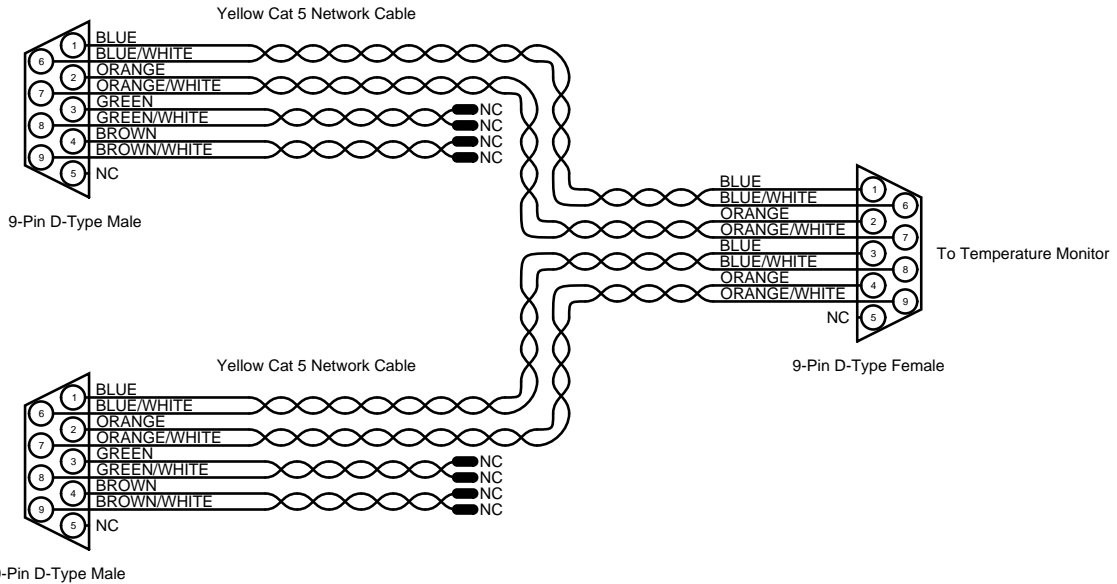
Figure 5: The LM35 wye cable.

In order to combine the room and dome temperatures to use a single connector on the rear of the temperature monitor an LM35-Wye cable was used. The LM35-Wye cable is shown in Figure 5.

The temperature monitor hardware has undergone several hardware revisions since the Narrabri unit was built. Given the lack of the LM35 board and the fact that the cloud detector interface is on veroboard it is strongly recommended that the temperature monitor here gets replaced on the next visit.
