TECHNICAL REPORT NO. 389

## Jabba fibre conversion at Carnarvon in 2018 April

Steven J. Hale and Eddie Ross

2018 June 22

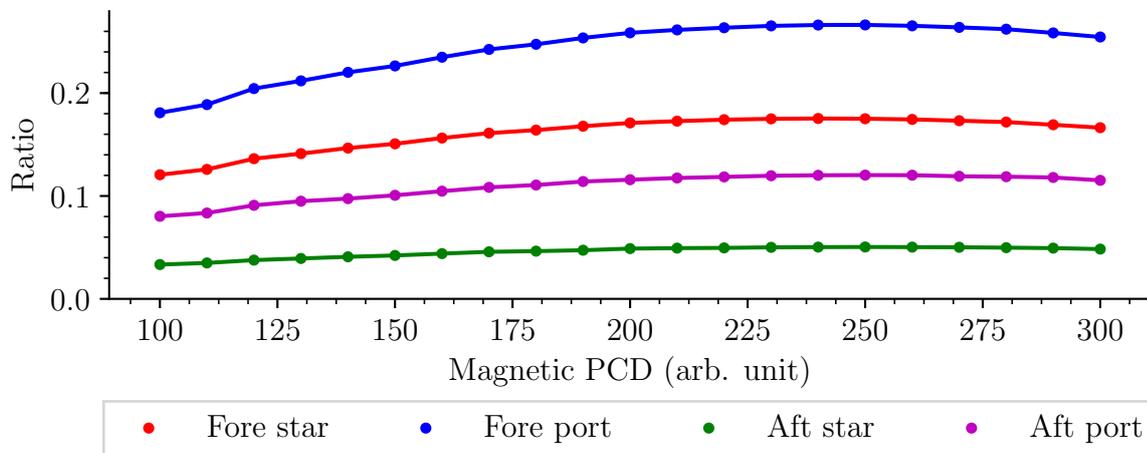
**Figure 5:** Magnetic Pockels cell calibration.

It is not possible to directly optimise the optimum voltage for the magnetic Pockels cell. Instead, the cell has to be moved behind the linear polariser where the standard velocity ratio can be measured. It is important to also move the supply cables, so that the whole final circuit of driver-cables-cell is checked at once. The drive voltage can then be scanned to find the voltage at which the ratio is maximum, and this is shown in Figure 5. The driver dial setting is not calibrated to voltage and is an arbitrary unit. The initial setting was 170, and the ratio was found to be maximised at a setting of 250. It is likely that the magnetic Pockels cell voltage has never been optimised due to the cable issues found during the installation. The solar magnetic data from Jabba is likely unusable from 2009 onwards! Following optimisation cell L13 was returned to the magnetic position in front of the linear polariser.
